1 **Assessment of heritage rammed-earth buildings. The Alcázar of King Don**
2 **Pedro I (Spain).**

18 **ABSTRACT**

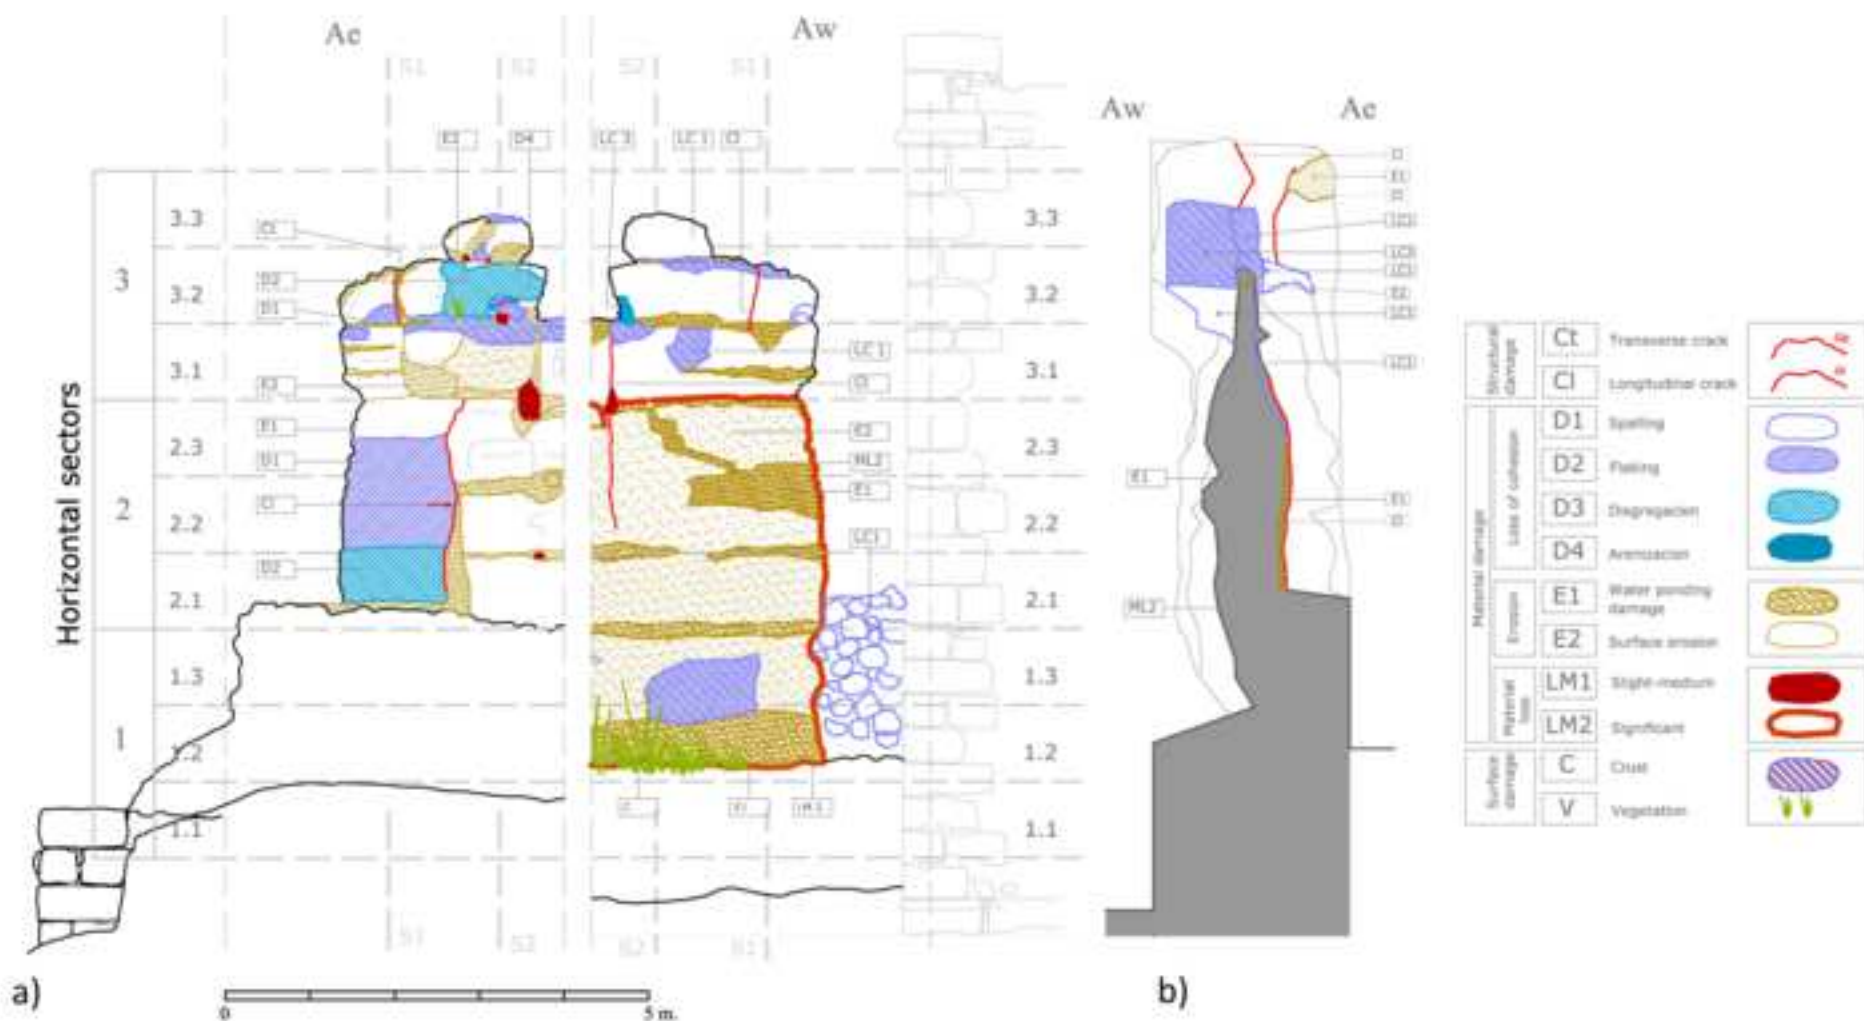
582 Fig. 4. Failures represented in two elevations (a), and cross-section S1 of vertical sector A (b).

202 damage is rated in one of two categories (low and high) depending on the development and
203 intensity of the surveyed failure. For instance, Figure 4 represents two sectors, where sector Aw
204 is considered as high-damage, and Ae as low-damage, since the former sector presents failures
205 that are more critical and more widely spread (loss of mass, LM2). In Section 3, Table 3 shows
206 the results of the damage survey and the category of each sector depending on the rate of
207 damage.
