Repair of the Church of La Purisima Concepcion of Huelva (Spain) with Jet-Grouting, for Damages Caused by the Construction of Diaphragm Walls in its Proximity

REPAIR OF THE CHURCH OF LA PURISIMA CONCEPCION OF HUELVA (SPAIN) WITH JET-GROUTING, FOR DAMAGES CAUSED BY THE CONSTRUCTION OF DIAPHRAGM WALLS IN ITS PROXIMITY

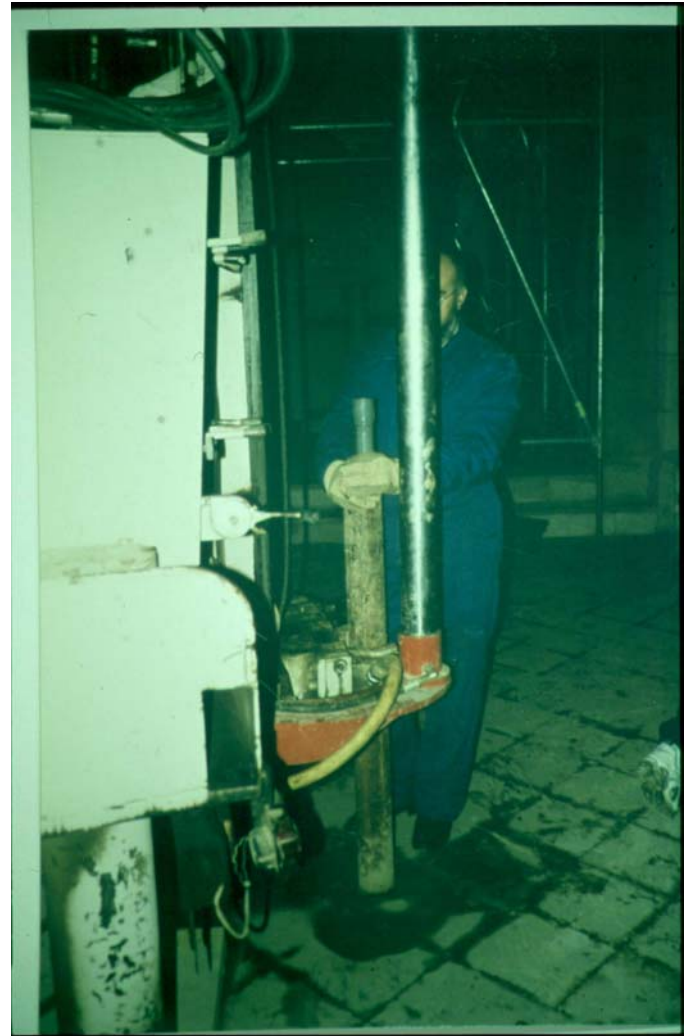
Fig. 2. Bore holes machine working inside the church

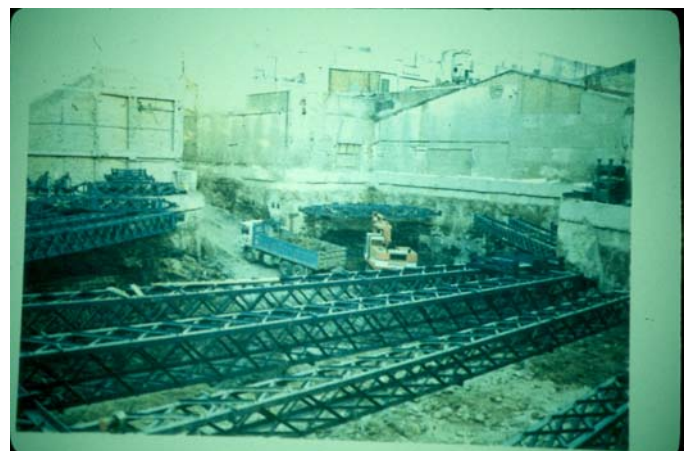
Because of the irregular geometry of solar, the bracing supports were not arranged perpendicular to the walls, but are placed in angles even in 41°, what complicates clearly the

transmission of efforts and the efficacy of the pre-stressed. Besides the lengths of many of the support are next to the 30m. The wall was built in very long parts in many cases, longer than the 5 meters.

Fig 5. Bracing support.

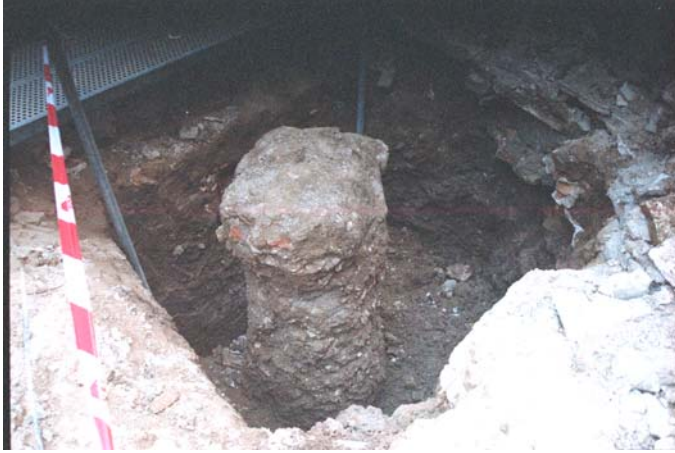
Fig. 6. Jet-grouting column.

The repair of the Church consisted in “Jet Grouting” (J-1) all around the church. The system consists essentially in the cement grouted with very high pressures breaking the adjacent soil, at the same time that is mixed with the whitewash of cement grouted and whose result is a column of cemented soil. The employed columns have a length of 15 and 30 meters and a diameter of 70-80 cm.

The inclination of the columns went of 7° in the perimeter of the temple and of 15° in the four central pillars. 65 columns of 15 meters they were carried out and 31 of 30 meters.

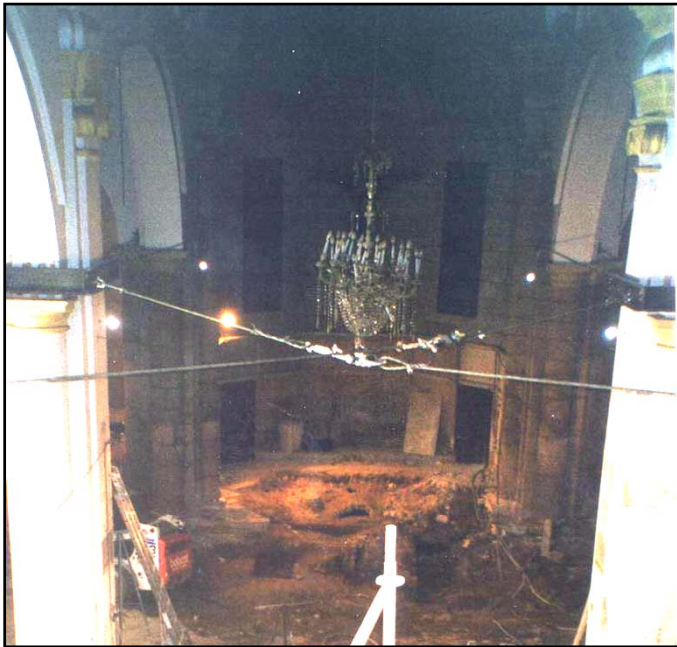
Fig. 7. Struts among head of pillars.

Before begin any grouting was carried out a leveling of the building and of the environment, to be able to control the possible movements induced by it, as well as the monitoring of the cracks of the arches and in the different walls. Also there were placed horizontal struts among heads of pillars in the two directions, by means of a steel cables, giving them stability to the church.

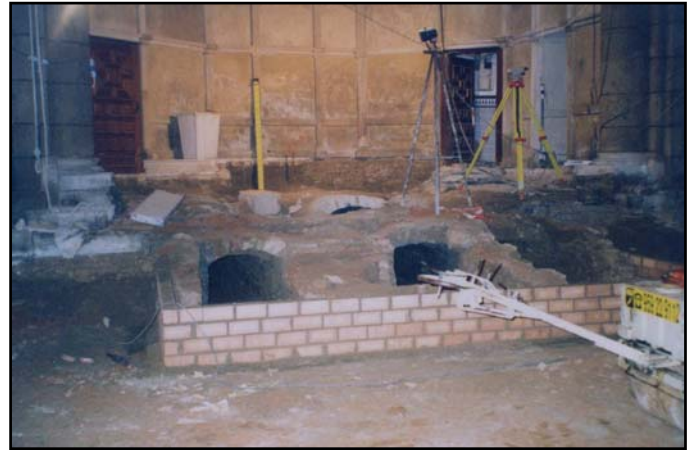
Fig 9. Crypts

In some zones the excavation was made by hand because they found three crypts in the presbytery and an under the chapel of the Vera Cruz, in which human remains were found. Their vaults are straight tube with circular guideline, built with a solid thread of a foot brick received with lime mortar.

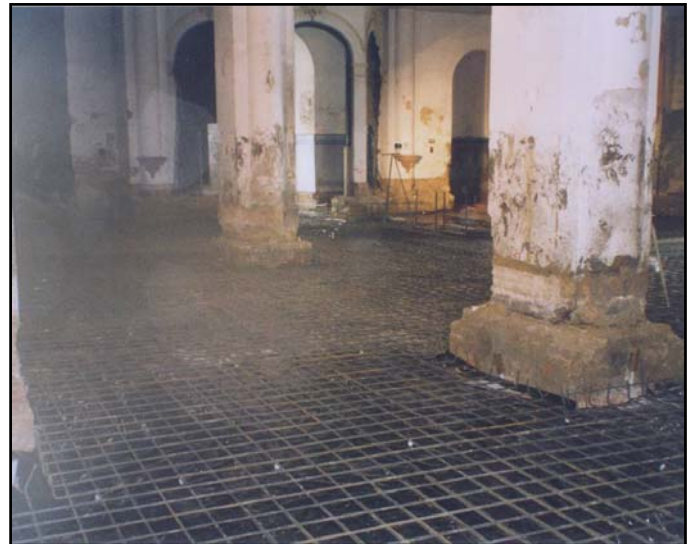
Fig 10. Concrete slab.

After finishing with the injection it was excavated to a depth of 1,10 meters, being filled with gravel and compacting the 40 lower centimeters. A PVC sheet was placed above the gravel and a concrete slab was built, with a surrounding beam to tie the heads of all the columns of Jet of the interior of the church.

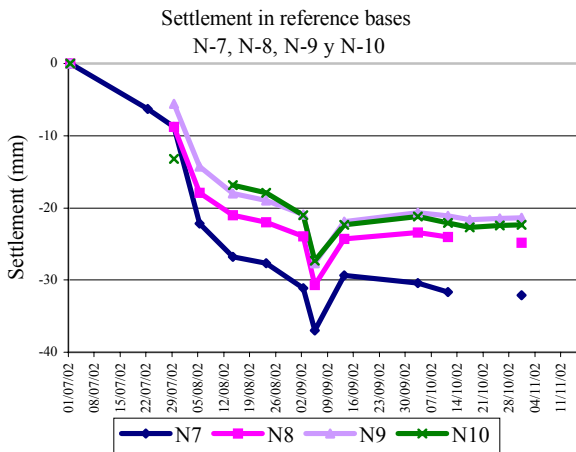
Fig 8. Settlements in reference bases.

The measured heaves went of 9 mm maximum in some points, oscillating most of them, around 1-2 mm, as we can see in the graphics (fig. 8).
