Degradation analysis of photovoltaic modules after operating for 22 years. A case study with comparisons

ABSTRACT

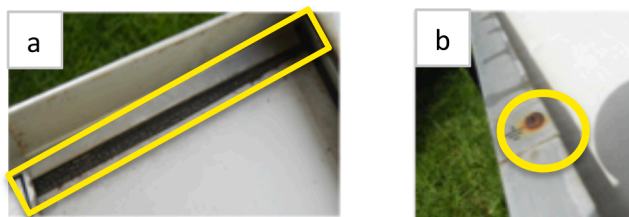
All the module aluminium frames were in good conditions. Nevertheless the silicone joint is cracked and the grounding screws present

Fig. 2. Frame defects: silicone joint cracked (a) and grounding screw oxidation (b).

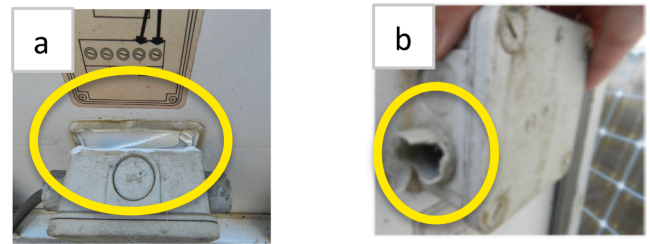
All modules have junction box conduits degraded. Another defect found is that 4% of junction boxes (2 per PV module) are bad attached to the backsheet as it is shown in Fig. 3.

Fig. 3. Junction box defects: Degraded conducts (a) and detached junction box (b).

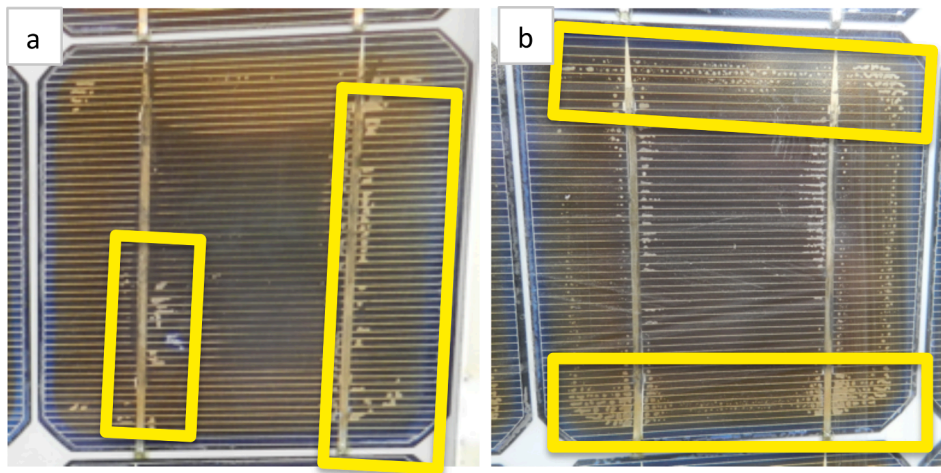
EVA is the dominant encapsulant material used in the lamination of c-Si PV modules. The milky pattern is the most common type of delamination observed in all PV modules but the degree of affection is not identical among all of them. A severe milky pattern is observed on large areas over the solar cells, mainly at the proximity of the interconnection ribbons and at the cell discoloration perimeter, and, to a lesser degree, at the cell perimeter as shown in Fig. 4.

The origin of this defect could lie in a chemical reaction between the cell antireflecting coating and certain additives in the module encapsulant.

Fig. 4. Milky pattern at the proximity of the interconnection ribbons (a) and at the cell discoloration perimeter (b).

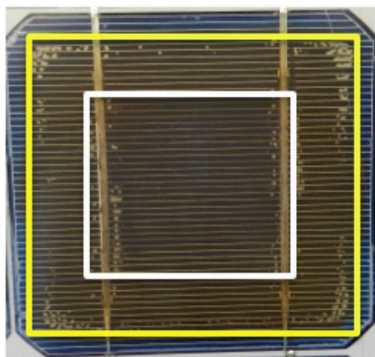
This discoloration is not totally homogeneous in cells. Inside the cells, the discoloration is lower at cells perimeter. Additionally, two levels of discoloration with almost square shape have been observed. These are either a more intense discoloration inside the cells interconnection ribbons and also a squared less intense discoloration that surrounds the previous one up to approximately 0,5 cm from the cell perimeter, as shown in Figs. 5 and 6.

Fig. 5. Concentric discoloration levels in the cell.

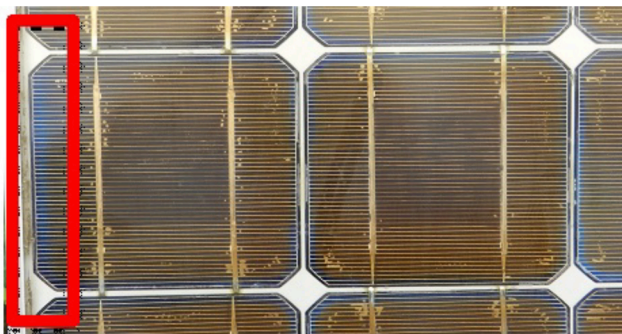
Fig. 6. Non-symmetrical discoloration levels in cells located on the perimeter of the PV module (red box) and two concentric discoloration levels in both cells. (For interpretation of the references to color in this figure legend, the reader is referred to the web version of this article.)

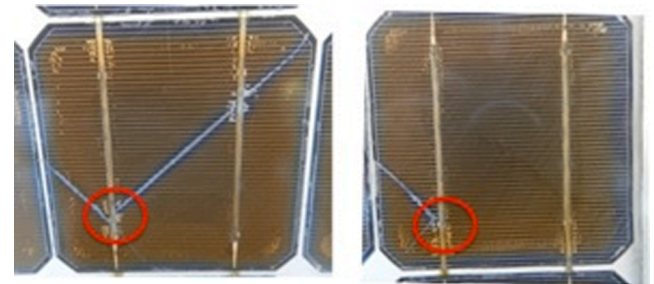
the back-sheet. Fig. 7 shows the visual image (top) of a typical crack in the back-sheet of a module and the corresponding crack in the cell at the same location.

The cell cracks may have been formed during mechanical or thermal stresses on the cells during manufacturing, transport or bad handling during loading and unloading of the container or installation, disassemble and reassemble and the exposure period. In this study, it has been observed, Fig. 7, that about 50% of the cell cracks have just been originated in the solder point between the interconnections ribbons of two cells according to Itoh et al. (2014).

Fig. 7. Two cracked cell originated in the welding of the interconnection ribbons between two cells.

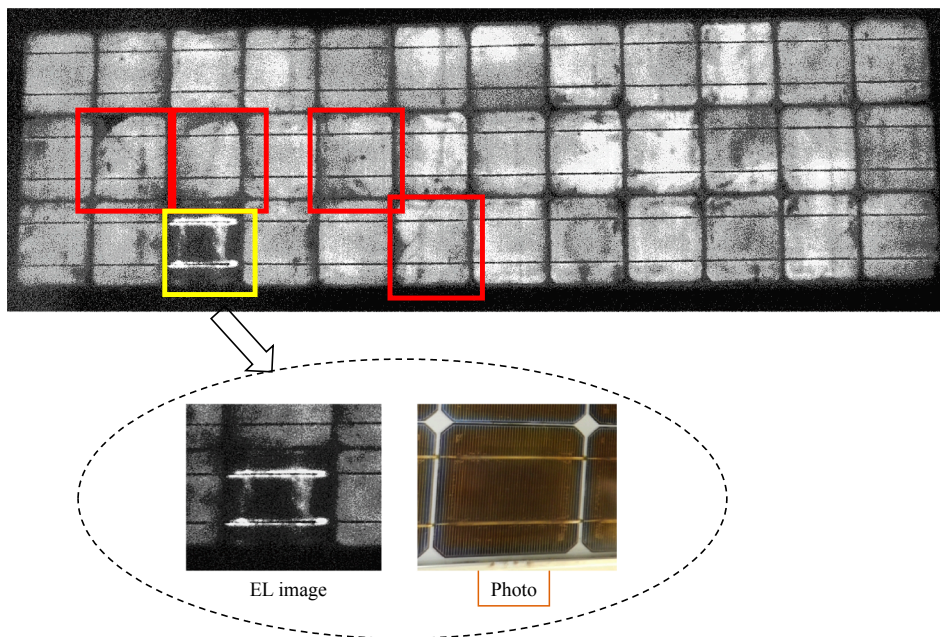
Depending on the size, shape, position and length of the crack, the impact on the PV module performance is very different (Papargyri et al., 2020). While single cracks perpendicular to the busbars cannot electrically separate any area of the cell from the busbars, cracks parallel to the busbar may lead to high separated cell areas, up to 25% for cells with two busbars (Kajari-Schröder et al., 2011). In our research, more than 70% of the cracked cells were due to perpendicular breaks to the busbars. Fig. 8 shows the utility of the EL test to identify defects in the cells of the PV module. For instance, the cell with the yellow circle is defective. Only with a visual inspection the cell does not seem to be in bad conditions but with EL image the defect is detected. Other defects such as cracked cells (red square in Fig. 8) with the non-operative part can be easily identified.

Fig. 8. Electroluminescence image of a PV module with a PV cell photo.

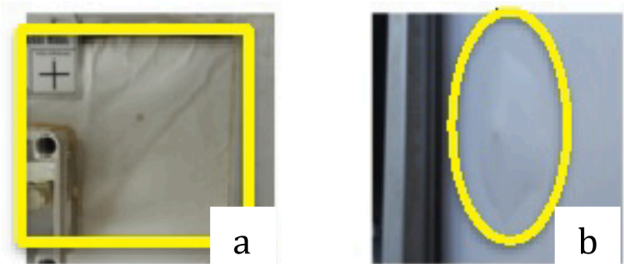
In 14,29% of the PV modules bubbles were observed and in 7,14% of the PVmodules delamination of the backsheet was detected as shown in Fig. 9. This delamination took place at the interface between the outer PVF and the PET, and between the PET and the inner PVF, mainly in the place of the junction box, but not only there. The inner PVF remained well attached to the EVA. This could indicate a stability problem of the proprietary adhesive used at the backsheet. In general, delamination defects depend on encapsulant materials, climate and exposure time (Julien et al., 2020)

Fig. 9. Backsheet delamination (a) and bubble (b).

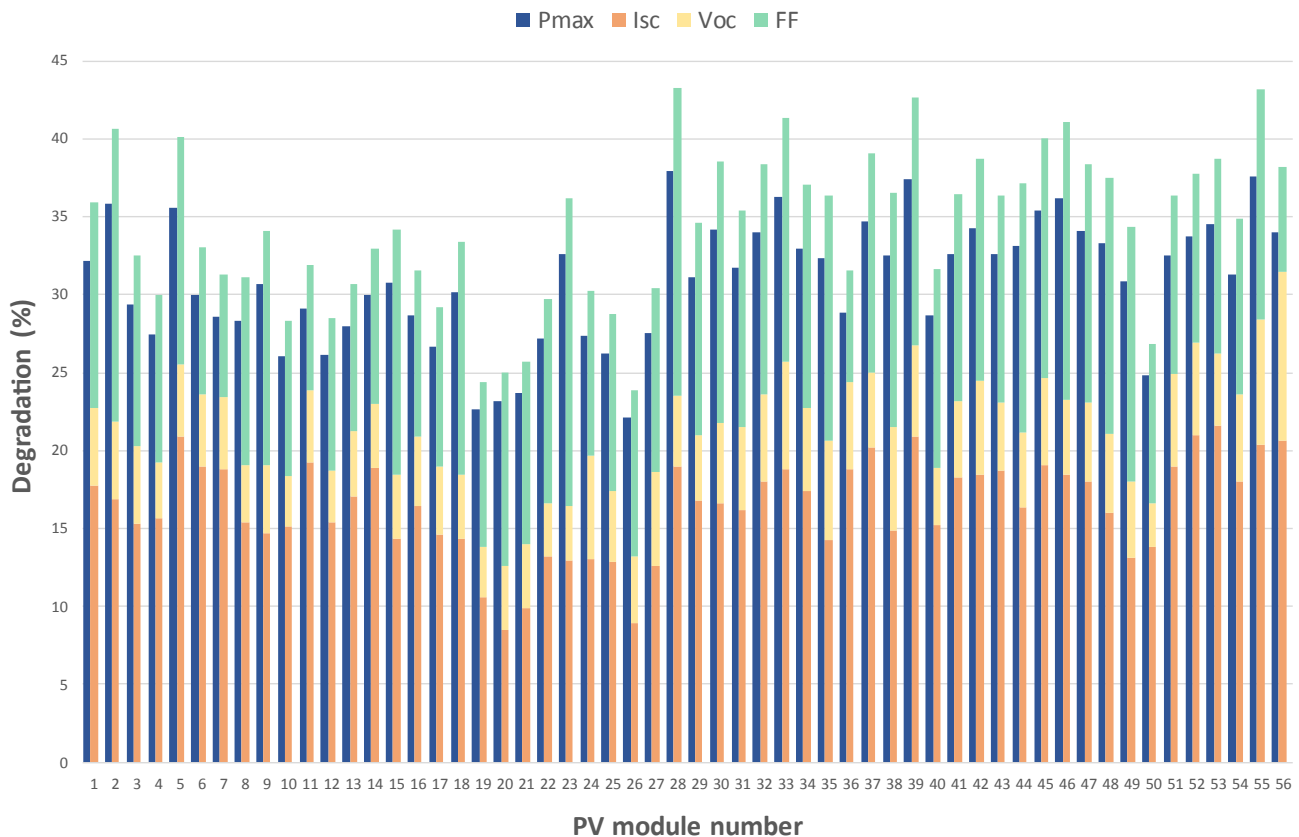
Fig. 10 shows in a column the degradation percentages of P_{max} , and in another column the degradation percentages of I_{sc} , V_{oc} and FF for all the 56 PV modules analyzed.

Fig. 10 shows that the degradation of the maximum power of most of the analysed PV modules is due to a greater extent to the short-circuit current degradation, followed by the degradation of the fill factor and the open circuit voltage. Likewise, it has been obtained that the P_{max} value shows an average degradation of 30,9% throughout the 22 operation years, having a maximum of 38,0% and a minimum of 22,2%, which corresponds at an annual ratio between 1,0–1,7%/year with an average of 1,4%/year. Moreover, the average degradation of the I_{sc} has been 16,4%, which corresponds to an annual ratio between 0,4–1,0%/year with an average annual ratio of 0,8%/year. The average FF degradation has been 13,0%/year which corresponds to an annual ratio between 0,3–0,9%/year, with an average annual ratio of 0,6%/year. The V_{oc} average degradation has been 4,9%, which corresponds to an annual ratio between 0,1–0,5%/year, with an average annual ratio of 0,2%/year.

Fig. 10. Total degradation percentage of the 56 PV modules (2 bars for each module). In the dark blue bar Pmax, in the other bar in orange, yellow and green colors, Isc, Voc and FF degradation respectively. (For interpretation of the references to color in this figure legend, the reader is referred to the web version of this article.)

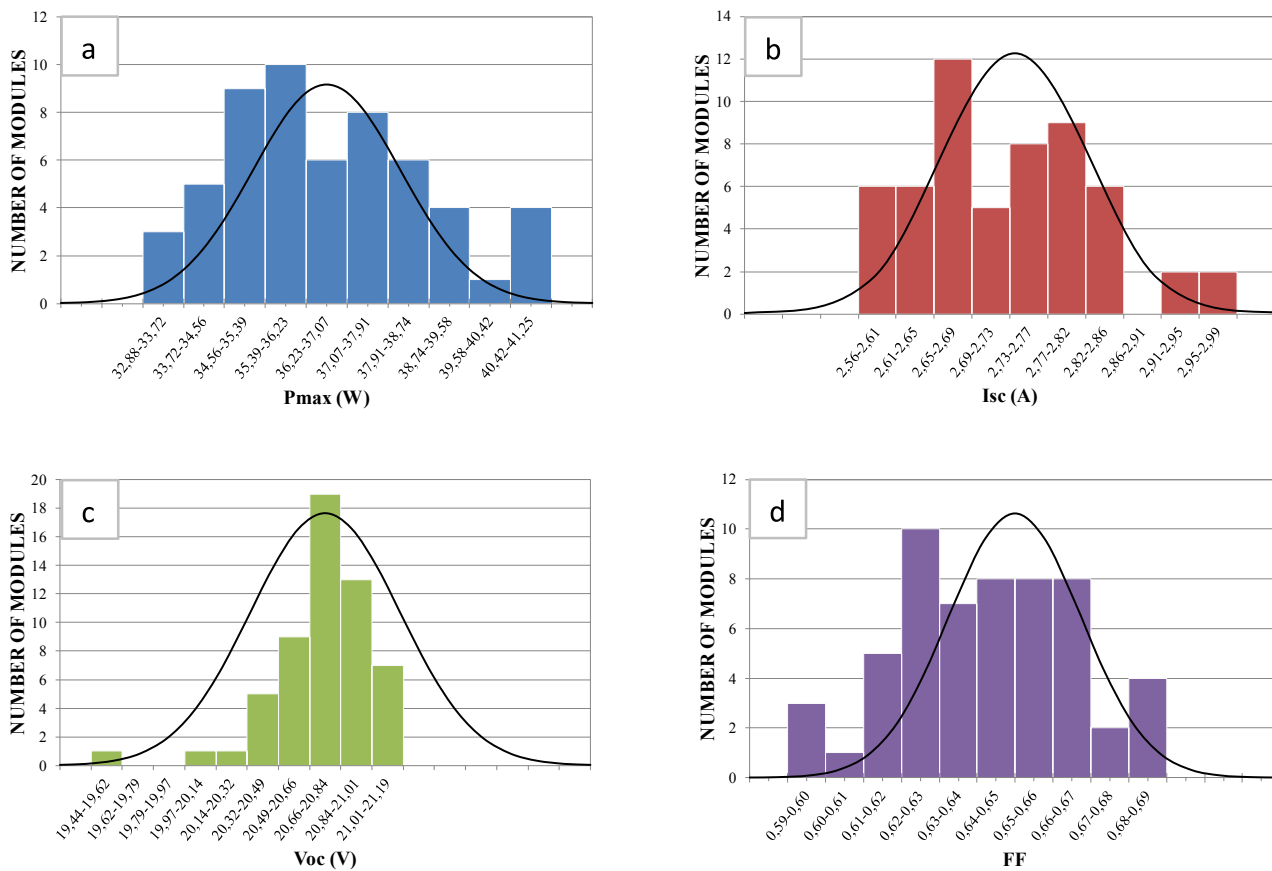
Fig. 11. Degradation rates dispersion parameters after 22 years of outdoor exposition. (a) Maximum power, (b) Short circuit current, (c) Open circuit voltage and (d) Fill factor.

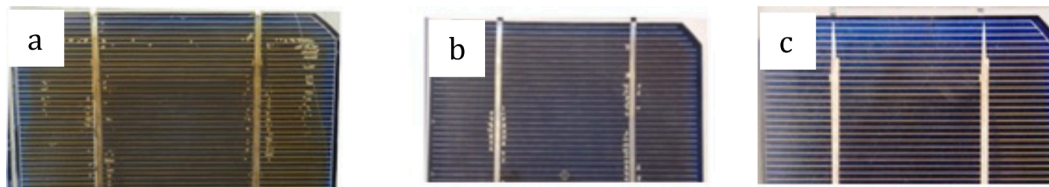
However, although all studies show discoloration symptoms, as the operating time increases, the severity of discoloration, cell oxidation and milky pattern increases. Fig. 12 shows the appearance of the cell in three of the four studies. With these images, the difference in the severity of discoloration, milky pattern, and especially of oxidation of cell and interconnects. According to the IEA-PVPS T13-09: 2017 (Köntges et al., 2017) and Ferreira da Fonseca et al. (2020), oxidation defects exponentially affect degradation and would partly explain the higher degradation rate in our study, added to the FF and Voc degradation rate.

Fig. 12. Visual appearance of a cell after 22 years of operation (this study, photo a), compared with a similar cell after 15 years (Ferreira da Fonseca et al., 2020, photo b) and 12 years of operation (Sanchez-Friera et al., 2011, photo c).
