European Geosciences Union General Assembly 2013, EGU

## Characterization of Compounds Formed and Added on Surface of Outdoor Seville City Hall

M.D. Robador<sup>1</sup>, F. Arroyo<sup>2</sup>, J.L. Perez-Rodriguez<sup>3,\*</sup>

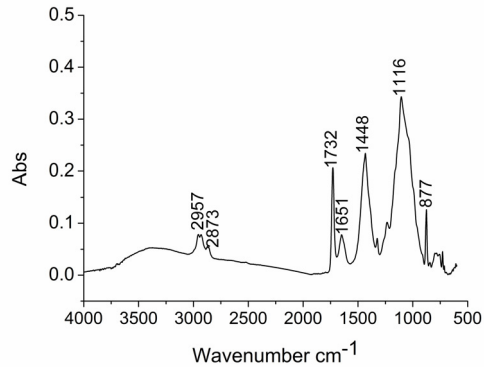
The study by scanning electron microscopy of small fragments showed a compact and continuous cover that suggests a polymer layer (fig. 2). The IRTF spectra obtained in the external surface (fig. 3) showed absorptions bands at 2849, 2873, 2957, 2980, 1732, 1448 and 1324  $\text{cm}^{-1}$  attributed to acrylic resin. The band at 1116  $\text{cm}^{-1}$  was attributed to gypsum. The mass spectroscopy of the black crust showed the presence of alkanes produced by petrol combustion. Other organic compounds were also detected as isoprenic hydrocarbons, fatty acids, amides and polycyclic aromatic hydrocarbons. These organic compounds have been found also in other monuments of Seville [4, 5]. The XRD analysis of the black crust showed the presence of gypsum with calcite and quartz. The chemical analysis carried out by EDX in the SEM showed also the presence of microspherules of different chemical composition.

Fig.3 FTIR

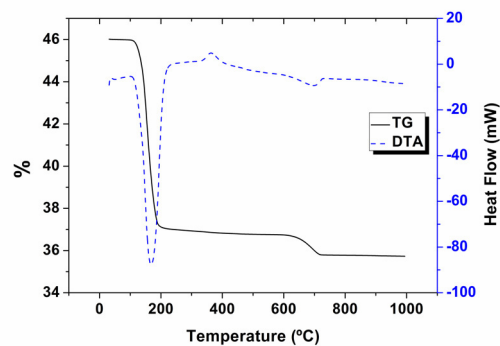
Reposition materials were observed covering losses of pieces and fixing fragments of stones. Gypsum is the main component of these samples (80-95%) according with the XRD (fig. 4) and TG studies (fig 6). Other materials used, similarly that the gypsum previously describes or used to join stones pieces were characterized as mortars. These materials were constituted by calcite and inert material, mainly quartz. In addition, feldspars and mica appeared. One of these samples is a material constituted by calcite 40%, quartz 50%, mica < 5% and feldspars < 5%. Disaggregated stone showed a high concentration of gypsum (45%), quartz (15%) and calcite (38%) in the external area. In internal parts of the sample the calcite percentage increased to 60%. These data suggested that this sample has been altered by the effect of the environmental contamination, mainly by  $\text{SO}_3$ . The calcite content decreased in comparison with the original stone (no-altered) being the alteration higher in the external part of the sample. Gypsum was also found in the interior of the stone confirming that it has emigrated due the high porosity of the stone.

Fig. 6 ATD and TG curves of superficial material
