European Geosciences Union General Assembly 2013, EGU

## Characterization of Compounds Formed and Added on Surface of Outdoor Seville City Hall

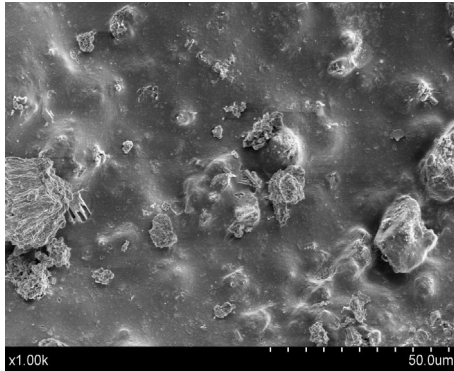
Fig.2. Microphotography by SEM

The study by scanning electron microscopy of small fragments showed a compact and continuous cover that suggests a polymer layer (fig. 2). The IRTF spectra obtained in the external surface (fig. 3) showed absorptions bands at 2849, 2873, 2957, 2980, 1732, 1448 and 1324  $\text{cm}^{-1}$  attributed to acrylic resin. The band at 1116  $\text{cm}^{-1}$  was attributed to gypsum. The mass spectroscopy of the black crust showed the presence of alkanes produced by petrol combustion. Other organic compounds were also detected as isoprenic hydrocarbons, fatty acids, amides and polycyclic aromatic hydrocarbons. These organic compounds have been found also in other monuments of Seville [4, 5]. The XRD analysis of the black crust showed the presence of gypsum with calcite and quartz. The chemical analysis carried out by EDX in the SEM showed also the presence of microspherules of different chemical composition.

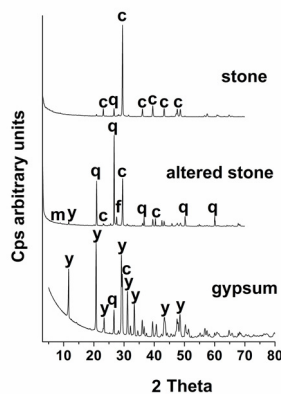
Fig. 4. XRD of studied materials: c: calcite, q: quartz, y: gypsum, m: mica, f: feldspars

The XRD of stone showed the presence of calcite and quartz (fig 4). The concentration of calcite in the stone was calculated about 95% (Table 1) and quartz percentage about 5%. In all samples was also detected the presence of small percentages of gypsum (between 2 and 5%).

Reposition materials were observed covering losses of pieces and fixing fragments of stones. Gypsum is the main component of these samples (80-95%) according with the XRD (fig. 4) and TG studies (fig 6). Other materials used, similarly that the gypsum previously describes or used to join stones pieces were characterized as mortars. These materials were constituted by calcite and inert material, mainly quartz. In addition, feldspars and mica appeared. One of these samples is a material constituted by calcite 40%, quartz 50%, mica <5% and feldspars <5%. Disaggregated stone showed a high concentration of gypsum (45%), quartz (15%) and calcite (38%) in the external area. In internal parts of the sample the calcite percentage increased to 60%. These data suggested that this sample has been altered by the effect of the environmental contamination, mainly by  $\text{SO}_3$ . The calcite content decreased in comparison with the original stone (no-altered) being the alteration higher in the external part of the sample. Gypsum was also found in the interior of the stone confirming that it has emigrated due the high porosity of the stone.

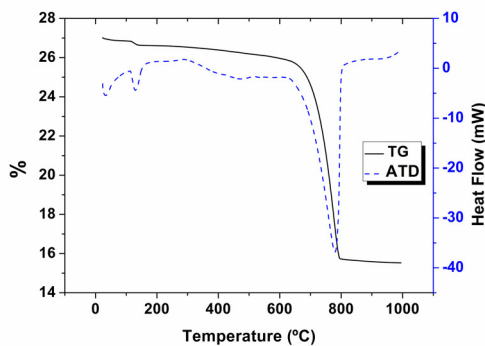
Fig.5. ATD and TG curves of stone

The mineralogical composition was calculated using the XRD (fig. 4) and the thermal study (figs 5 and 6). The phases present was determined by XRD. Calcite and gypsum percentages were determined in the thermogravimetric curve using the mass loss between 650 and 800°C and 100 and 200°C, respectively. The organic matter % was determined by the mass loss between 200 and 600°C that showed an exothermic effect with two maximums in the differential thermal curves. Figure 5 showed the DTA and TG curves of the stone.
