# Structural Analysis of La Giralda's 16<sup>th</sup>-century Sculpture/Weather Vane

## **Abstract**

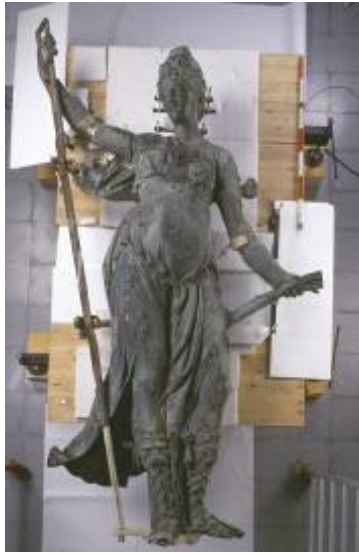
The Giraldillo's state of preservation was studied at the beginning of the restoration project. For the first time, it was possible to examine its parts in a restoration laboratory and thus perform a thorough analysis of the marks left by time (Fig. 6).

Fig. 6 The Giraldillo at the beginning of the restoration process.

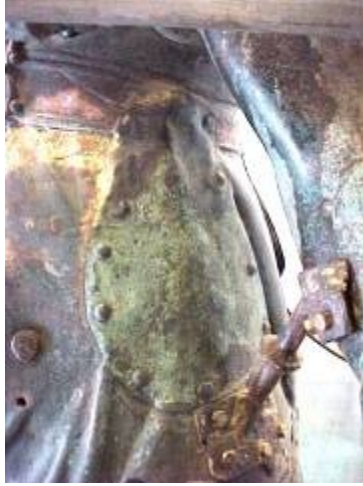
As for the iron structure, significant levels of corrosion were observed in various areas, with some areas showing complete disintegration, such as the lower section of the left vertical member. The structure itself was given a somewhat three-dimensional character by a transversal member that formed part of the upper horizontal structure and connected the sculpture's chest and back with the contact point where the sculpture rests on the bearing and the rotation axis. The connections between the transversal member and the sculpture were so damaged that a portion of the bronze sculpture on the chest had to be completely removed (during the restoration in the 1980s) and replaced with a provisional bolted cover that allowed partial observation of the inside of the sculpture.

Fig. 7 An example of patches applied to the sculpture (left hip).

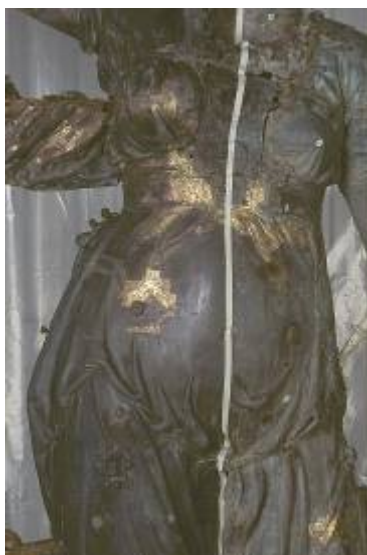
Widespread corrosion was also observed in the sculpture's internal reinforcements, which consist of six iron strips joined with bronze-plated rivets. As in the case of the internal structure's left vertical member, they also showed signs of galvanic corrosion as a result of the bronze-iron interfaces. Numerous patched-over areas and cracks were observed in the sculpture itself (Fig. 7). The patches, which had been applied to cover holes and cracks, had to be removed to allow a proper study of the holes and cracks themselves. Most of the cracks that had not been covered with patches were covered with soft-weld beads applied during the repair work done in the 1980s (Fig. 8).

Fig. 8 Cracks in the areas of the abdomen and chest covered with welds applied in the 1980s.

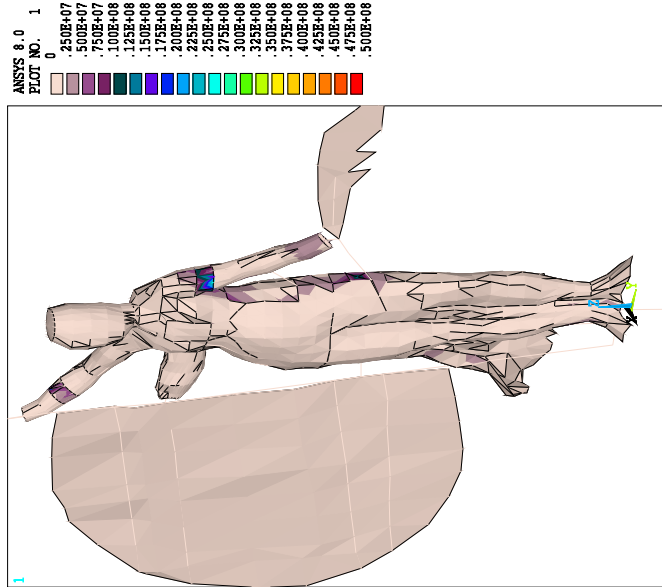
The gravity-induced mechanical stress levels observed in the Giraldillo are minimal (Fig. 16). Maximum stress values up to 35 MPa can be observed on the central part of the upper horizontal bar because of bending moments induced by the weight of the various components of the Giraldillo ensemble. For the rest of the internal bar structure, typical values are around 10 MPa. Values in the sculpture were lower than 6 MPa.

Fig. 16 Von Mises equivalent stress map (0-50 MPa), representing the effects of its own weight.

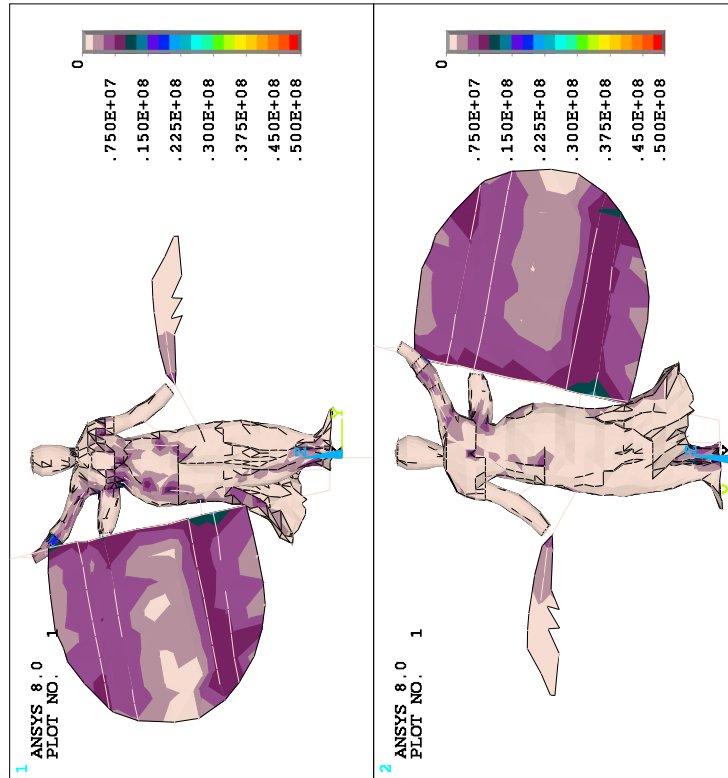
Therefore, the areas where the thermal effects are most significant are those where the thermal deformations of the sculpture and internal iron elements are restricted. Higher stress levels are observed along trajectories extending from the internal iron strips that serve as reinforcements of the cast bronze sheet of the sculpture, with even higher concentrations at connection points. Similar effects are also observed at connection points with the internal structure. It is important to highlight the chest and back connections, which may be part of the reason for the deterioration observed in these areas, combined with the damage caused by the 1770 addition of the upper horizontal member in the internal structure. However, the maximum Von Mises equivalent stress levels found in the sculpture are around 24 MPa on the left shoulder and the right arm, where, conservatively, the thin external patches attached to the structure were considered as the only resistant elements for these areas in the finite element model. Von Mises equivalent stress levels of around 10 MPa were observed at other connection points.

Regarding the internal reinforcements, it is important to mention that due to the restriction of free thermal deformation imposed by the sculpture, stress levels observed ranged between 80 MPa on the strips along the right arm and 30 to 50 MPa on the rest of them.

Fig. 17 Von Mises equivalent stress map (0-50 MPa), under uniform heating conditions.

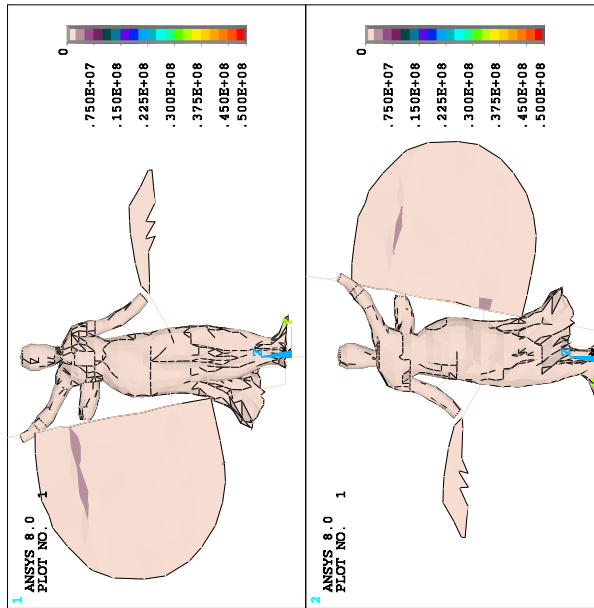
Since the Giraldillo works as a weather vane and is continuously subjected to wind action, wind could be suspected to be the cause of most of the sculpture's damages and defects. However, wind-generated forces proved to be insignificant. Therefore, the idea that cracks in the sculpture are a consequence of wind load induced fatigue has been discarded, since Von Mises equivalent stress levels produced by wind action are negligible (maximum values are around 0.3 MPa at certain connection points of the sculpture and 18 MPa at the horizontal middle and upper members of the internal bar structure). These values are much lower than those expected for a fatigue limit, according to the elastic and strength limit of the materials (Table 1). Nevertheless, a new section for these elements of the internal structure should be proposed during the restoration process, so that they could more easily bear the induced horizontal bending moments caused by wind pressure on the standard and palm frond, as they are the only significant forces induced by the wind. By doing so, any fatigue effect will be completely avoided.

It was also determined that a high-speed wind (45 m/s) hitting the Giraldillo laterally causes lower mechanical stress than a lighter wind (11 m/s) striking it frontally (Fig. 18). Therefore, beyond the issue of preserving the Giraldillo's function as a weather vane, the conservation effort also proves to be important to minimise wind-generated stress. The bending and torsion moments predicted in the axis with the numerical model (579 Nm and 2,581 Nm respectively) matched the experimental results (600 Nm and 2,747 Nm, respectively) obtained before the restoration process began with strain gages attached to the axis and wind-speed readings taken simultaneously [10].

Fig. 18 Von Mises equivalent stress map (0-50 MPa) observed under the conditions of an 11m/s headwind.

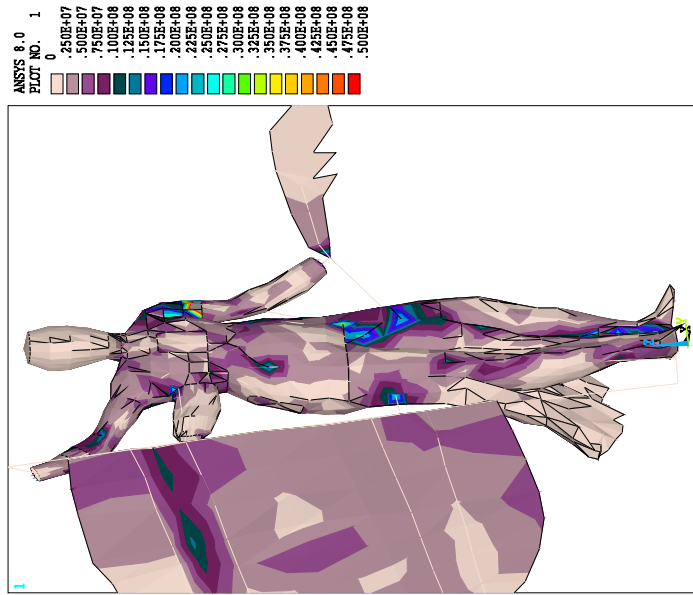
The seismic load cause the highest mechanical stress levels in the sculpture and internal structure of the Giraldillo. The only significantly high stress levels, however, occurred in the areas of force transmission around the sculpture/internal structure connection points (Fig. 21 and Fig. 22).

In a frontal seismic movement, high stress levels are obtained around damaged areas of the right arm (almost 95 MPa). This level cannot be accepted, according to the material properties (Table 1) and hypothesis of elastic behaviour. In spite of the fact that the finite element model is too conservative to consider patches and cracks in this area, it is clear that this effect will clearly require some improvements when the Giraldillo is restored. Thus, it would be necessary to uncouple the right hand from the stick of the standard to prevent the inertia forces of the standard from being transmitted to the right arm. Moreover, the internal reinforcements of this arm should be replaced by more resistant ones.

Regarding the internal bar structure, the most significant stress levels are reached by the upper horizontal bar because of the horizontal bending movements induced by the movement of the standard. This effect is similar to that observed for the frontal wind action. However, the stress level is acceptable again (80 MPa), although the flexural behaviour of this bar should be enhanced during restoration.

Fig. 21 Von Mises equivalent stress map (0-50 MPa) produced by frontal seismic action.

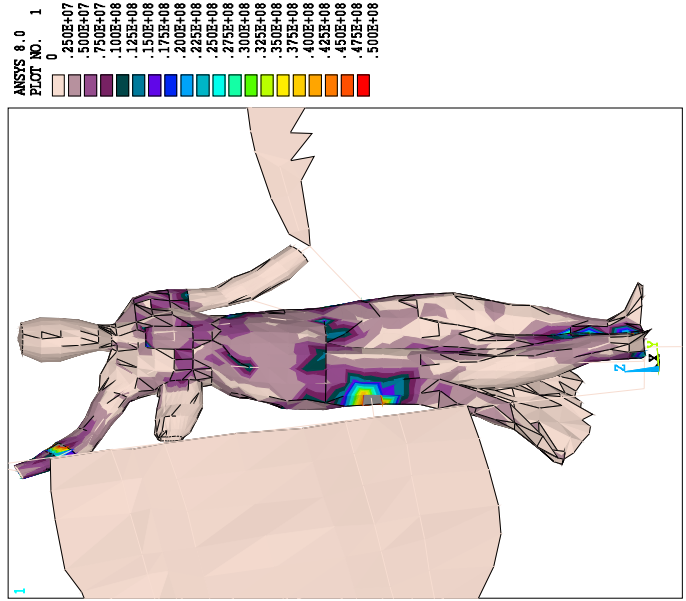
As regards lateral seismic excitation, the inertia effects of the standard and palm frond movement are much lower. Generally speaking, the stress levels of the sculpture, internal bar structure and reinforcements are lower than in frontal seismic movement. Nevertheless, high stress levels can be observed in the sculpture at connection points with the internal structure located at both legs. This is due to the fact that the inertia forces of the standard and palm frond act perpendicular to the bronze shell of the sculpture, instead of tangent to its surface, as

happens when frontal vibration takes place. The equivalent Von Mises stress levels observed at these connection points are higher than 100 MPa, which is not acceptable. Nevertheless, these values are not so high in the real situation, since they turn to acceptable values at a short distance from the connection point (around 5 cm). That means that a more detailed model for these areas would be needed for the restoration of the Giraldillo and these connection points should be adequately designed to reduce the transmission of these inertia forces perpendicular to the bronze sheet.

Fig. 22 Von Mises equivalent stress map (0-50 MPa) produced by lateral seismic action.
