# Exterior Brick Walls: Learning Nonquality through Failures and Climate-Pathological Distribution

**Abstract:** The object of this research was to identify the list of climatological variables involved in the appearance of construction failures in the external walls of dwellings through the analysis of over one thousand cases. The data source used consisted of the judicial records of the Justice Administration, a source to which few researchers have access, given the dispersion of the data and the permissions required to access it. Once obtained, all situations pertaining to dwellings were read and annotated, until 100% of the cases were accounted for, and percentages of recurrence were calculated for each of the nine different types of failures that were described. A study was carried out by so-called *strips of climatic location* according to four climatological variables (situation, latitude, climate, and annual rainfall) that were sorted from largest to smallest to obtain the *ranks of pathology concentration* according to the resulting preponderance. Using these results, technicians will be able to identify the most problematic climate-geographical areas by determining the r

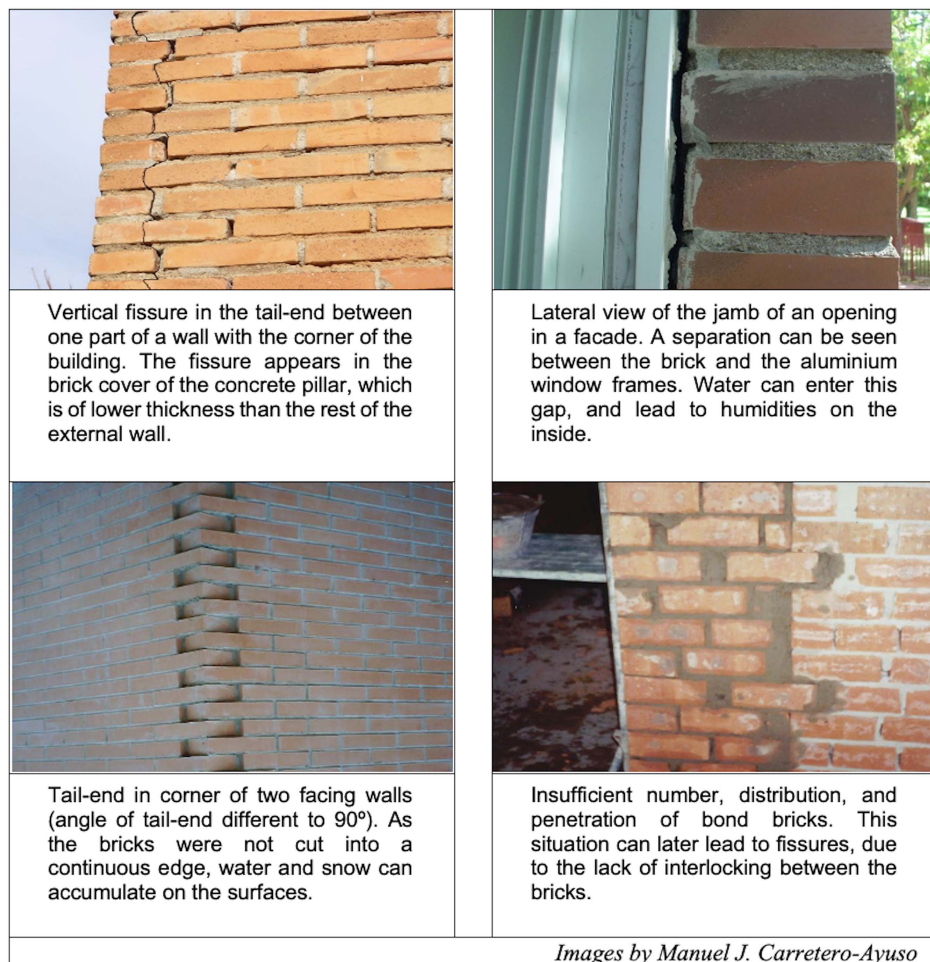
It was found that the different failures studied could occur as a result of irregularities or deficiencies during the construction work. Quality control during the execution of such work is fundamental for preventing problems during the service life of external walls. Indeed, it was found that these situations could very frequently lead to cracks or humidity issues. Fig. 5 shows some photographs that visually depict some of these deficiencies.

**Fig. 5.** Photographic examples of several execution problems.
