Integration of disciplines in the structural analysis of historical constructions. The Monastery of San Jerónimo de Buenavista (Seville-Spain)

Abstract

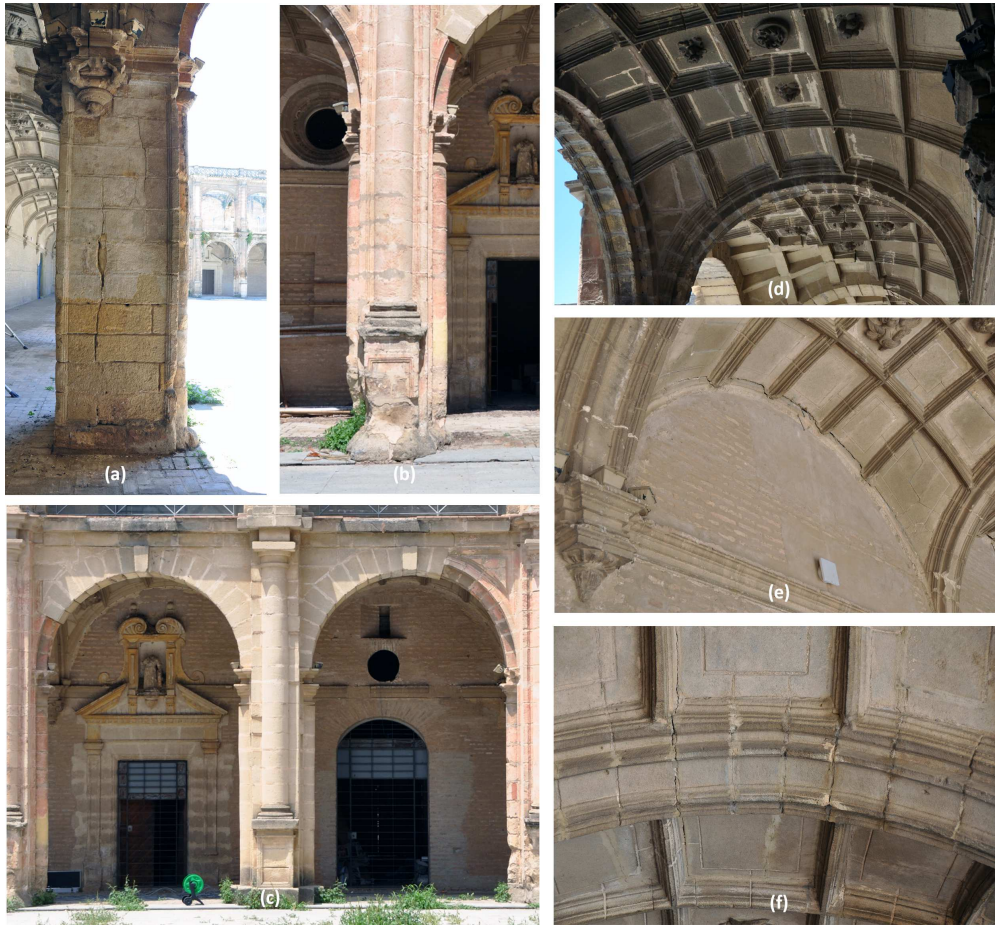
138 Today, the historical part of the building presents severe damages, which have worsened with
139 the construction of the new building. By comparing the inspections carried out in 2003 [13], that
140 is, before the construction of the new civic centre, with others made since 2013, therefore after the
141 attachment of the new building [15–17], changes in the damage state of the cloister were detected.
142 Thus, for example, current damages such as the longitudinal cracks in the vaults of the north
143 gallery (Fig. 6d), the cracks in the keys of the arches of the ground floor of the east wing (Fig. 6f)
144 or the longitudinal cracks between vaults and eastern wall (Fig. 6e) were not mentioned as detected
145 damages in the 2003 inspection report [13]. The current state shows that the most relevant damage
146 is concentrated along the northern and eastern wings of the cloister. Damages includes cracks and

147 material loss, as illustrated in Figure 6.

Figure 6: Most significant damage: (a) vertical cracks in the north wing columns; (b) section loss in the north wing columns; (c) rebuilt column after the 1969 Portuguese earthquake (Fig. 9 - column 10); (d) longitudinal cracks in the vaults of the ground floor of the north gallery; (e) Longitudinal cracks at the intersection of the vaults with the historic wall of the east wing; and (f) cracks in the keys of the arches of the ground floor of the east wing.

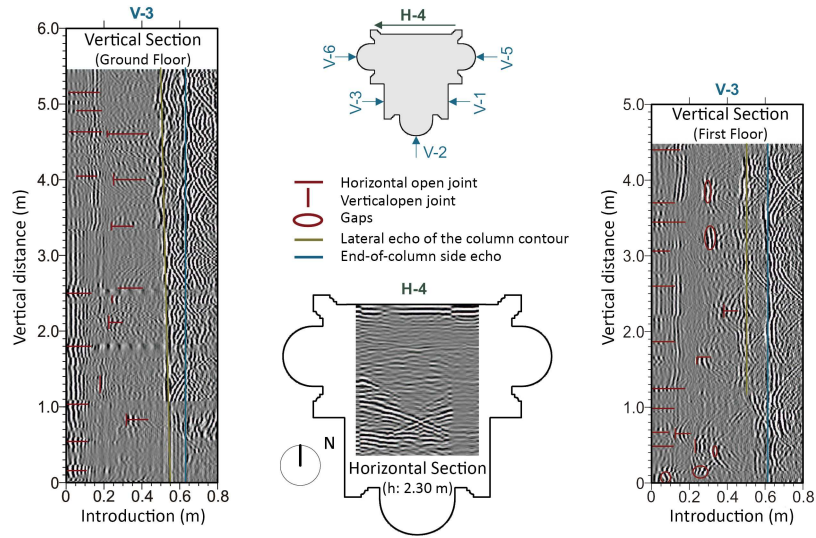
204 With the aim of determining the internal composition of the sections of the columns of the main
205 cloister and to assess their state, a series of wave propagation tests were carried out. On the one
206 hand, 12 columns on both stories were inspected with the use of a single-frequency 2D georadar
207 (Fig. 9; columns 1-10 and 13-14). In this case, a 2.3 GHz nominal frequency antenna was used
208 with an effective penetration of up to 0.80 m. The radargrams obtained showed that these were
209 solid columns made of a single material. However, inner gaps were detected, but these were only
210 a few centimeters wide and therefore irrelevant, located generally between each block of stone [15]
211 (Fig. 10).

Figure 10: GPR images of column 9 [15].

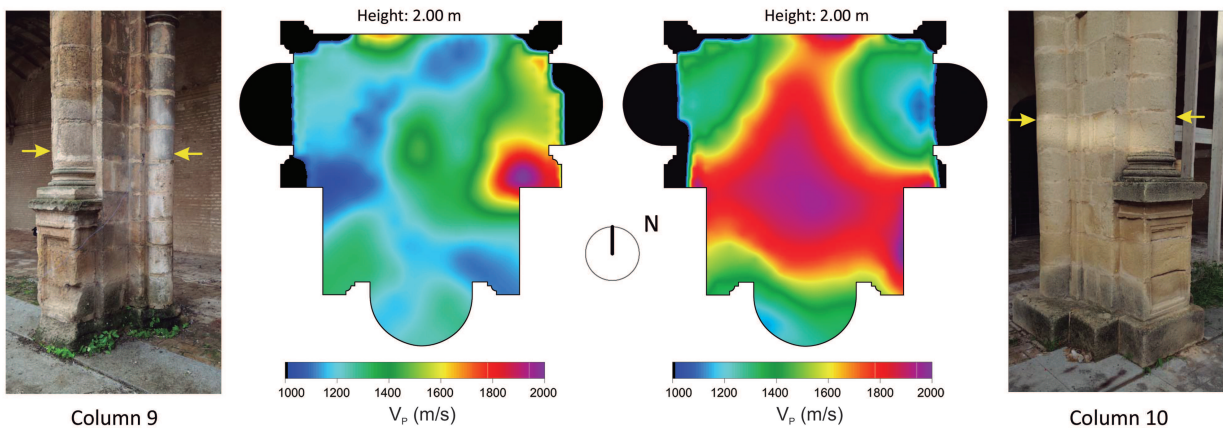
212 On the other hand, 10 columns (1-4 and 9-14) were inspected by means of high-resolution
 213 seismic tomography with the aim of detecting excessive material degradation. Two horizontal
 214 planes of each of these columns were studied, at heights +0.70m and +2.00m. The velocity models
 215 obtained present values typical of the calcarenite stone that they are made of, that is, between
 216 1000 and 2000m/s [15]. However, the tomograms show velocities that are generally lower at inferior
 217 levels (Fig. 11). Likewise, at the same heights, velocities that are considerably lower (in the order
 218 of 30%) in the columns of the northern wing in comparison with the values recorded for those on
 219 the southern wing [15]. These results show that there is more material degradation and, therefore,
 220 a reduction of capabilities in the areas with a lower associated propagation velocity. There is one

221 exception: the column on the northern wing that was rebuilt. This column presents higher velocity
 222 values, reaching up to 1995 m/s at its core.

Figure 11: Tomography of columns 9 and 10 [15].

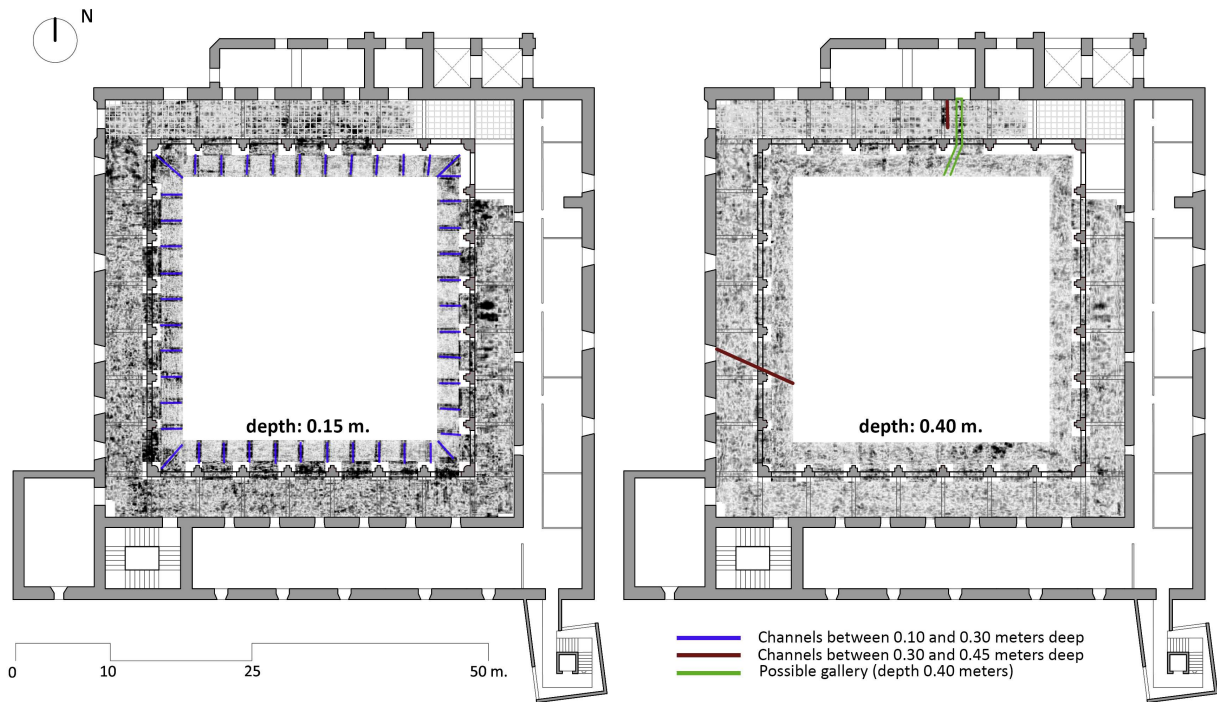
276 As a result, the test showed the existence of a series of structures and anomalies. On the one
277 hand, a set of channels was located at a depth of 0.10 m, along with others at a depth ranging
278 between 0.30 and 0.45 m. On the other hand, a possible angled gallery was identified, its layout
279 connecting the courtyard with the entrance into the tower. The gallery appears to be approximately
280 1 m wide, and located at a depth of 0.30-0.40 m (Fig. 12). Finally, the results indicate the possible
281 existence of tie beams between the foundation elements, albeit in what seems like discontinuous
282 form. Likewise, the reflections indicate that humidity levels are higher in the area around the
283 mentioned tie beams [15].

Figure 12: GPR images of foundations (depth: 0.15 and 0.40 m) [15].

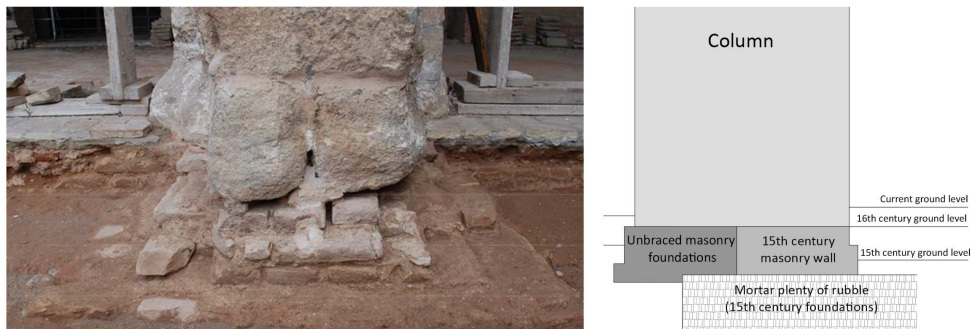
290 • In general, each of the columns of the northern wing has its own independent foundation,
 291 at a shallow depth. Only part of the bases of the columns, the northern halves, is set upon
 292 a strip foundation consisting of the remains of a fifteenth-century brick wall reused for this
 293 purpose. This element rests upon a layer of lime mortar. The southern halves of the bases
 294 of the columns rest directly on the ground. Only one independent element was constructed,
 295 in the form of a shallow foundation, attached to the aforementioned wall and with no tie
 296 beams. This element is made of several courses of roughly laid bricks set with low quality
 297 mortar (Fig. 13).

Figure 13: Historical foundations: front view (a) and cross section (b).

298 • The building system that has been described led to differential settlements between the
 299 northern and southern halves of the bases of the columns. According to the archaeologists,
 300 this differential settlement reaches up to 2.5 cm (column 11).

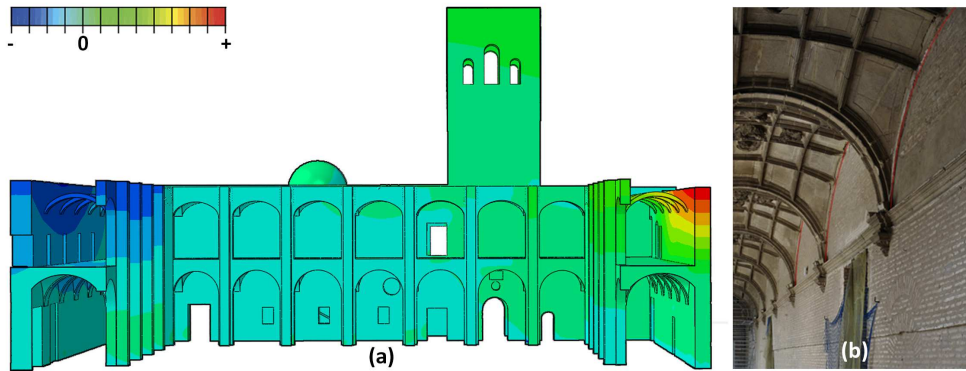
503 Regarding the eastern and western wings, the model shows that they behave differently in spite
504 of having the same geometric layout. The fact that the wall of the eastern wing is made out of
505 rammed earth, in contrast with the corresponding wall on the western wing, which is brickwork,
506 explains why the former is more affected, even before incorporating the civic center into the model.
507 The model shows that the wall of the eastern wing tends to move towards the east, opening up the
508 structure that supports the gallery. This is in line with the most pronounced damages presented
509 by the arches of the upper floor of this wing. Likewise, and still within this tendency to open up, in
510 this state, the structural model manages to identify damages compatible with the separation crack
511 that exists in the eastern wing between the vaults of the first floor and the wall (Fig. 19). The

Figure 19: Section through West and East wings (a); Displacements along the X axis (b) and cracks between vaults and wall in the East wing.

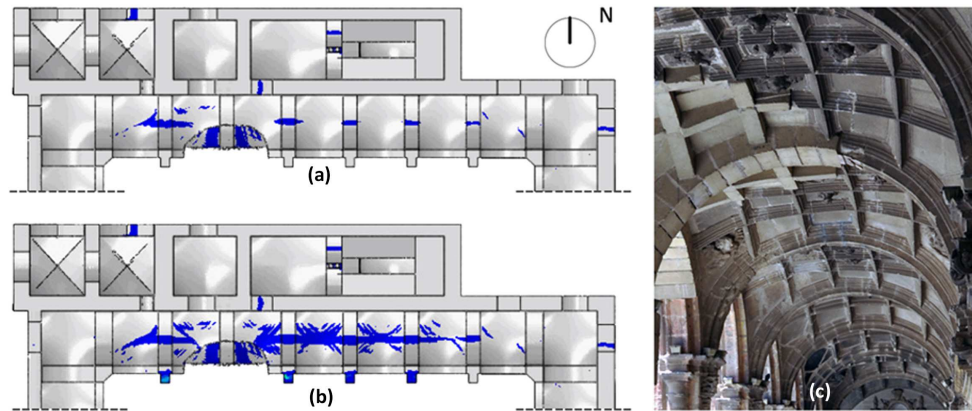
524 northern wing, which becomes greater in the arches adjacent to the missing column. In addition,
 525 the introduction of the differential settlements at the base of the columns is the key for the model
 526 to show the damage that runs longitudinally along the vaults of the first floor (Fig. 20).

Figure 20: North wing: Damage areas before (a) and after (b) considering differential settlements; (c) Cracks along vaults.

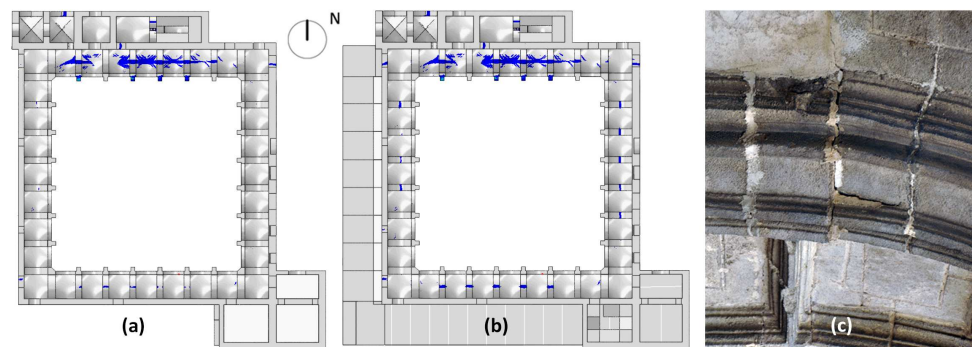
527 Moreover, the results indicate that the construction of the civic center accentuates aspects of
 528 the structural behavior of the cloister that were already incipient before the construction of the
 529 new building. The most relevant are: (i) the development of hinges in the keystones of the arches
 530 of the first floor, and not only those of the northern wing (Fig. 21); (ii) the displacement towards
 531 the east both of the eastern wing wall and of the eastern side of the northern gallery; (iii) the
 532 opening up of the supporting structure of the southern wing, that is, the movement of the wall
 533 towards the south and of the columns towards the north.

Figure 21: Increase of damage in the keystones of arches after introducing the new civic center: Views from below the historical construction, with past (a) and current architectural configuration (b), and example of cracks in an arch keystone (c).

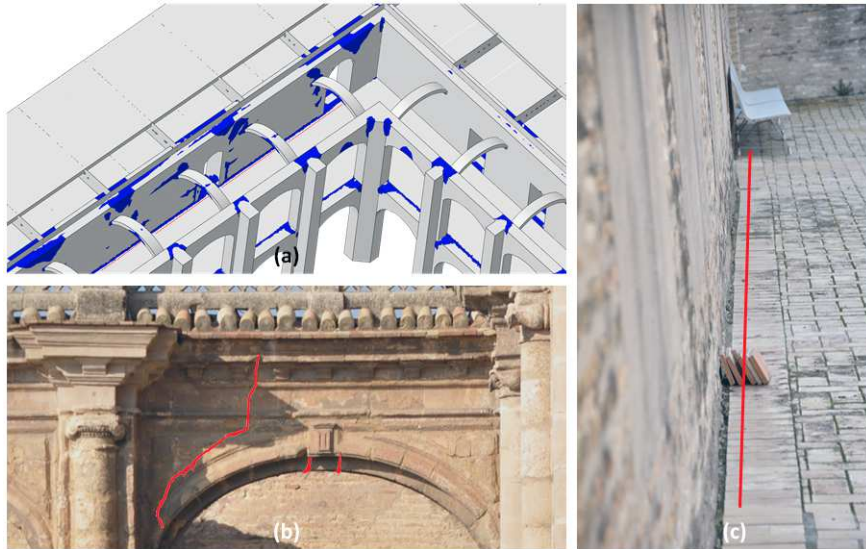
538 other hand, by increasing the load to determine the collapse, the model shows damage areas that
539 coincide not only with those where the building presents cracks of importance, but even areas where
540 minor cracks exist (Fig. 22). This occurs when a load that is 1.5 to 2.0 times that of the self-weight
541 of the structure is introduced. Finally, if a load of 2.15 times the self-weight of the structure is
542 applied, the same reaches a state of collapse due to the failure of the tower.

Figure 22: Additional damages on the West wing: model results and current state of the building.
