Research Article

Operational Modal Analysis: A Tool for Assessing Changes on Structural Health State of Historical Constructions after Consolidation and Reinforcement Works—Jura Chapel (Jerez de la Frontera, Spain)

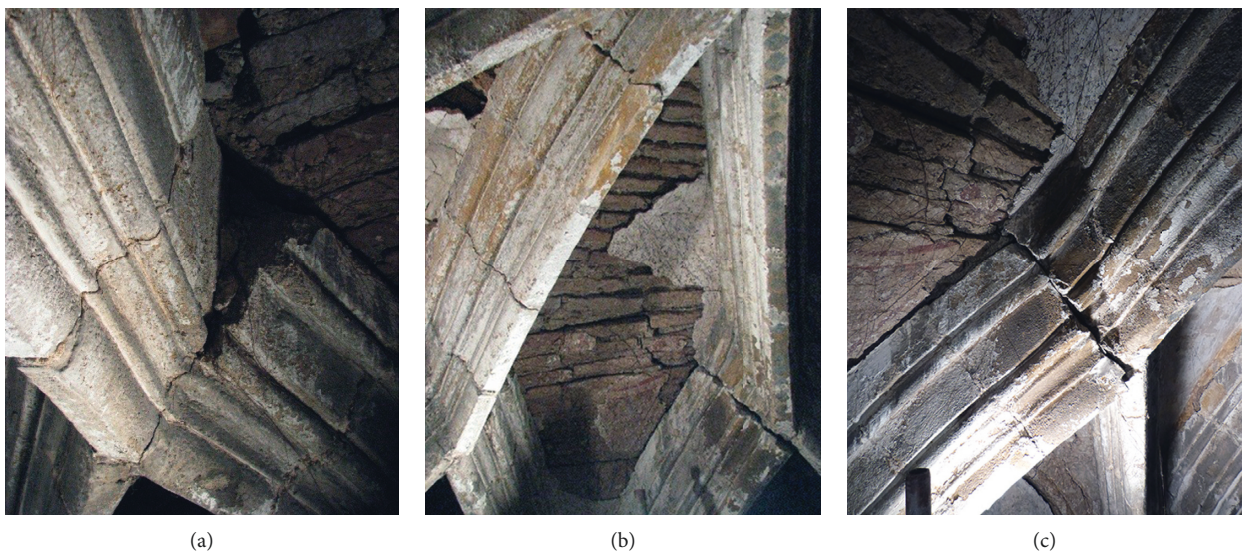
FIGURE 4: Joint between ribs and voussoir devoid of ornamentation.

However, in this case, there were visual evidences of a structural disconnection between vault ribs and the brick web at some points (Figure 4). This made one suspect that taking measurements on the vault extrados could not provide correct data to make a proper analysis. This was the reason why experimental campaigns by positioning accelerometers directly on the ribs from the intrados became the most reasonable option to reach the main aim of this study. As it has been explained before, the vault did not count on decoration so the accelerometers could be fixed without problems in this case.

The intervention focused on consolidating the structural unity of the chapel using minimally invasive techniques. The first step was to clean the walls and the vault webs, making it easier to identify the cracks and fissures. In the case of the walls, the cracks were sewn together using carbon fibre bars with a diameter of 8 mm. The length of these bars varies between 100 and 150 cm (Figure 6). They were placed transversally and along each of the cracks, at a depth of approximately 15 cm with respect to the exterior wall. Likewise, the most deteriorated ashlars were replaced. Regarding the consolidation of the vault web, the joints between the bricks were cleaned and refilled with sand-and-lime mortar. This same procedure was repeated with the joints between the voussoirs in the vault. With regard to the vault, the only arches that were sewn to the web were the lower ones. This task was performed at each joint, where the greatest displacement of the voussoirs had occurred. In this case, 8 mm diameter stainless steel bars were used to do this.

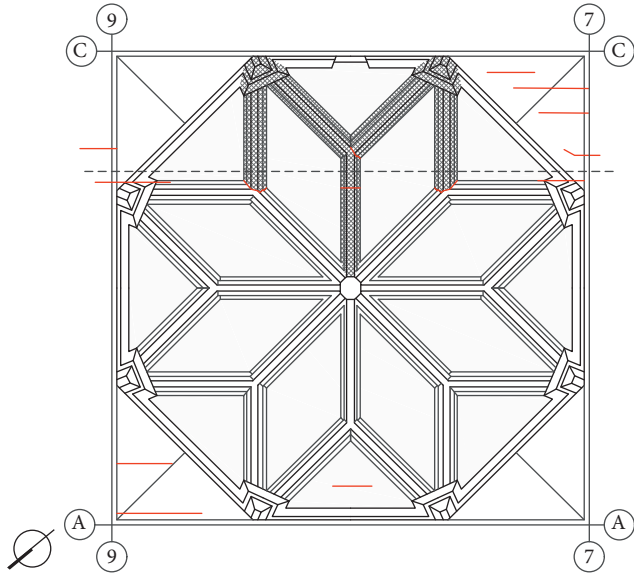
FIGURE 5: Plan of the chapel vault. The shaded area indicates the ribs affected by the movements, the red lines indicate the cracks mapped, and the dotted line illustrates the relationship between the cracks in the vault and the side walls.

part, thus decompressing the intrados. Figure 5 shows the fissures in the ribs, which are associated with the damages detected on the walls of the northern corner.

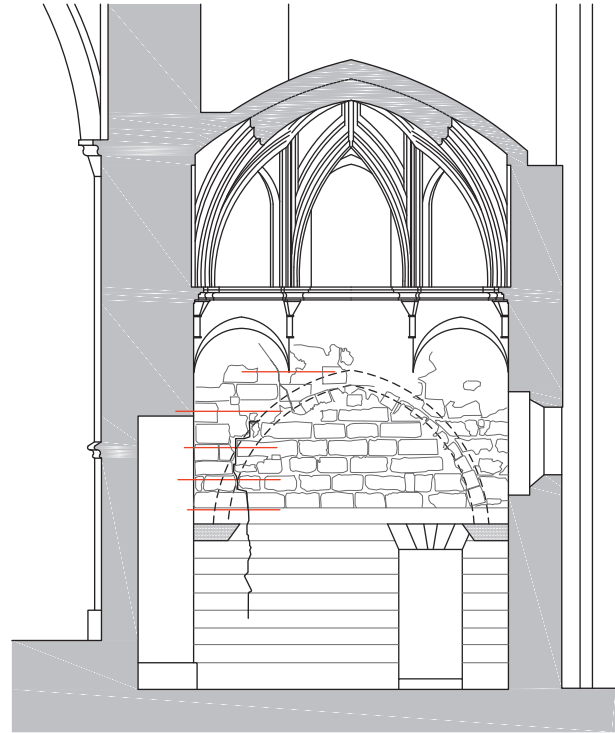
FIGURE 6: Position of the bars sewn with carbon fibre bars: wall 7-A-C.

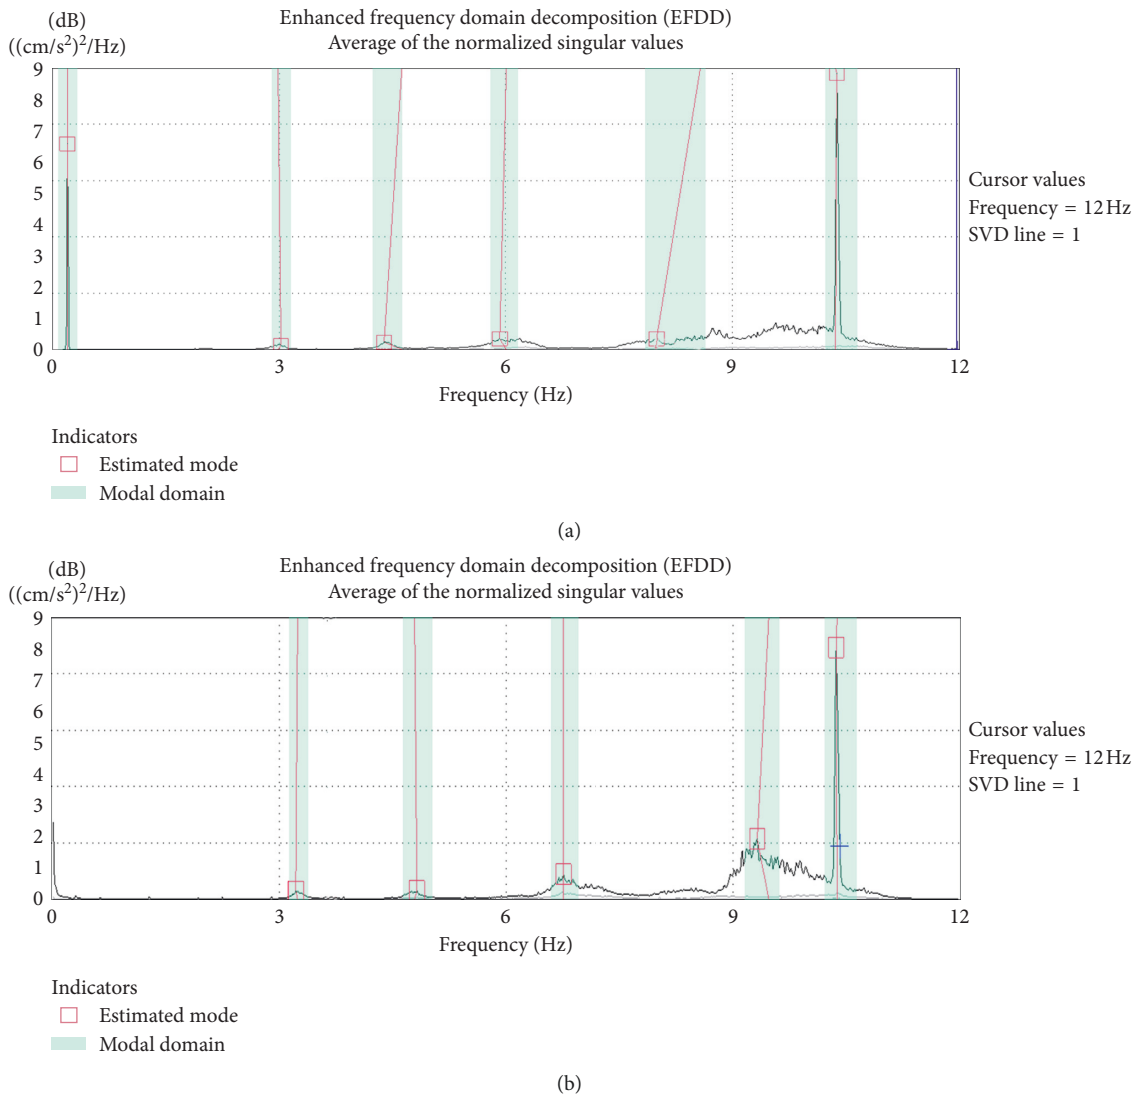
FIGURE 12: Ambient tests before and after works: intrados of the vault (EFDD).

As shown in Table 3, the differences between the natural frequencies are highly significant. It can be noted that the first vibration mode, identified before the intervention (about 0.2 Hz), is a vibration mode whose associated frequency is very low for this type of structure. The explanation of the existence of this mode is the crack on the rib that can be seen in Figure 4. In this case, the mode shape shows the free movement of the rib under the excitation frequency. Once the consolidation works were carried out, it can be observed that this vibration mode disappears, confirming the connection between elements.

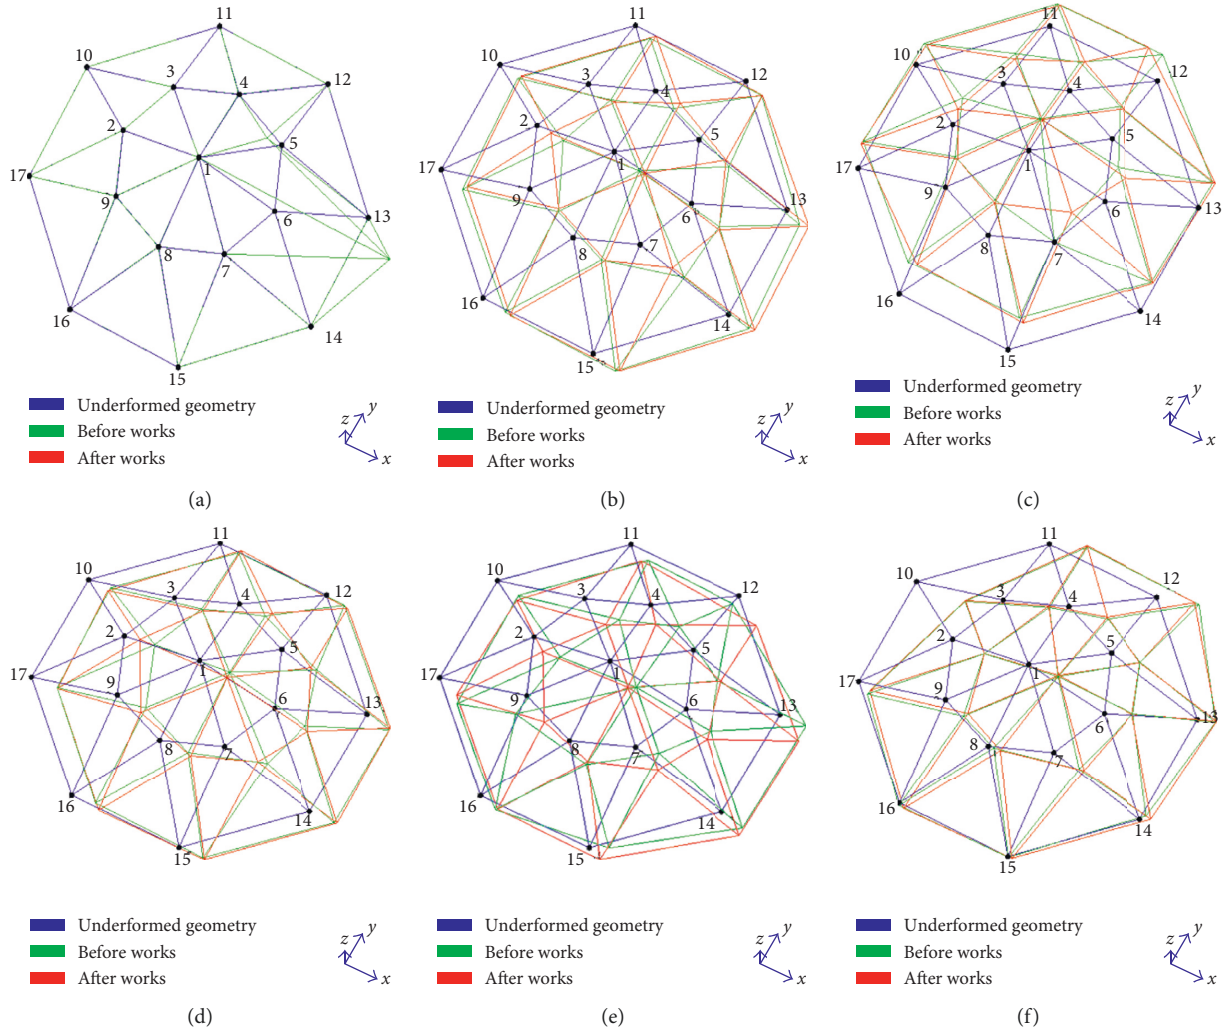
mass increasing (about 12%) and according to (1). Meanwhile, MAC values were always higher than 0.80, which indicate a good modal correlation between both experimental campaigns. As can be seen in Figure 14, the mode shapes, with the exception of the first mode, are very similar before and after the works, which means that the final structural behaviour of the vault has not changed in relation to the previous one.

FIGURE 14: The first six-mode shape of the vault for the damaged and repaired cases. (a) 1st mode, (b) 2nd mode, (c) 3rd mode, (d) 4th mode, (e) 5th mode, and (f) 6th mode.
