DAMAGE IN HISTORIC RAMMED EARTH STRUCTURES: A CASE STUDY AT AMBEL, ZARAGOZA, SPAIN

Paul Jaquin* (United Kingdom)
Integral Engineering Design

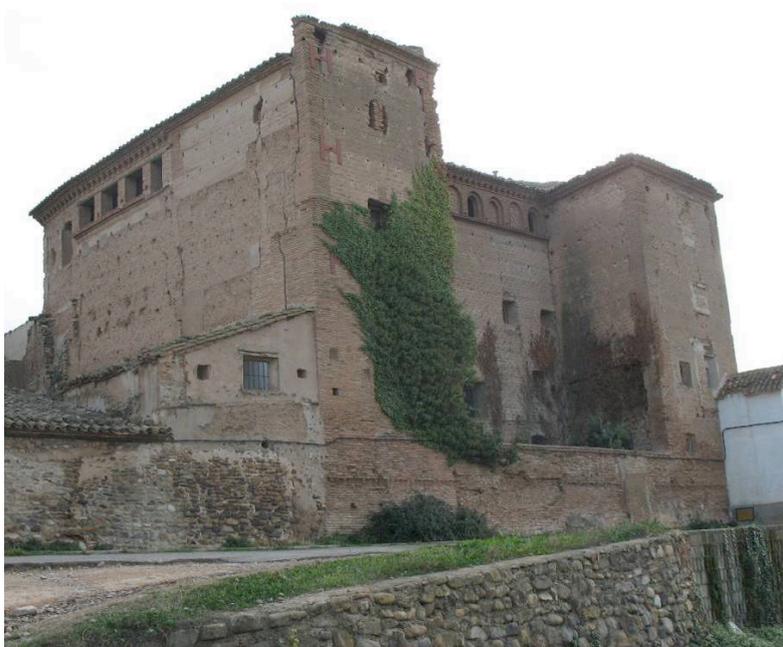
Today there are two independent sets of cracks in the east elevation (Fig. 1) – two slightly inclined cracks in the centre of the building; and two vertical cracks at the north end of the east elevation, which are related to the lean of the north gable end wall. This wall leans outwards from ground level to mid-height of the second storey, with the section above this being built vertically on top of a leaning wall. The current owners of the building installed crack monitoring points in the early 1990s and this monitoring shows the continued opening of the cracks at the northern end of the tower. As a result,

Fig. 1. The preceptory at Ambel, north-east elevation. The gallery of arches between the towers is typical of 16th century architecture in this region. The first phase precinct wall reaches the base of ivy and stands 3m high.

shows that there is no structural tie between the between the two. Any structural movement therefore results in an opening of the joint. This is particularly a problem in later medieval architecture, where brick quoins are used, and structural movement (for example of the gable end of a structure) is unrestrained and leads to an opening of the joint. An example of this can be seen on Fig. 1 immediately below the eaves at the northern end of the tower.

Where water has been allowed to gather and run down the face of a wall, cast structures, such as described in Section 4.1, are observed on the face of the wall (Fig. 5). However, these have served as a forewarning of further damage and caused the building owners to undertake repairs. As a result, there are no deep incisions into the rammed earth as shown in Fig. 4, and as observed at other historic rammed earth sites (Jaquin, 2008b). However, the eaves do not protrude on any of the faces, and this may have allowed a water flow down the face of the wall. If water is allowed to gather behind the render, then the rammed earth may become locally saturated, meaning the liquid bridges providing a bond between the render coat and the rammed earth may become saturated, causing the render to spall away from the wall (Fig. 1).

tie bars were placed at ceiling level at the ground, first and second storeys in 2000. These are fixed internally by bolting onto the ceiling beams and protrude externally to link to H-shaped bars on the facade which were positioned so as to overlap the brick quoins (Fig. 1).

may have succeeded in stiffening the north end of the structure, but because ground movement has not been halted, further deformation and cracking has occurred. In 2000 H-shaped spreader plates were fixed to the face of the wall, which are affixed to 150 mm x 80 mm I-beam sections running through the length of the building. These I-sections are bolted to the transverse ceiling timbers at each side of the building at ground, first and second floor levels.

Although this intervention follows sensible principles, it may be noted that the horizontal component of the lean of the gable wall is transferred directly to the transverse timbers through bolting, which maybe prove unsatisfactory, with the bolts shearing from the timber with increased horizontal load from the gable wall. Monitoring of crack growth shows that the placement of this system has not arrested the growth of the cracks, suggesting that it is yet to engage or is proving ineffective. Future work is now being suggested which will involve the placement of spreader plates on the outside of the south wall, allowing the I-beam sections to span the whole length of the building and thereby stiffen the whole structure.

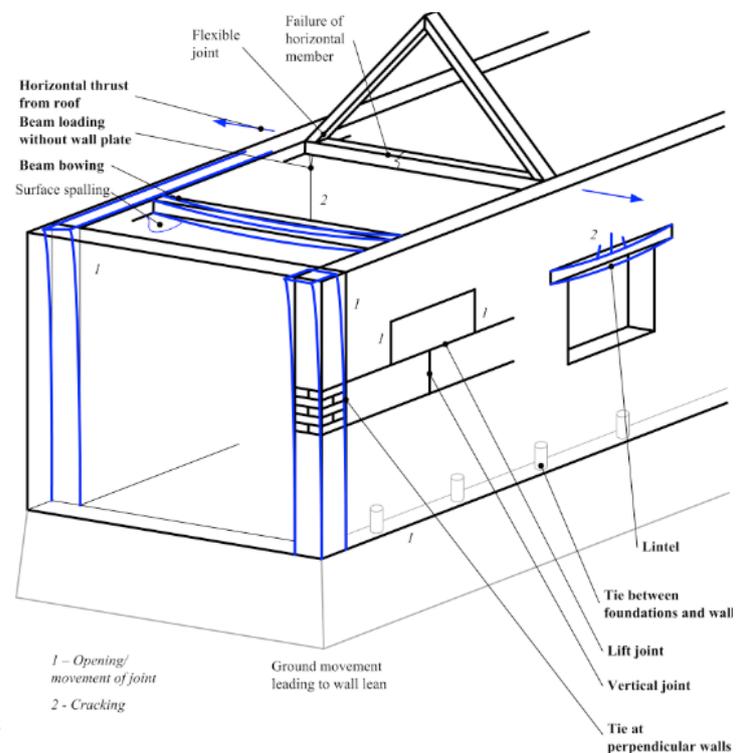
Fig. 2. Examples of failures of structural elements

or later alteration to the structure, there is the potential for shear failure of the wall beneath the loaded beam. Out of plane failure can also occur where a beam joining a wall is insufficiently stiff and bows under loading. This causes an increased load at the face of the wall, and can lead to spalling of the material at the face (Fig. 2).

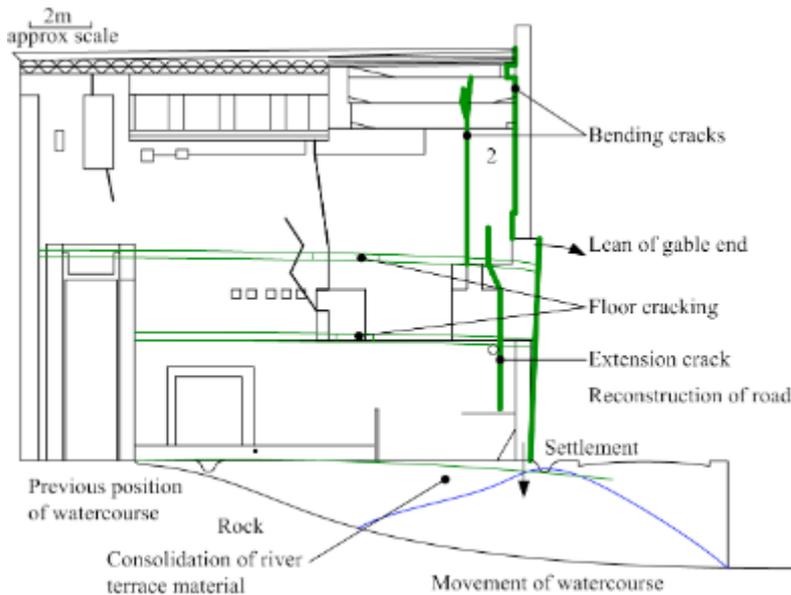
The gable end wall of the north-east granary at Ambel is showing a significant outward lean at the head of the wall, and monitoring of the cracking patterns shows that the cracks continue to open. The cause of this lean is assumed to be an ineffective retaining wall to the north of the gable wall, allowing continued settlement of the ground. The nature of the foundations of the tower is not known. As it is not currently possible to reinstate this wall, or to upgrade the road, hard intervention techniques have been used.

In the late 18th century a number of hard repair measures were already being enacted at to prevent collapse of the leaning north wall. There is no structural tie between the rammed earth north and east walls, and the brick quoin at the corners. As described above, a further storey tower may have existed at the north of the granary, and this tower may have provided a structural tie between the gable end and the transverse walls. Analysis of the architectural fabric suggests that timber buttressing was placed against the external wall, and repairs were carried out to the ceiling arches at each floor. In addition, battens were embedded at the north end of the east and west walls, spanning to the leaning north wall. Their effectiveness is questionable, as cracks are present in the wall at the south end of these timbers. This indicates that the timbers

gable end wall. This timber is causing in-plane cracking of the rammed earth wall because of the lack of a wall plate.

Fig. 3. Cracking patterns and causes, east-facing elevation of the north-east tower at Ambel

Where the cause of the structural problem has been mitigated, then a soft repair of filling of the cracks is recommended. This will not only improve the appearance of the building but also prevent water ingress. At Ambel, cracks in the centre of the long east wall are thought to have formed prior to the movement of the gable end, and have therefore been filled. The filler is brick, which would originally have matched the scored rendered original face of the rammed earth, although this is now removed. Filling with similar fallen material in rammed earth is problematic, though the column method is recommended by Pearson (1997) and other possibilities are suggested in Jaquin (2008a).

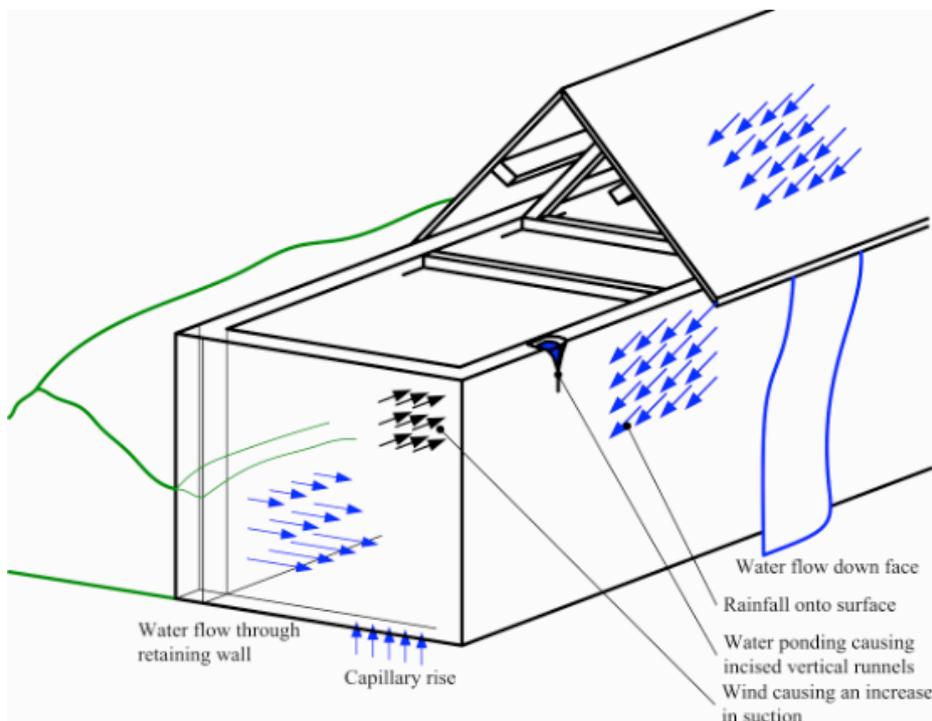
Fig. 4. Causes of damage by water

to flow down the surface of a wall. This usually happens where it is allowed to gather (pond) at the head of a wall, and flow down the face. Because of the larger volumes of water involved, the rate of water infiltration overtakes the rate at which water is removed from the wall by evaporation, and so a drip forms on the surface of the wall. This may allow the surface of the rammed earth to become saturated, and for soil particles to become suspended within the liquid and flow. This mechanism can be seen in the formation of worm cast type structures where material has first flowed into a slurry, then dried to leave mounds of fine material on the wall face. The presence of these structures indicates the downward movement of material and is thus indicative of past water flow. The likely cause of the formation of the structures is the slow downward movement of water down the face of a wall, for example a drip which is able to pick up material and transport it in solution down the wall, until such a point as the drip evaporates and the material is returned to the wall. Inspection of these structures indicates that they contain only very small particles, as it is only these which may be picked up by the water. The rate of infiltration of water into the body of the wall is sufficiently slow that the drip of water is able to continue down the face of the wall, saturating and therefore picking up smaller soil particles, before all the water is absorbed by capillary action into the wall and those smaller soil particles redeposited. If the rate of water flow is increased, such as by an ineffective drain, then larger soil particles and larger volumes of material are picked up by the water flow, and incisions form in the vertical face of the wall (Fig. 4). This mechanism involves the movement of material down the wall causes a

Repair of rammed earth walls damaged by water should only be attempted when the cause of the water flow has been addressed. It has been argued that the main repair strategy for water damage is reinstatement of the head of the wall to prevent further water flow down the face. This has taken the form of concrete ring beams for the restoration of the towers at Biar and La Rambla (Jaquin, 2008a) or as bamboo matting at Ait Ben Haddou in Morocco. If it is possible, then the roof of the structure must be reinstated, and the drainage from this correctly positioned.

Repair of the face of a wall, where damaged by water, should involve reinstatement with the fallen or similar material which will provide similar material properties (stiffness, permeability and shrinkage) as the rest of the wall. There are many examples of the repair of rammed earth buildings using a less permeable render such as cement (see Jaquin, 2008b). While this render reduces the flow of water into the wall, it also reduces the flow of water out of the wall. If water is able to enter the wall by any other means (for example through capillary rise), and is not able to escape (water only flows upwards by capillary rise), then there is an increase in water content of the wall. This leads to a loss of strength and stiffness, and the wall will fail, either through a the build up of water behind a less permeable render, or by becoming saturated and losing strength and stiffness.
