# Towards the incorporation of a raised walkway at the Royal Alcázar of Seville: status and execution of the works

The Milanese architect Vermondo Resta arrived in Seville in the 16th century and soon became the master builder for the Alcázar, in charge of all the construction works undertaken in this royal palace dating from the Middle Ages. One of the challenges he addressed was the transformation of a fragment of the 12th century wall, which had lost its defensive function, into a double-storey gallery with views over the palace gardens. It was called the *Galería del Grutesco*, or Grotto Gallery. At the beginning of the 21st century arose the opportunity to restore this space to the design that Resta had conceived four centuries earlier. This article discusses the need to undertake this restoration and describes the technical solution that was proposed and recently executed.

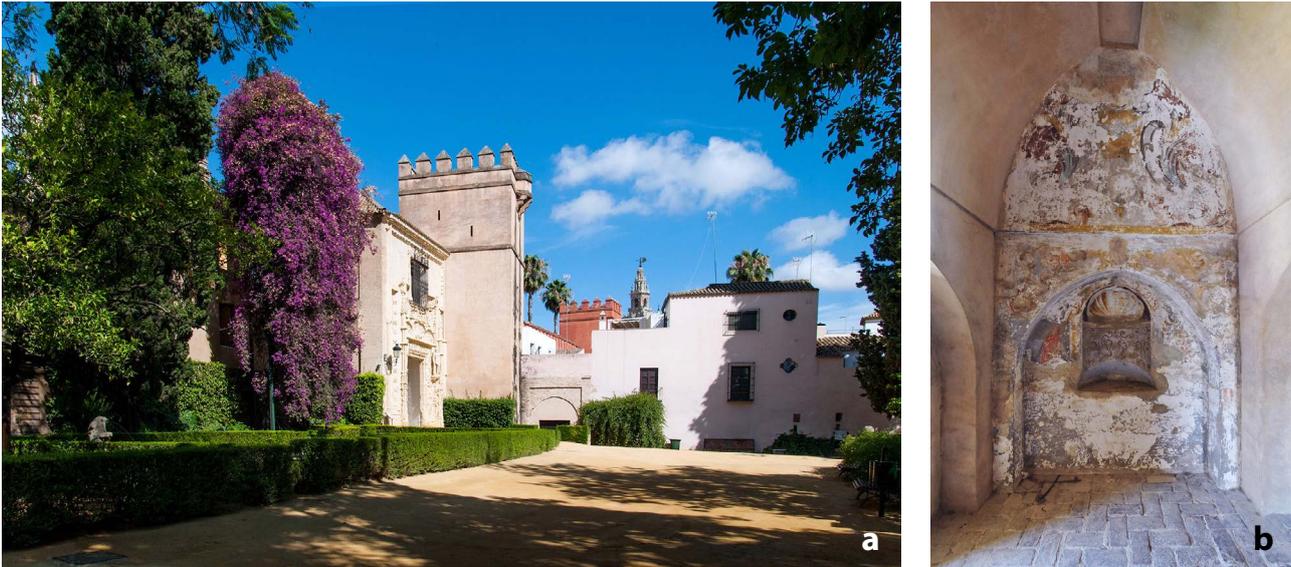
**Figure 4.** a) The Water Tower with the Marchena Gate adjoining its south flank; in the background, the intermediate tower with its ochre rendering. b) The fresco remains inside the tower.

were repaired in 1991 [8, p. 70]. In contrast, the most dilapidated area is the intermediate tower, where several wooden beams in the roof structure show signs of rot and the steps are in a state of great disrepair. At a great distance, somewhat neglected but better preserved than the tower, both sections of the parapet walk reveal abundant dirt due to the presence of damp on the floor tiles, merlons and ceramic gargoyles.

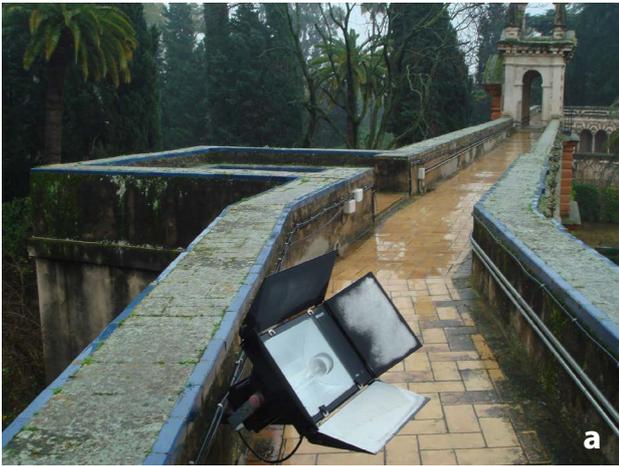
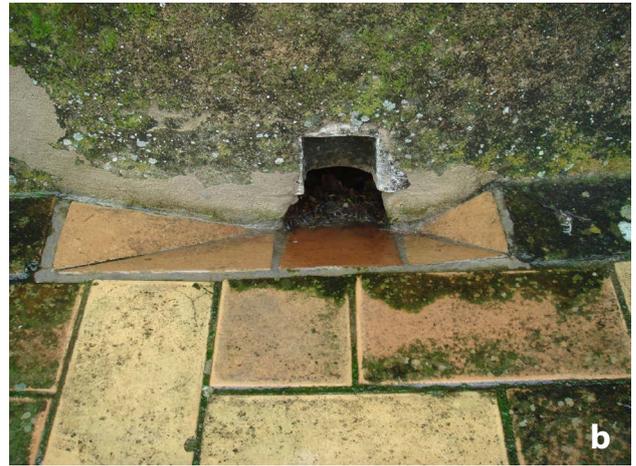
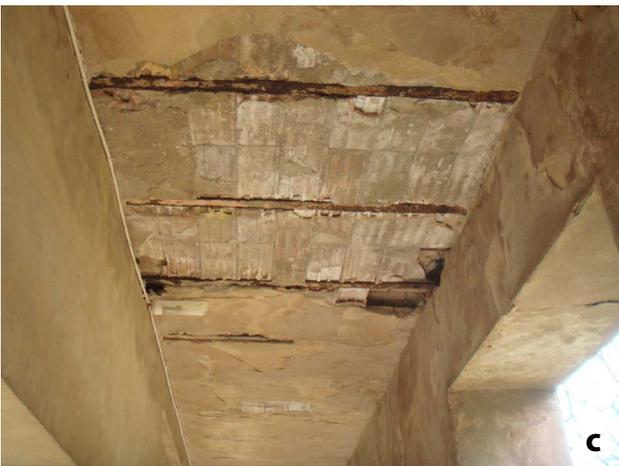
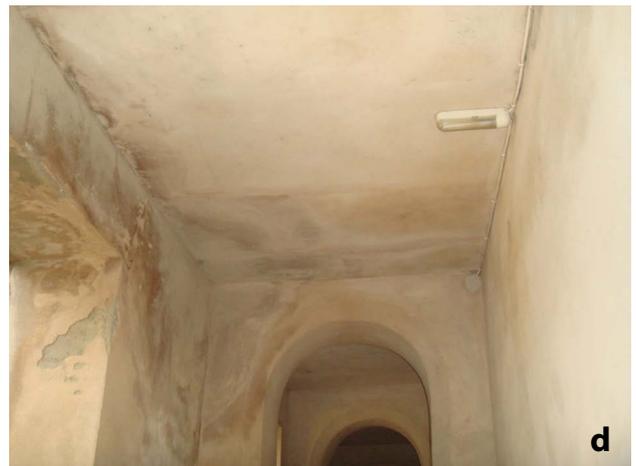
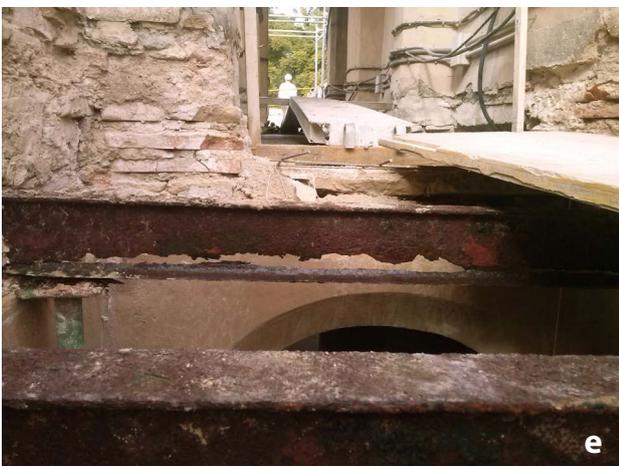
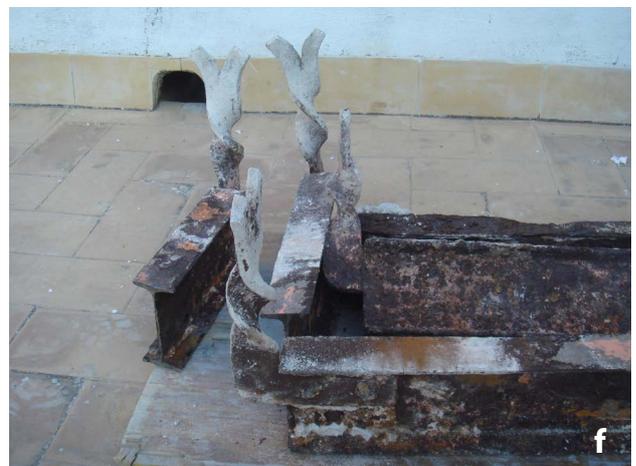
The original structure of the Gallery was made of wooden beams. However, at the beginning of the 20th century, it had been replaced by metal beams. At present, there was no trace of the ligneous structure, and the metal profiles showed a high degree of oxidation, with the result that half of the roofed gallery had to be closed due to falling debris. In the section still open to the public, the ceiling and walls presented very obvious patches of damp. Meanwhile, the restricted flat roof – the open walkway designed by Vermondo Resta –, which had been closed to the public at some unknown point during the 20th century, served as a *vast conduit*, conveying numerous installations (electrical, water, etc.) along the interior face of the parapets. The possibility of recovering this upper itinerary for visitors had not been advanced by the new paving laid in the late 20th century [7, pp. 38-39], which had made the height of the parapets too low, nor by the forced mouth of the gargoyles to drain rainwater, which left highly visible remains of accumulated dirt and large patches of damp in its trail (Figure 5).

**Figure 5.** a) General view of the open walkway with the installations running along the inside of the parapets and the accumulated dirt along the edges. b) Forced mouth of one of the gargoyles. c) State of the roof structure in the closed area. d) Patches of damp in the area open to the public. e) Oxidation of metal beams. f) Wall anchors.

The only exception to this criterion of minimal intervention was the replacement of the roof structure of the Grotto Gallery, which cannot be avoided. Three options were presented: to execute a new wood structure, to replicate the existing solution of metal beams, or to create a new structural floor. Given the absolute lack of information about the original slab, it was not considered appropriate to simulate a construction system in wood, which details were unknown. Regarding the use of metal profiles, experience had shown the catastrophic effects of oxidation, and the very ornamental shape of the wall, with its rustic stone inserts, hindered the definitive disappearance of moisture. The option remained was to design an alternative structural system. The somewhat unconventional structural solution of the composite roof deck was chosen as the best system for resolving the preliminary conditions:

The first beams we saw when we commenced the demolition confirmed our worst suspicions and supported the decision to replace the entire roof structure. This meant that we also had to remove the embedded heads of the beams and the 50 solid iron square-profile tie beams that appeared, having been inserted in 1759 after the earthquake. The removal of the tie beams and some of the wooden beams was a slow, laborious process since many of them were so deeply embedded as to be almost touching the façade.

Since we had done away with the support system provided by the existing metal elements, we had to reinforce the bracing that would now serve as the new roof structure, so we inserted metal connectors between the composite roof deck and the side walls. For this we used Hilti HAS M10 anchor rods secured with HY-30 resin, placed every 30 centimetres.

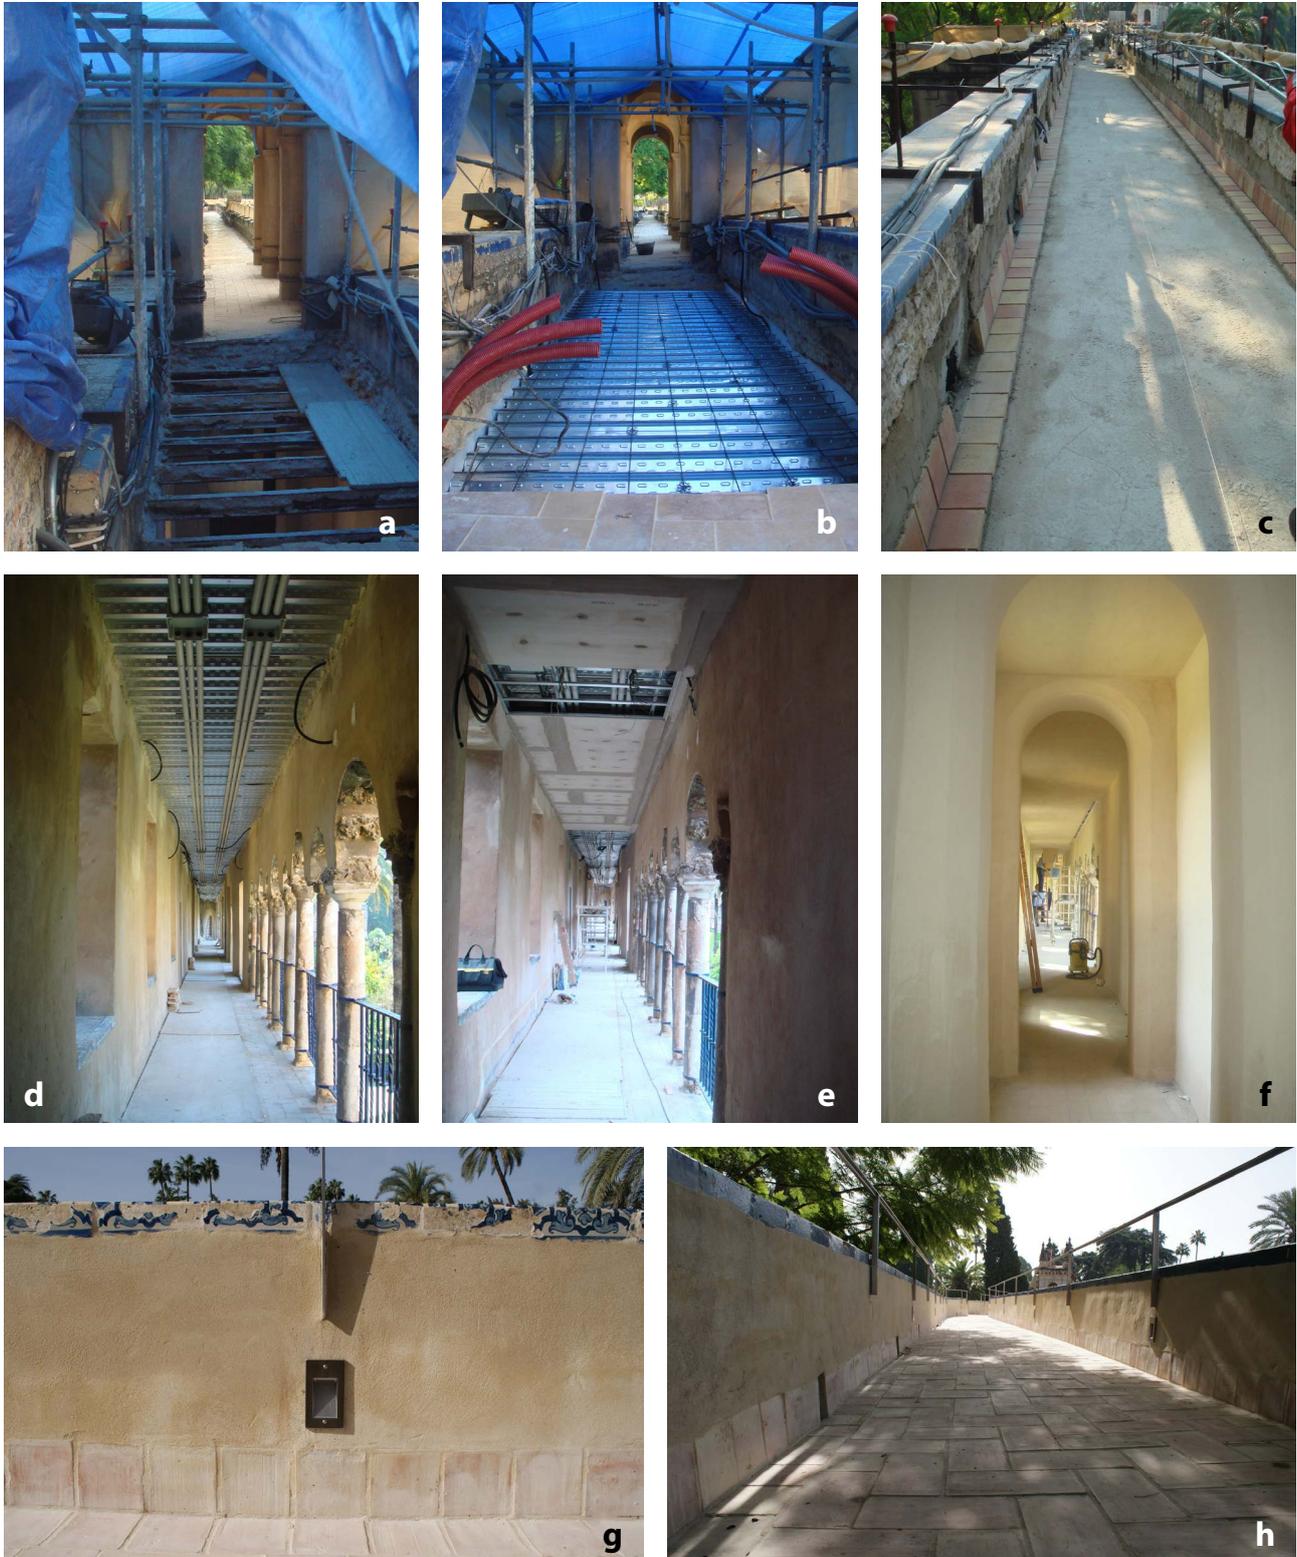
**Figure 6.** *a)* Demolition. *b)* New roof deck profile. *c)* Beginning with the handmade ceramic floor tiles. *d)* Installations under the roof deck profile. *e)* False ceiling. *f)* Interior final state. *g)* Small lamps connected to a double circuit to provide normal lighting and emergency lighting. *h)* Final state of the walkway.

Having replaced the roof structure, the remaining works were mostly related to recovering the open walkway. We chose handmade ceramic floor tiles to restore the original colour and texture to the flat roof. Unlike the

homogeneity of industrial pieces, wood-fired tiles present different nuances of colour depending on where they are placed inside the kiln during firing. Before forming the roof and laying the tiles, we had to repair the walls, which

had been seriously damaged by water seepage. We then cleaned the ceramic pieces along the top of the parapets, removing all traces of cement and repointing the pieces with lime mortar.

With regard to the installations that ran along the Grotto Gallery parapets, all cables were re-laid under the false ceiling, with electrical boxes every 12 metres. This apparently simple operation, which was essential to recover the open walkway, permitted conduits for the surveillance, lighting, telephony and internet circuits from the gardens to the palace buildings. A set of empty pipes has also been installed for future extensions. The Grotto Gallery and its false ceiling therefore constitute a major hub for the Alcázar's entire network of installations. The false ceiling, which contains access panels with concealed profiles to blend into the background, was completely rendered.
