CONSERVATION OF ANDALUSIAN MONUMENTAL HERITAGE: THE CASE STUDY OF THE NIEBLA WALLS IN SPAIN

Jacinto Canivell, Ana González-Serrano

Theme 7: Ancient/Historic and Innovative Solutions for Damage Prevention and Performance Improvement
Keywords: Assessment, risk, conservation, vulnerability

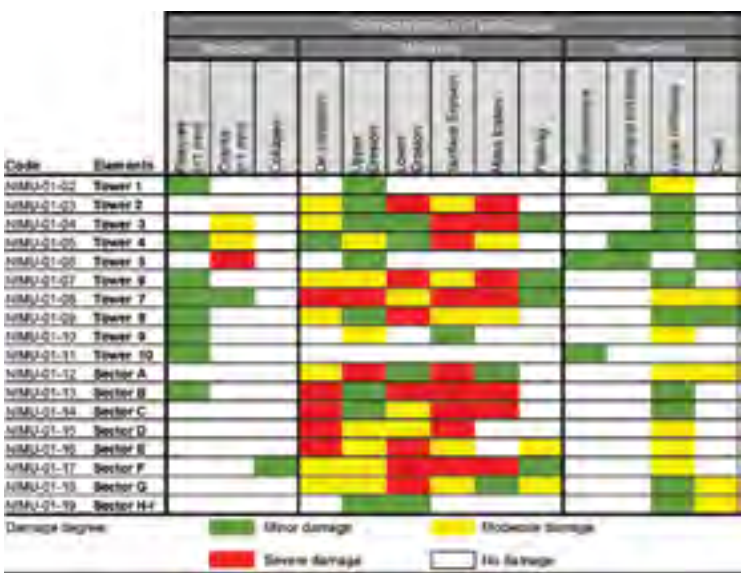
Table 2. Damage characterization of Niebla wall between Towers 1-10 (credits: J. Canivell, 2011)

Materials damage: These include the damage affecting the integrity of the rammed-earth mass. Lack of consistency is a very clear sign in the restored layers of rammed-earth, which disintegrates with a simple touch of the hand. This rammed earth appears to be of irregular compaction, resulting from insufficient control of the work, in light of the inclusions of large stone blocks, fired bricks and even organic materials. In general, erosion is typically caused by external agents (moisture, wind-driven rain, temperature, and fauna). Severe erosion is found in the highest lifts of rammed earth, which is more susceptible to moisture infiltration and the effects of wind. Erosion at the lower parts of the wall is often linked to capillary rise, or the backsplash of water against the wall at the lower lifts. Surface erosion is generally spread and is normally caused by the continuous washing of rainwater. In the sections studied, erosion is aggravated by the accumulation of water in certain obstacles (joints, weep holes), producing cavities. Mass losses, although sometimes confused with erosion, have a different origin. The poor quality of the rammed-earth is the cause of these types of detachments, also aided by other external agents, showing more severity in Sections B, C and F. Finally, a special mention is made of flaking as a singular condition, through which the mass of the wall disintegrates in slab-like shapes, parallel to the façade.

Generally, damage to the integrity of the mass has deteriorated the rammed earth with greater severity in the sections studied, due to the exposure to the southwest (the predominant direction of winds and rains), and the low quality of the restoration rammed earth (particularly between T1 and T7). In certain sections (T7 to T10), the quality of the rammed earth dramatically improves (3), even though its exposure similar.

Superficial damage usually affects only shallow layers of rammed earth and can lead to erosion. The efflorescence that shows up as surface deposit of salts is difficult to identify on rammed-earth masonry and even more so, if it is eroded. However, small deposits have been observed in some stone areas and towers. The uniform soiling is linked to the existence of an aggressive environment with a high proportion of suspended particles, causing a widespread contamination of the wall. Local soiling is caused by the differential water-washing of the wall, causing staining typically at the top of the wall, or at intersections between walls and towers. These dirt crusts are a result of the accumulation of muddy moisture and the development of fungi and lichens, forming thin harder surface layers, which when detached, leave a weakened rammed earth exposed to the outside environment.

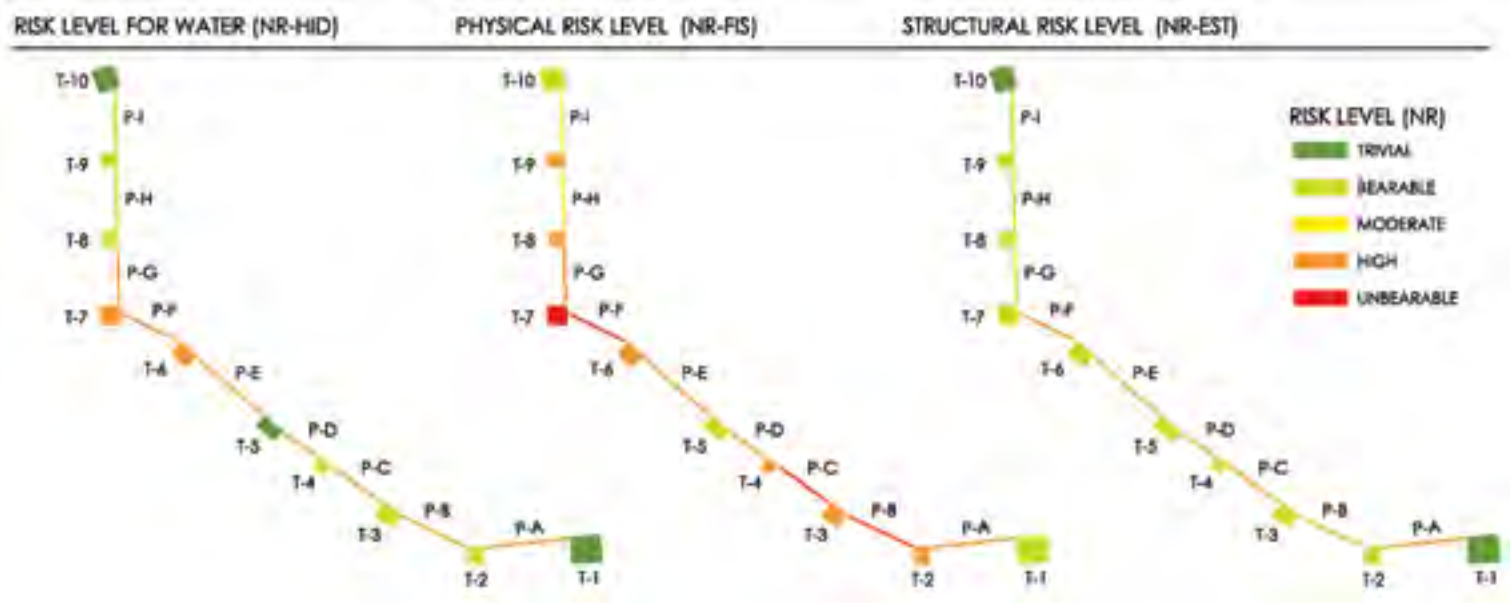
Fig.2 Distribution of the NR for the analyzed wall sections (T1 through T10) (credits: J. Canivell, 2011)

Fig. 2 provides evidence of the NR data for each element

analyzed. Red represents an accumulation of high levels for risk factors and, therefore, high risk of occurrence and development of pathological processes, producing serious consequences to the asset or its users. The diagrams show how the highest vulnerability corresponds to NR-FIS (erosion, de-cohesion, mass loss), and especially in the fabric and intermittent towers from Towers 1 to 7, which also corresponds to the first phase of intervention (Table 1). In these most vulnerable sections, corrective measures are urgently needed to repair damage, as well as preventive measures to mitigate risks and to ensure greater durability.

This assessment methodology provides an easy and useful tool to prioritize repair actions on a set of components, assigning different levels of intervention (NI) for each NR. For high NR, more urgent preventive measures and stronger corrective measures will be required, thus reducing vulnerability. Also, in the case of high NC, maintenance plans should be implemented or revised.

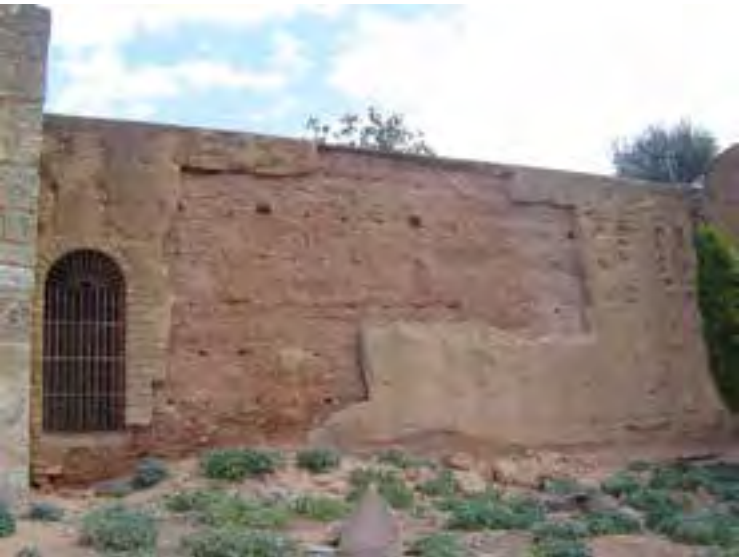
Fig.3 Damage in earthen the fabric of the wall between Towers 6 and 7 in 2009 (credits: A. González, 2009)

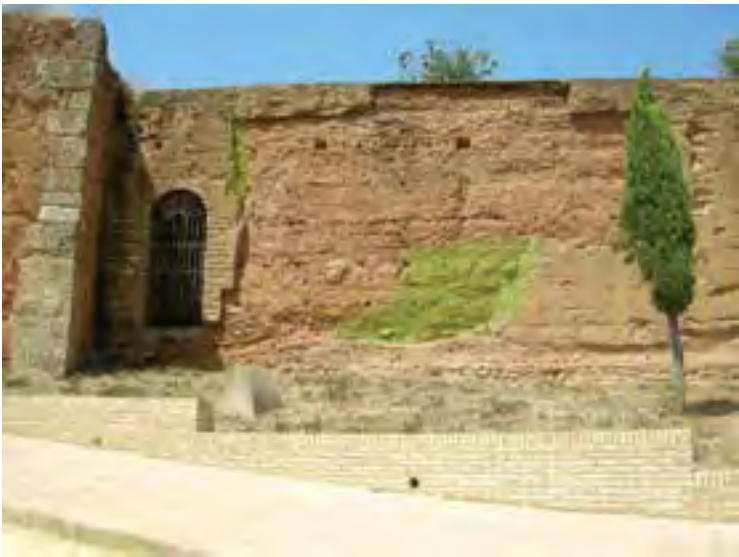
Fig.4 Damage in earthen the fabric of the wall between Towers 6 and 7 in 2011 (credits: J. Canivell, 2011)
