World Multidisciplinary Civil Engineering-Architecture-Urban Planning Symposium 2016,  
WMCAUS 2016

## Colours Found During Restoration of the Seville City Hall Facade

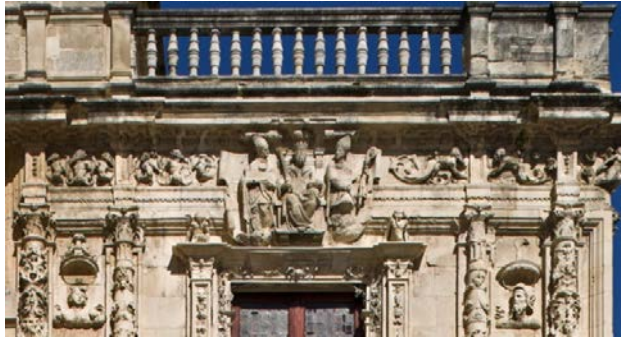
Fig. 1. San Fernando sculpture.

A total of 60 samples were collected from the façade and studied in this work. Samples 40, 41, 42 and 52 were collected from the San Fernando sculpture (Fig. 1). Several samples were taken from the protective layers of the façade. Sample 55 was possibly a resin. The restored façade area is shown in Figure 2.

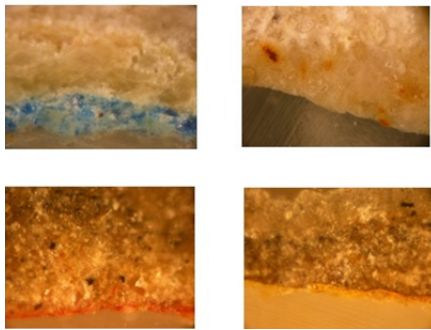
Fig. 3. Optical micrographs of the cross-sections of:  
a) sample 40, b) sample 41, c) sample 42, d) sample 52.

The Cl may be associated with the Pb as it is in sample 40. Our analyses indicate that, at one time, the wall paintings may have covered the entire surface of the façade. Sample 52 was collected from such a wall painting. The surface of sample 52 (cross-section shown in Fig. 3d) is a compact, yellowish layer with red particles and the interior is white. The yellow layer is composed of Ca and O (spectra c and d in Fig. 5) or calcite. The red particles contain Ca and Fe (spectrum e in Fig. 5). Therefore, the surface layer contains calcite with iron oxides as pigments. Pigments from other samples (samples 33, 34, 47 and 60) studied also content of iron oxides.

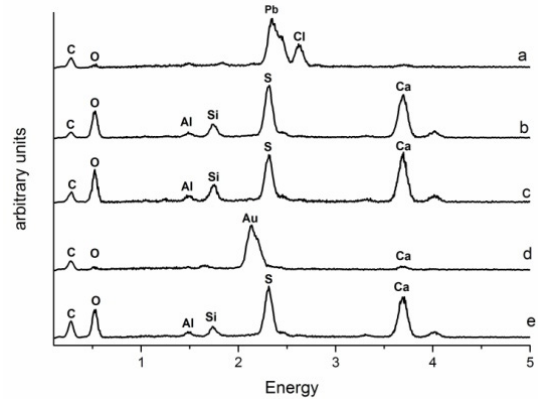
Fig. 4. EDX analysis of cross-sections of samples 40-41.

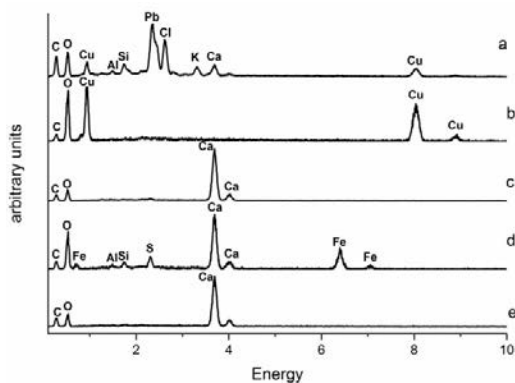
Fig. 5. EDX analysis of cross-sections of samples 42-52.

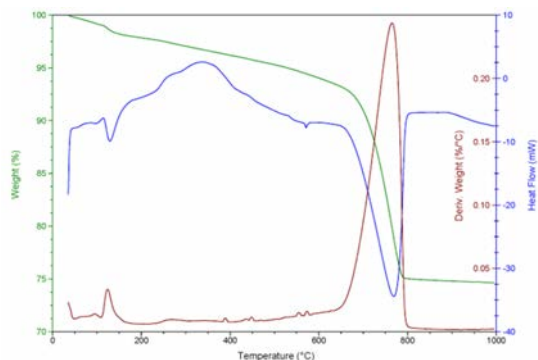
A black crust was also found in some zones of the façade. Mass spectroscopy of this black crust indicated the presence of alkanes produced by petrol combustion. Other organic compounds, including isoprene hydrocarbons, fatty acids, amides and polycyclic aromatic hydrocarbons, were also present. These organic compounds have also been found on other monuments in Seville [6-8]. XRD of the black crust samples revealed high gypsum content with smaller amounts of calcite and quartz. This analysis also identified the presence of Fe, Al, Ti, Cr, V and Pb, all of which are catalysts for gypsum formation in the presence of SO<sub>2</sub>.

The DTA/TG/DTG curves shown in Fig. 6 for the black crust indicate a high mass loss (16.5%) and an endothermic reaction attributed to the vaporization of water bound primarily in gypsum that occurs between 100 and 200 °C. The evolution of the organic compounds between 200 and 600 °C with a maximum exothermic reaction between 325 and 410 °C is of particular interest. The total mass loss associated with the organic compounds is between 5 and 7.5%. Another endothermic peak, with a mass loss of 3.5%, appears between 600 and 725 °C and corresponds to decomposition of carbonates.

Fig. 6. ATD/TG/DTG curves for black crust.

The stones were cleaned using water and natural soap so as not to damage them. After the stones were cleaned, they were consolidated and protected by stable, well-studied, mineral materials that were compatible with the stone. The degraded joint mortar was removed and filled with Cumen lime mortar in a technically controlled process.
