Article

Characterising Draught in Mediterranean Multifamily Housing

Instituto Universitario de Arquitectura y Ciencias de la Construcción, Escuela Técnica Superior de Arquitectura, Universidad de Sevilla, 41012 Sevilla, Spain; jfernandezaguera@us.es (J.F.-A.); mcampano@us.es (M.Á.C.)

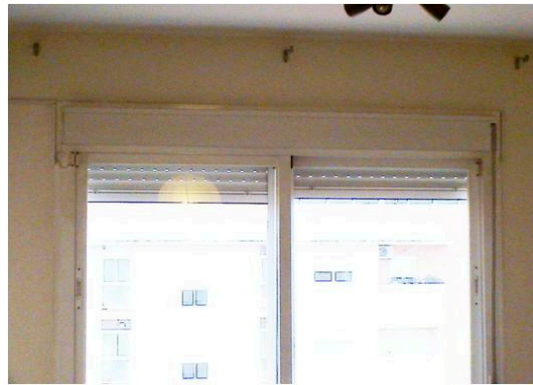
Figure 7. The window (visible spectrum) prior to the blower door test.

The façade opening depicted in Figure 7 was an aluminium compact roller sliding glass window located in the case study living room. The thermal condition of the opening and surroundings after the temperature stabilised and prior to the blower door test is shown in Figure 8, left. The wall surface temperatures were measured on the head jamb at the three monitoring points (Spi) labelled on the images.

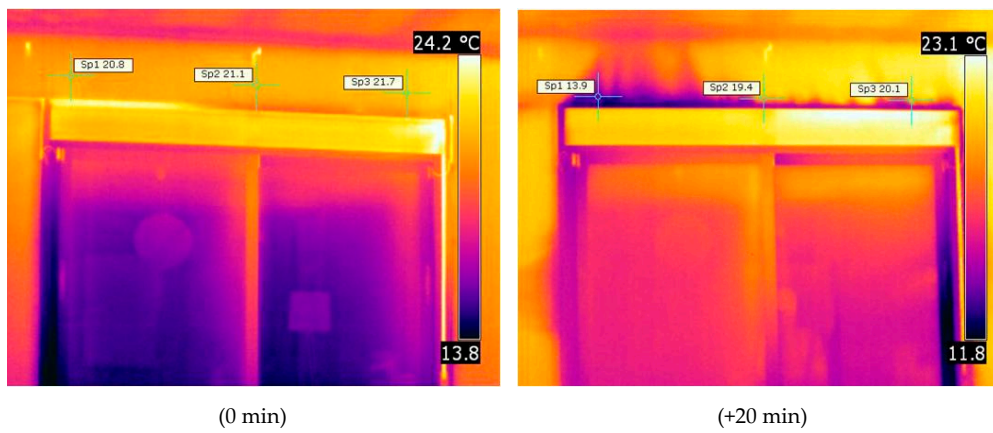
Figure 8. The tomographic image taken: left, prior to, and right, during the blower door test.

The conditions prevailing around the opening after the 20-min blower door test are depicted in Figure 8, right. The surface temperatures at the monitoring points during the blower door test are given in Table 7.

A decline in the temperature was observed at all three points during the test. Those changes were not uniform, however, due to the irregular construction and finishes at the window–enclosure joint. After 20 min, the temperature declined by up to 33.2% at the most air-permeable point (Sp1), compared to just 7.4% and 8% at the other two. That significant temperature drop in the area around point Sp1 (upper left) denoted a substantial inward flow of air.

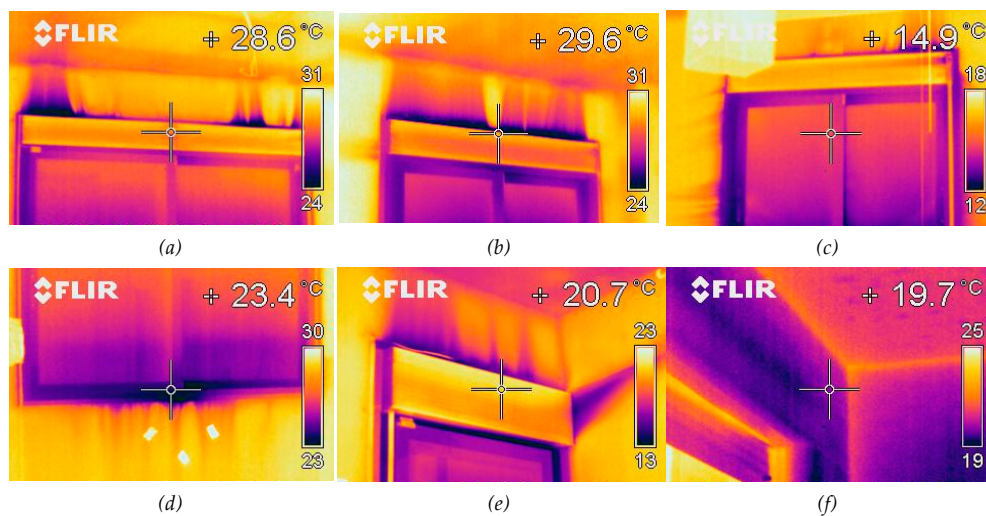
Figure 9. Thermographic images of several façade openings during a blower door test.

The images of the suite of openings analysed, samples of which are reproduced in Figure 9a–f showed that most of the uncontrolled entry paths on the façade were located around the openings, particularly at the seals between components. Further to the thermographic images, the most permeable areas were associated with the parts of the elements most difficult to manually seal, whilst air entry

was less intense in the rest of the perimeter. The area most clearly affected was around the shutter box, where the difficulty to ensure a satisfactory seal gave rise to a sizeable flow path (Figure 9e).

The sensitivity of this area of the envelope to manual on-site assembly procedures would explain the wide scatter in the performance of the various envelope components, as noted in earlier studies addressing other construction types and systems [30–32].

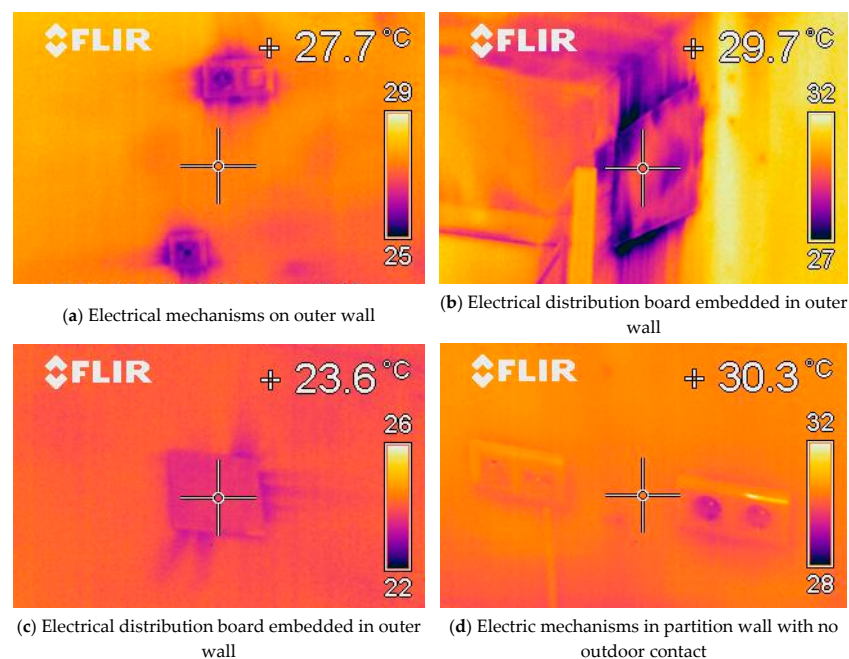
Figure 10. Thermographic images of the electrical mechanisms and distribution boards during a blower door test.

Another flow path for incoming air is associated with electric power mechanisms and conduits, as illustrated by the images reproduced Figure 10.

These flow paths make a notable contribution to airflow, especially when located on drywall (gypsum plaster panels paper-faced on both sides) partitions and indoor façade panels, as in this case study. Intense airflow pathways formed around electrical elements (outlets and boards) located on the inner side of one of the outer walls (Figure 10a) and a partition wall perpendicularly embedded in the outer wall (Figure 10b,c). In contrast, the elements located on inner walls or walls barely in contact with the outer envelope made no significant contribution to the ingress of outdoor air (Figure 10d).

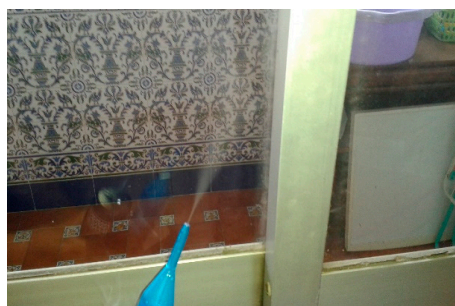
(a) The flow path between sliding door panels

The frames themselves, in particular, the sliding components, exhibited airflows more clearly than other envelope elements. Inter-panel closures (Figure 11a) and panel–window/door frame interfaces (Figure 11b) were the areas where airflows were most routinely identified. The indoor shutter box, whether built into the window frame or otherwise, was another area often observed to generate flow paths (Figure 11c), particularly around the operating mechanism (although other pathways appeared in the box itself, depending on construction type and state of repair). The area around the frames (Figure 11d) was yet another zone where air flows were identified, particularly in elements involving awkward on-site assembly.

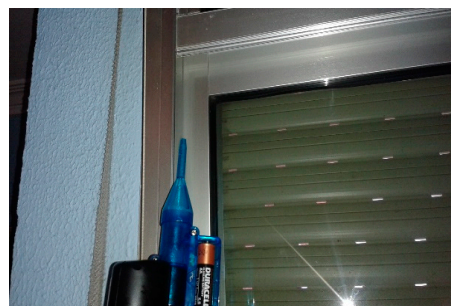
(b) The flow path in a (sliding) window frame

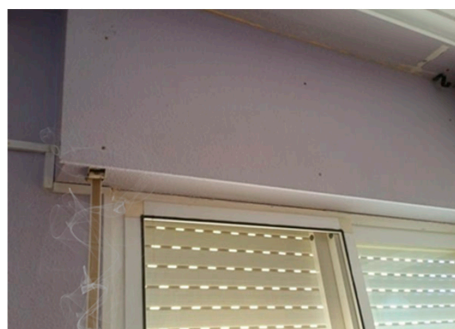
(c) The flow path associated with the shutter box

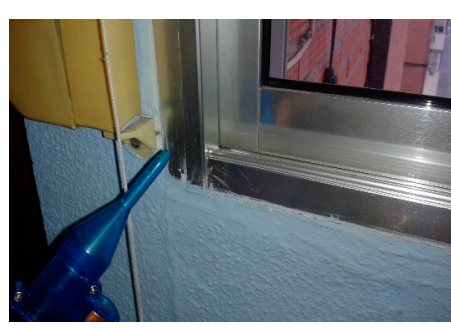
(d) The identification of the flow path at the frame-enclosure interface

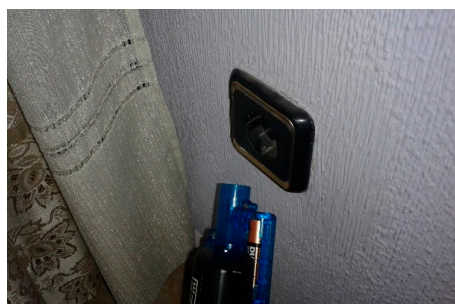
(e) The airflow across service penetrations: electrical outlets

One of the points not associated with window/door frames where airflows were observed were electric power outlets and similar mechanisms. Air leakage was often identified in mechanisms located on outer walls, especially where the element fully perforated the inner partition in masonry-air space-partition wall enclosures, connecting the indoor area with the air space (Figure 11e). A similar situation was observed in some (especially drywall) non-outer walls perpendicularly embedded in the façade (Figure 11f).

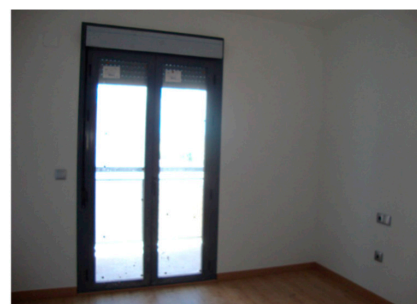
(f) The airflow across service penetrations: electrical outlets

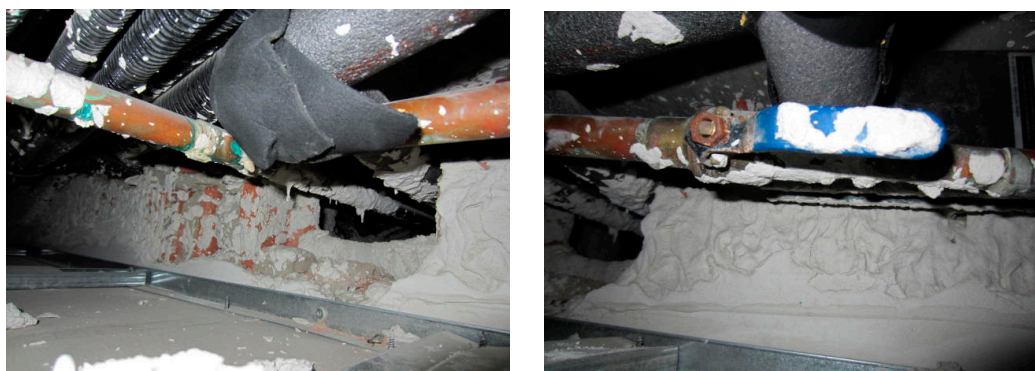
Most of these seldom sealed penetrations generate sizeable pathways, since they generally accommodate the drinking water service connection and in-flat distribution pipes (Figure 12a).

(a) Water pipe penetrations to flats from communal area service shafts

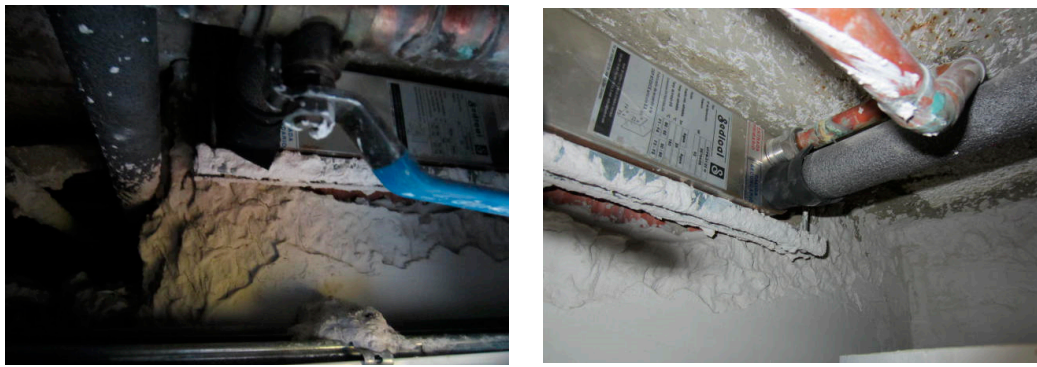
(b) An individual heat exchanger for a solar domestic hot water (DHW) system (secondary communal circuit)

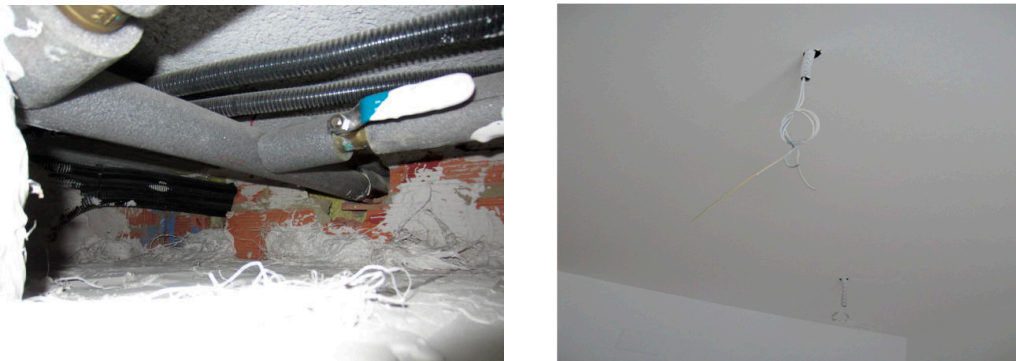
(c) The discontinuity in a lowered ceiling generated by a penetration for an electrical conduit

The electric power circuit also interrupts individual flat sectorisation substantially, both with regard to penetrations to accommodate conduits running into the flat from outside it and those required between rooms either across interconnected spaces above lowered ceilings or through the conduits (protective piping) themselves (Figure 12c). Those conditions may induce an inside-outside exchange in concealed spaces that may be connected to living areas across these indoor conduits.
