Concrete facade conservation of the Peru Pavilion of Seville (1927). Analysis of decay and evaluation of protection treatments

HISTORICAL INTRODUCTION OF THE BUILDING

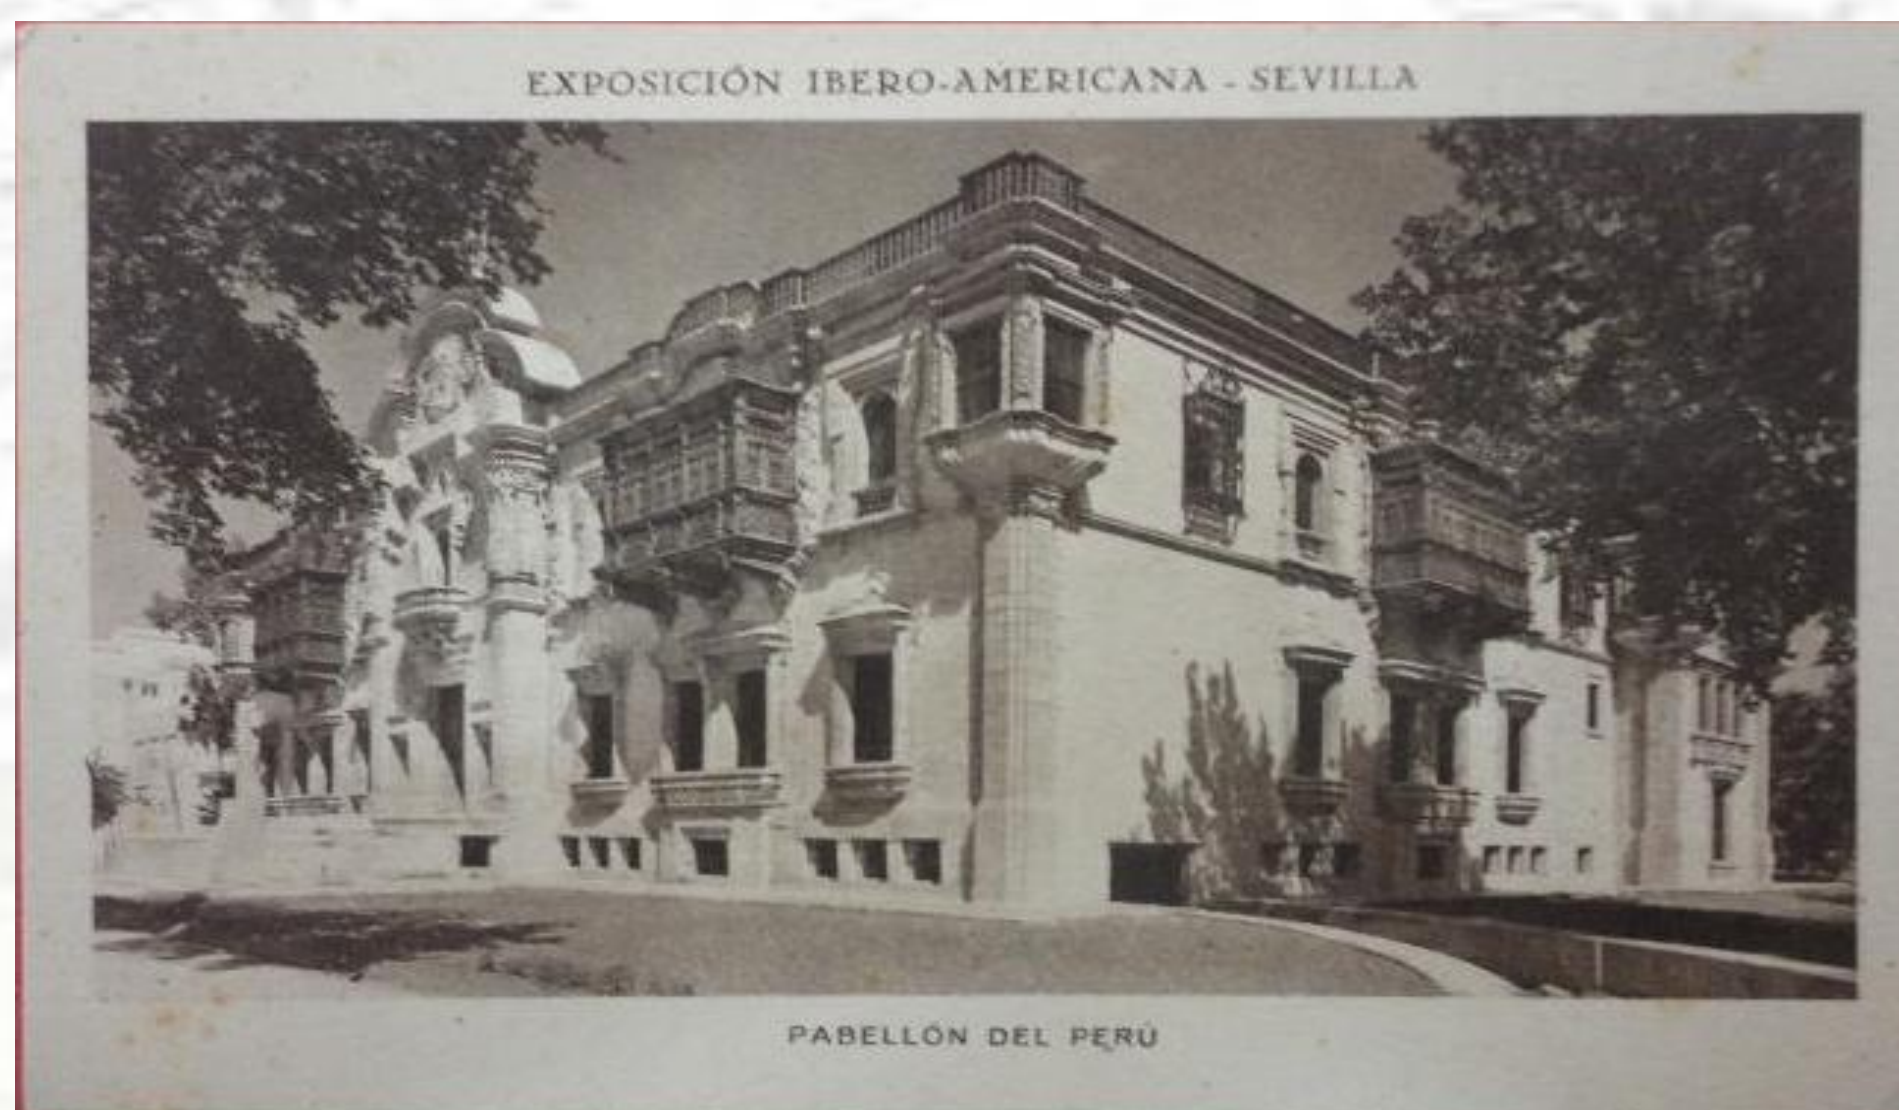
Image of the Peru Pavilion 1929

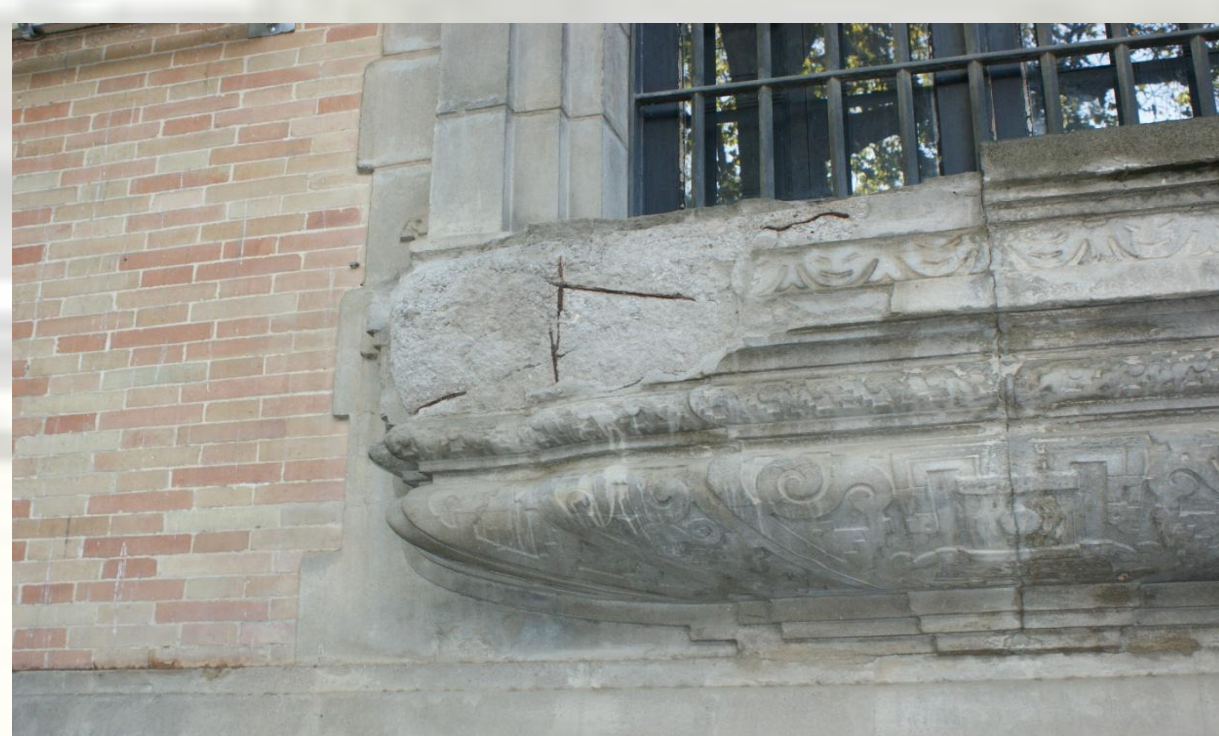
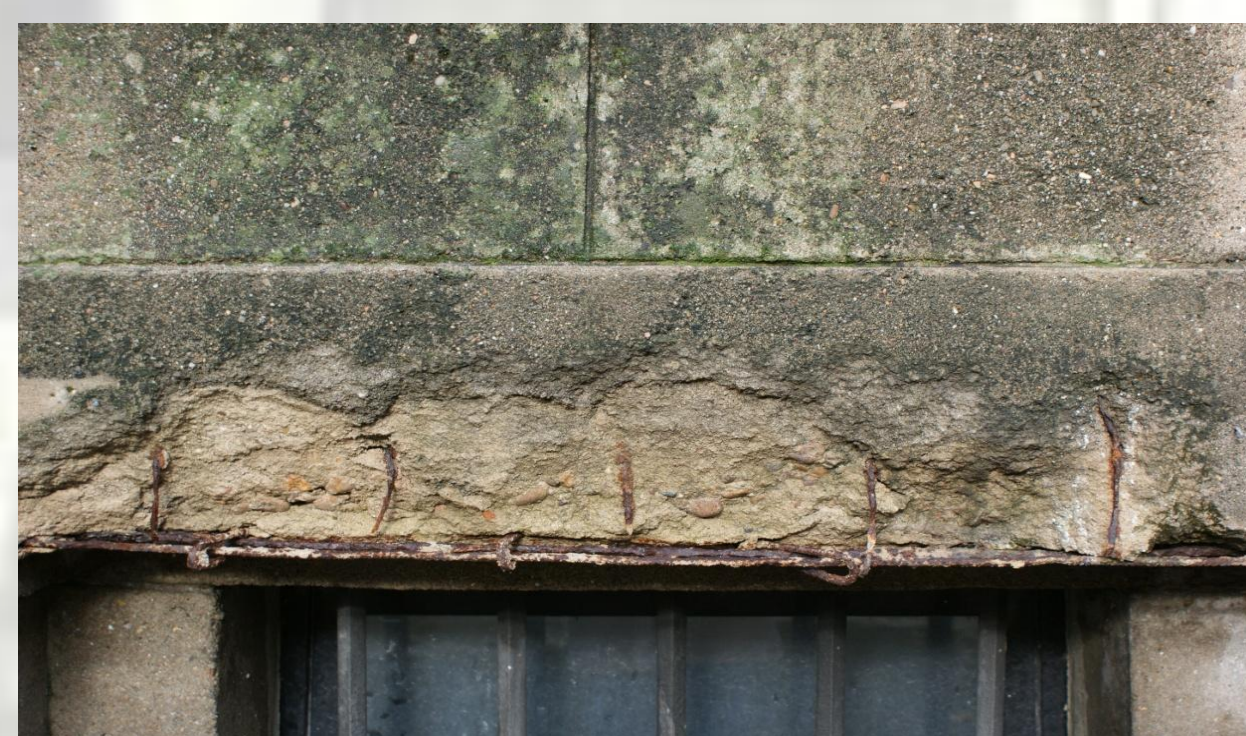
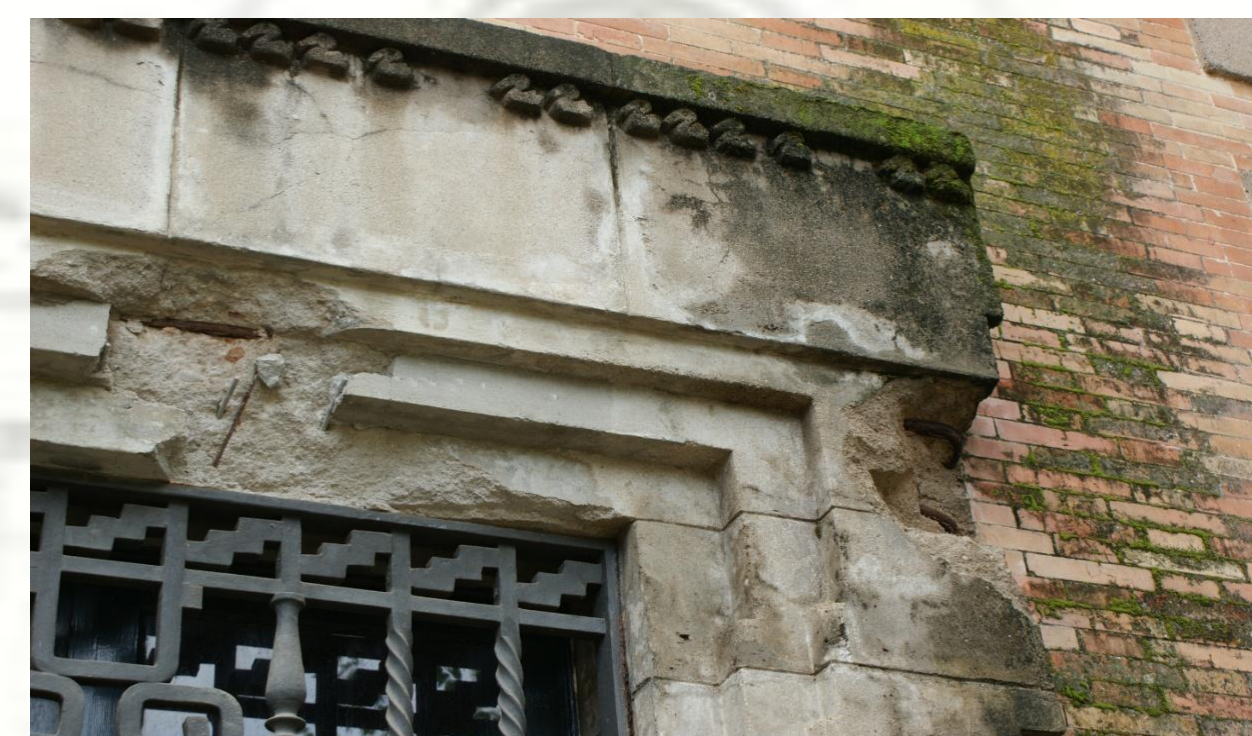
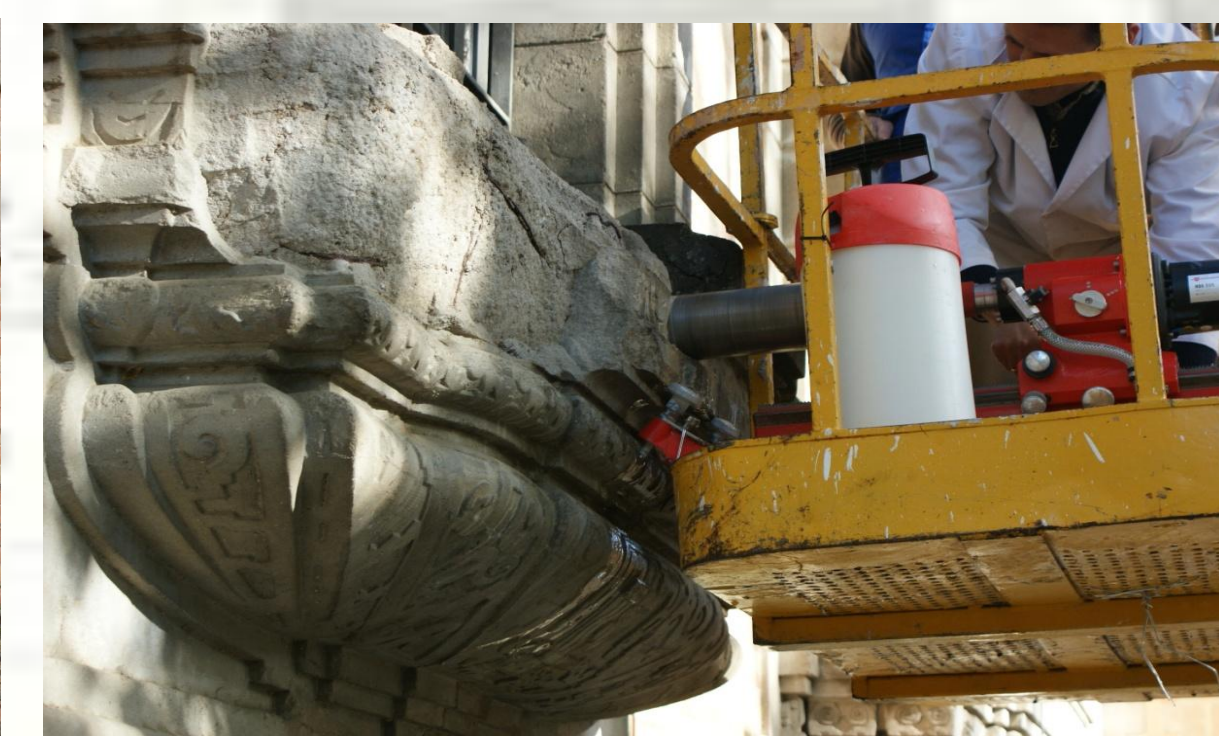
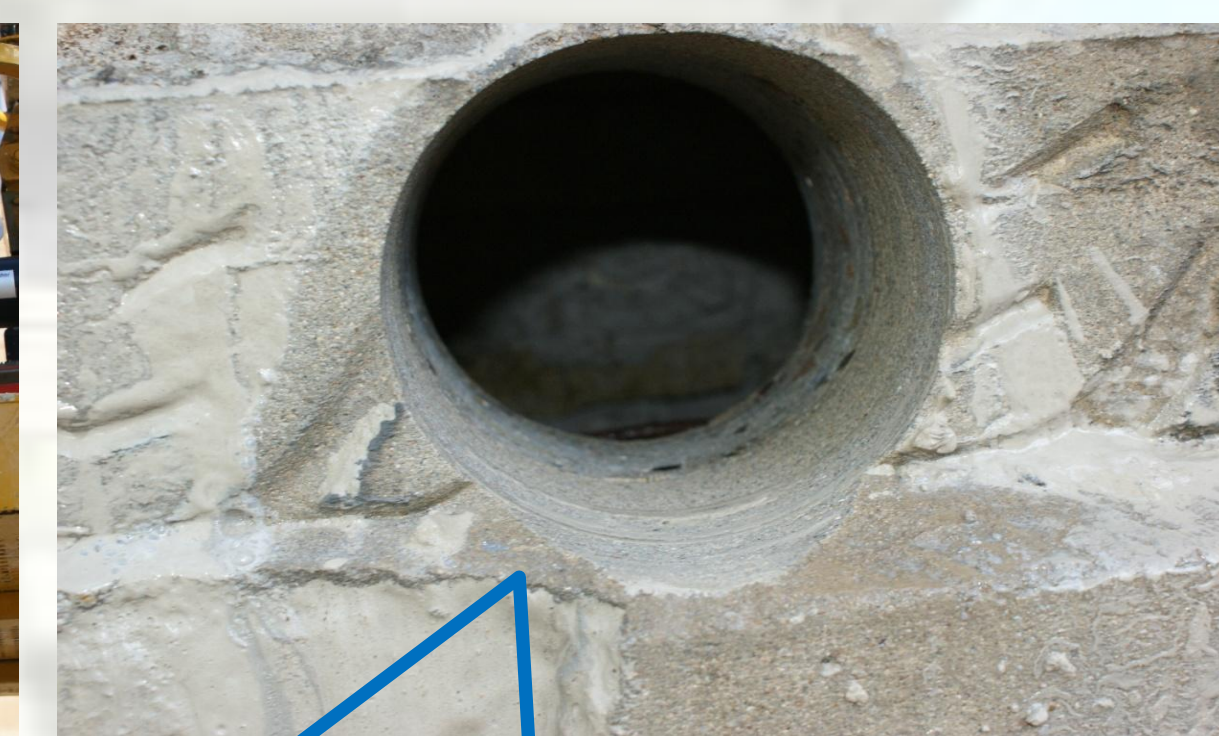
In the picture it can be seen the thickness of the prefabricated section and the difference between the outer mortar layer and the concrete interior.

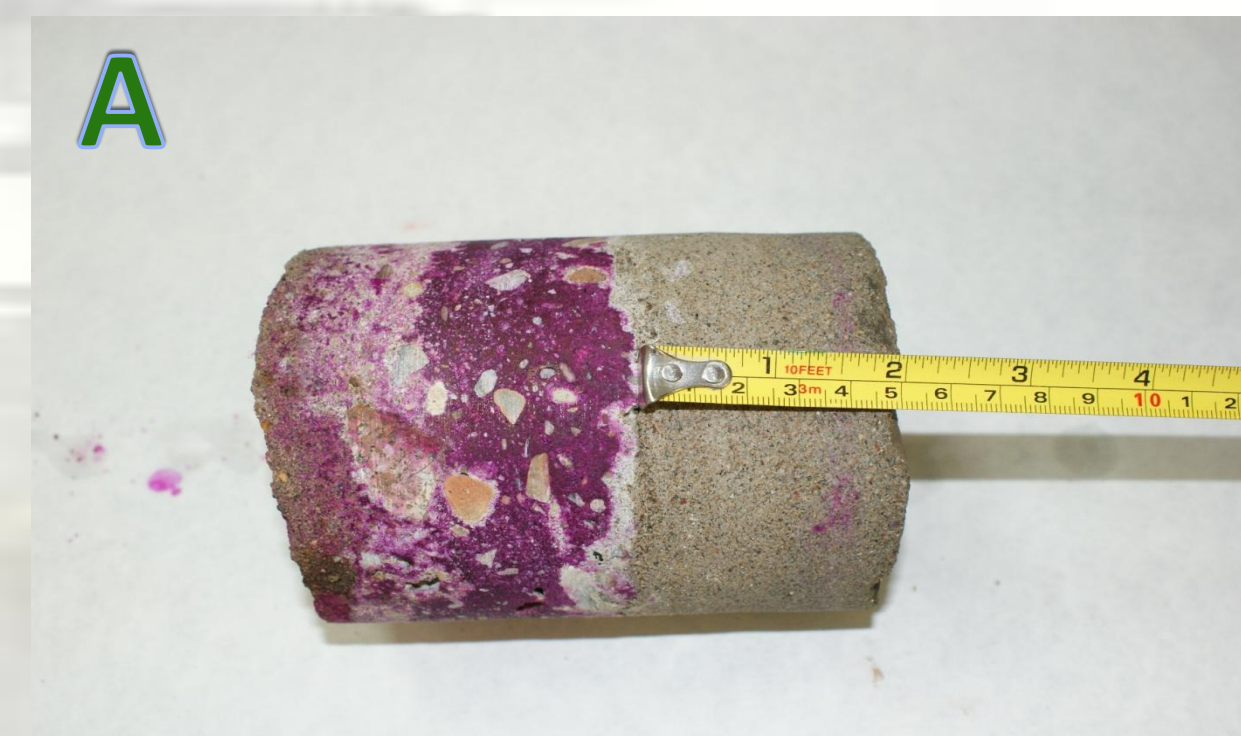
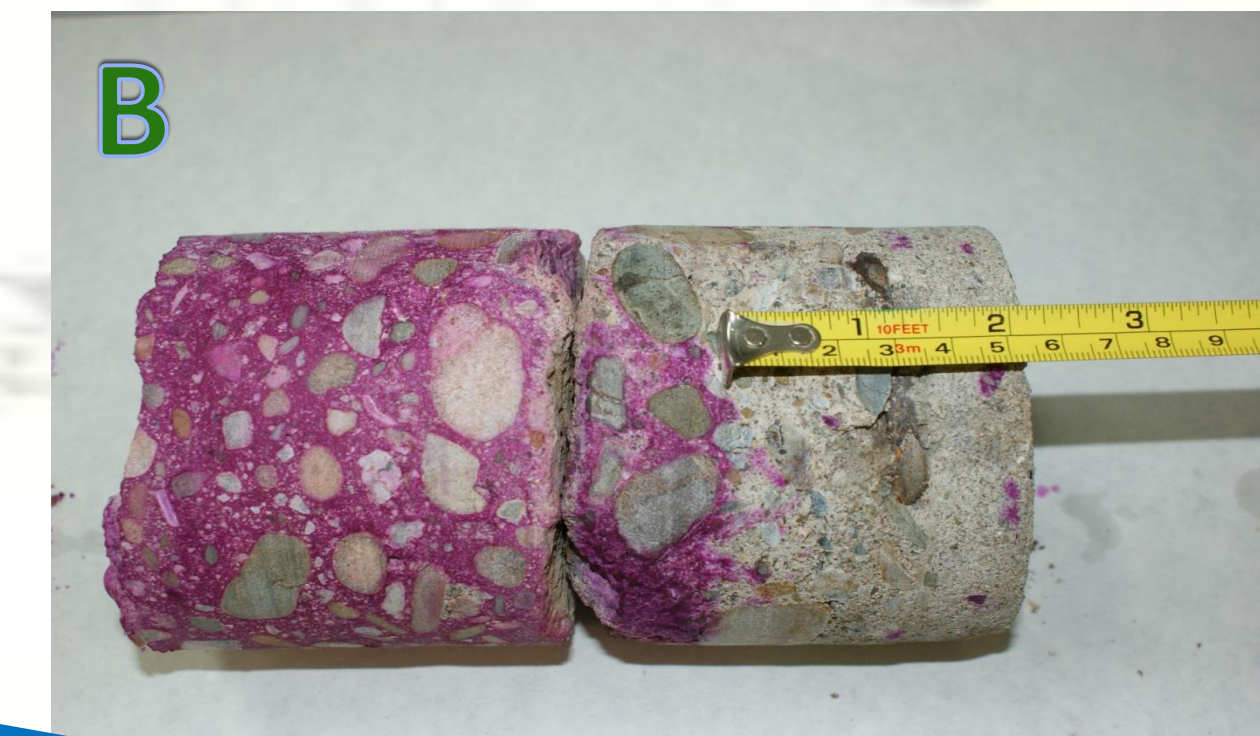
The depth of concrete carbonation is influenced mainly by the following factors: environmental relative humidity, open porosity, cement dosage (kg/m^3) and the age of the concrete. The phenolphthalein test was performed on the three specimens obtained, giving mean values of penetration of 53, 57 and 53 mm, which denote a mighty carbonation advance. This has affected the concrete around of the metal armatures, resulting in their depassivation and oxidation that has caused the fracture of the concrete.

The phenolphthalein test shows the depth of carbonation. The exterior layer (carbonated) has developed a lowering of the pH with respect to the non-carbonated interior layer, which maintains the initial concrete pH value (~ 13). In this range the indicator causes a purple coloration that does not appear in the exterior zone. In the images it can be verified that the circumstance occurs both in the samples in which the exterior layer is made of mortar (A), as in those that are just of concrete (B).
