Research article

Analysis of alterations presented in a white-concrete façade exposed to a marine environment—A case study in Cádiz (Spain)

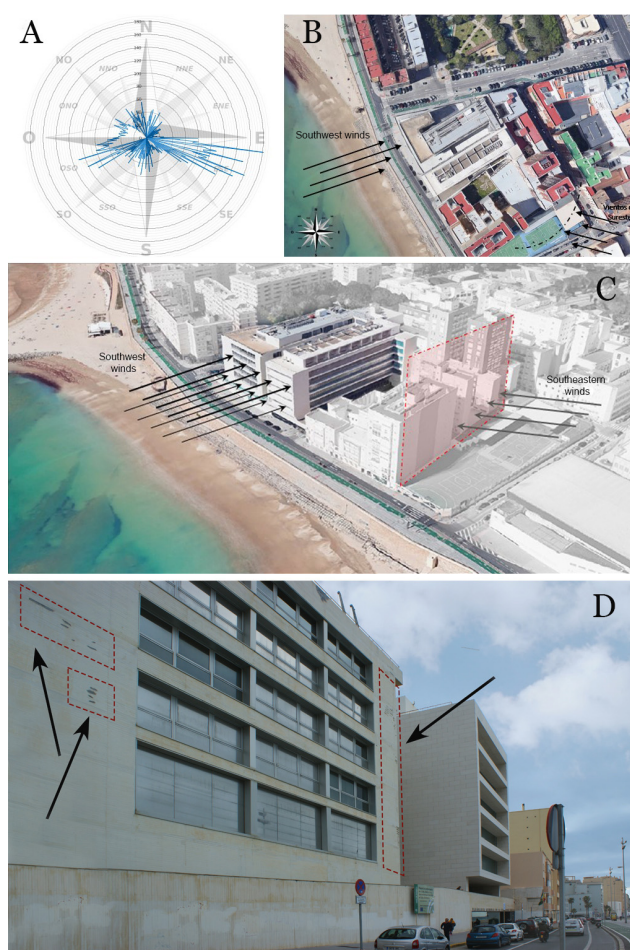
Figure 1. (A) Winds in the city of Cádiz between 02/16/19 and 05/28/20 (Own data. Source: AEMET). (B) Incidence of prevailing winds on the façades of the building studied on the ground plan and (C) in perspective. D: General image of the damage located on the south-west façade.

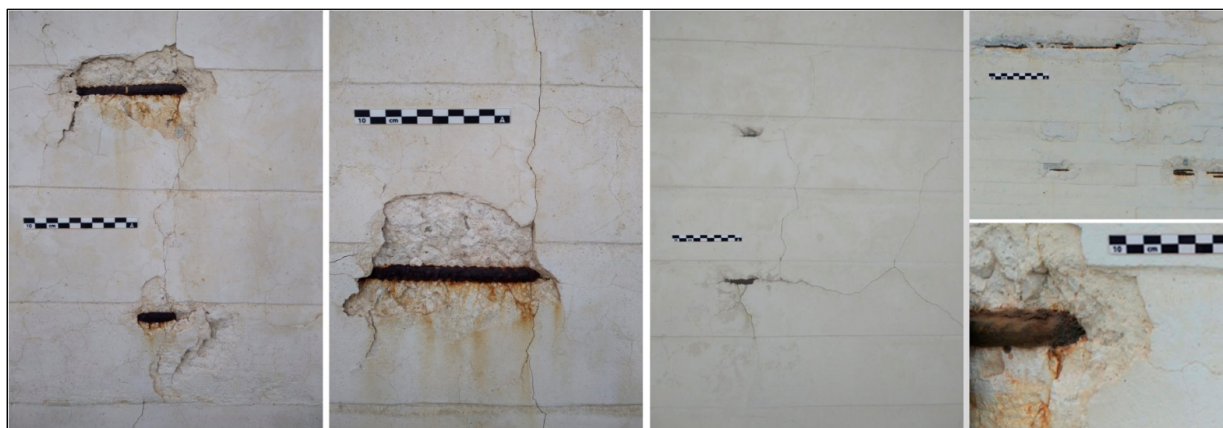
Figure 2 Close-up of alterations in the exposed reinforced concrete façade: detachments, shrinkage cracks, reinforcement corrosion, oxidation patinas.

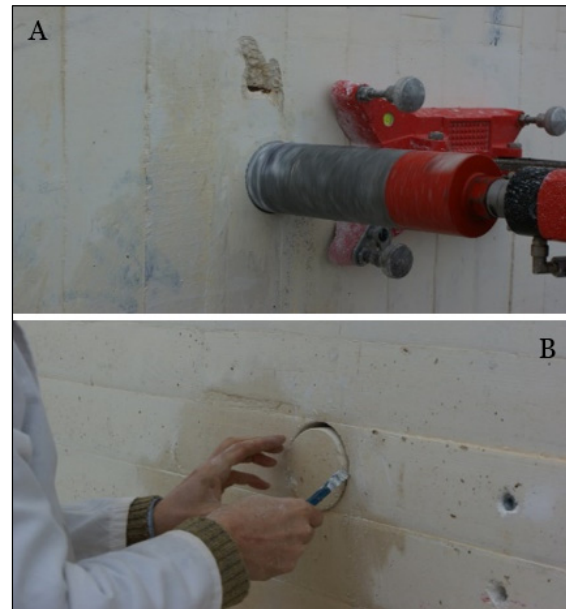
Figure 3. Process of extraction of two cores from the façade.

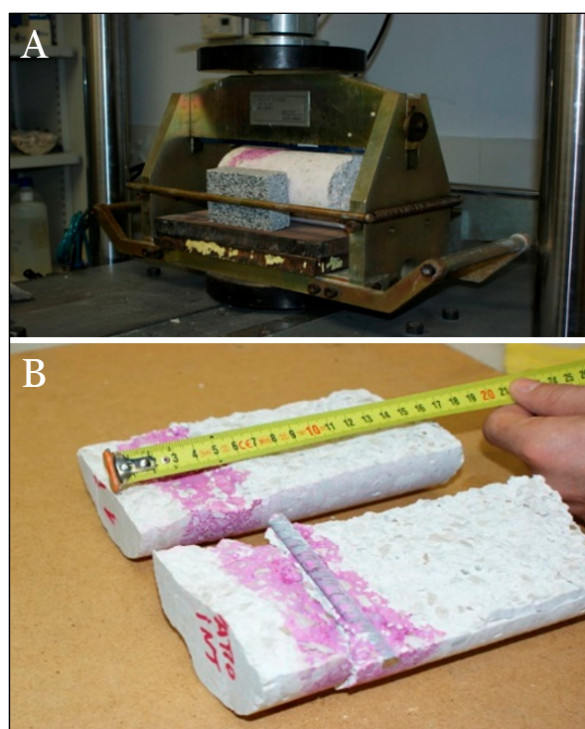
Figure 5. (A) Performance of the indirect traction test, (B) Phenolphthalein test—Carbonation front of core 5.

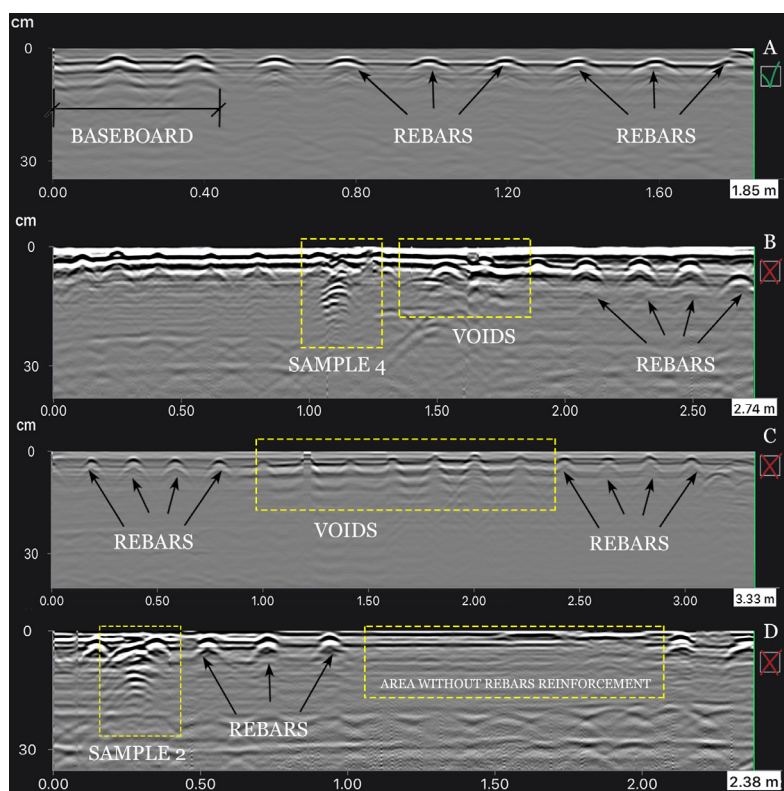
Figure 6. Vertical radargrams. (A) core area 3, (B) core area 4, (C) core area 6, (D) core area 2.

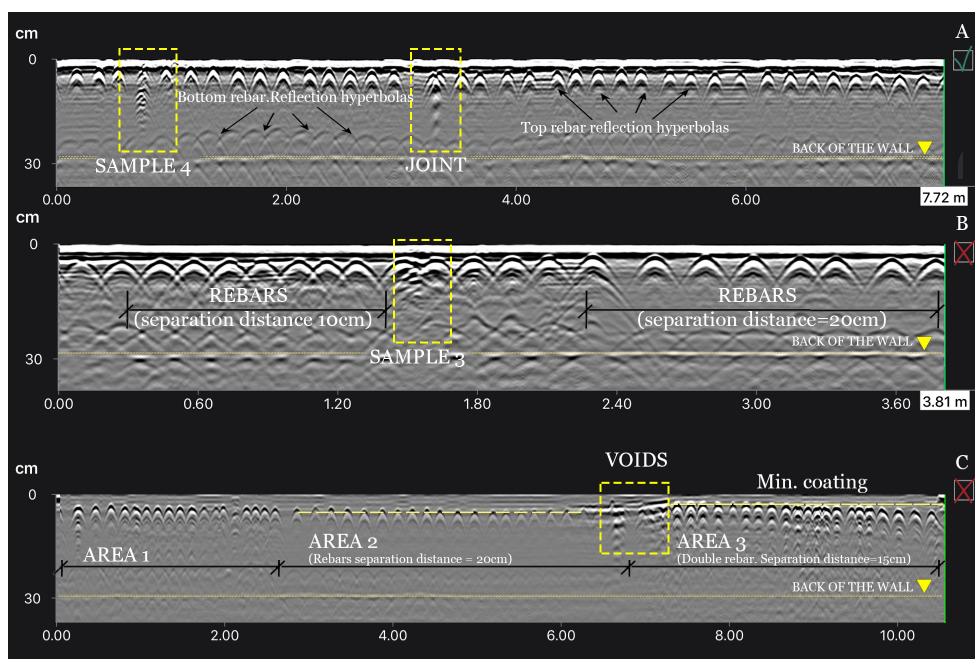
Figure 7. Horizontal radargrams. (A) core area 4, (B) core area 3, (C) core area 6.

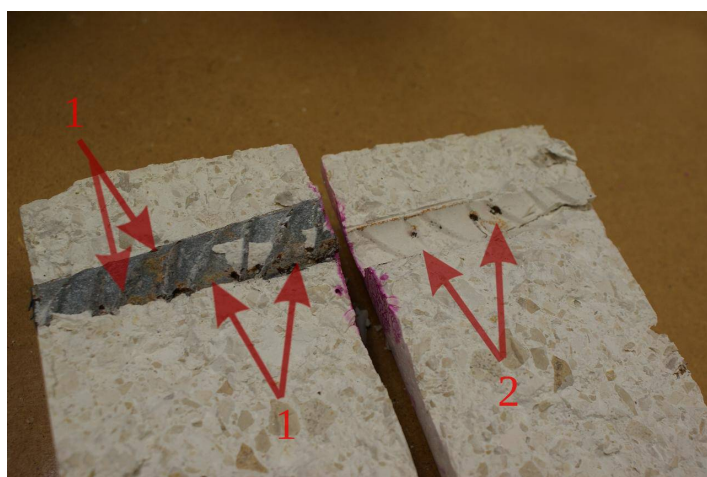
Figure 9. Low reinforcement coating thickness, initiation of the oxidation process due to pitting in the reinforcement caused by Cl^- and traces of rust on the surface of white concrete (1: Initiation of the oxidation process; 2: Pitting corrosion).
