Article

Heritage Sustainability of the Territory: Photogrammetric Survey of the Castle of Beas de Segura (Jaén, Spain)

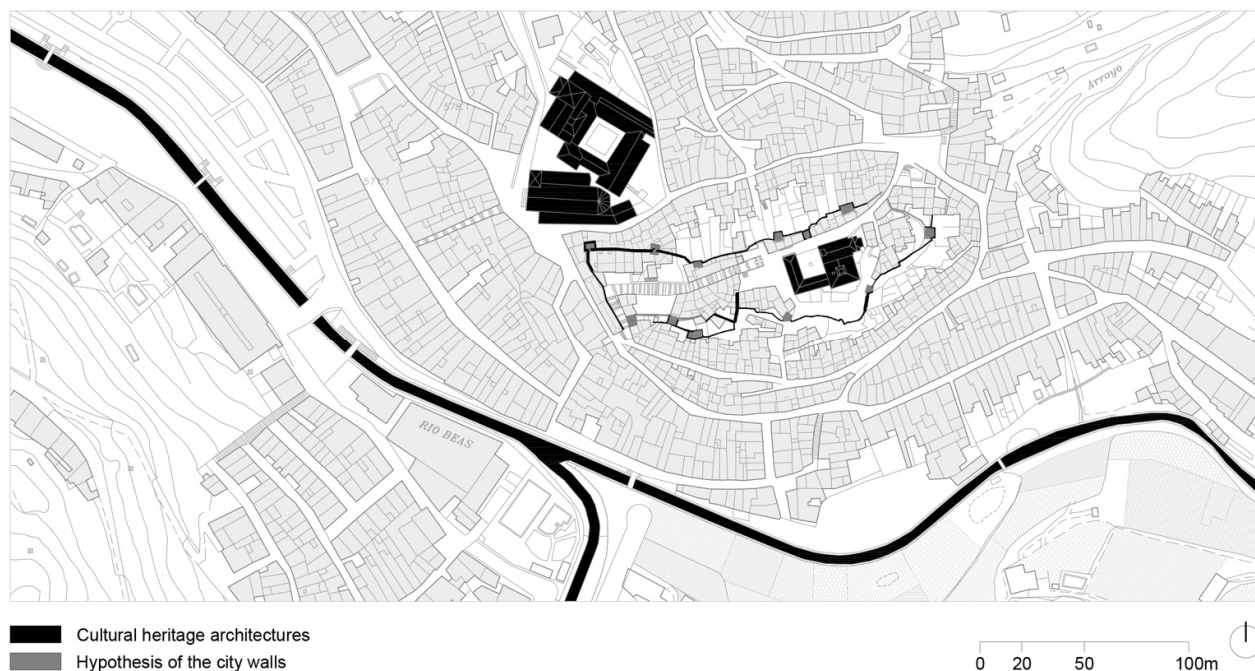
Figure 2. Plan of the situation in which the complex urban structure, next to the walled enclosures, can be observed [authors' own drawing].

The municipality of Beas, and specifically the area of the castle and fortress, has been a human settlement from the origins of civilisation [15] (Figure 2). Habitat remains from prehistoric times have been documented, especially in the cave area of the urban centre itself, and on the terraces of the Guadalimar River, where one of the oldest sites in Andalusia is found and ascribed to the Lower Palaeolithic. These are known, thanks to the studies carried out there by Cabré and Abad Breuil in 1913. Remains of useful elements such as flakes, biofacies, scrapers, and other tools, which undoubtedly belong to this prehistoric period, have been found during various archaeological campaigns.

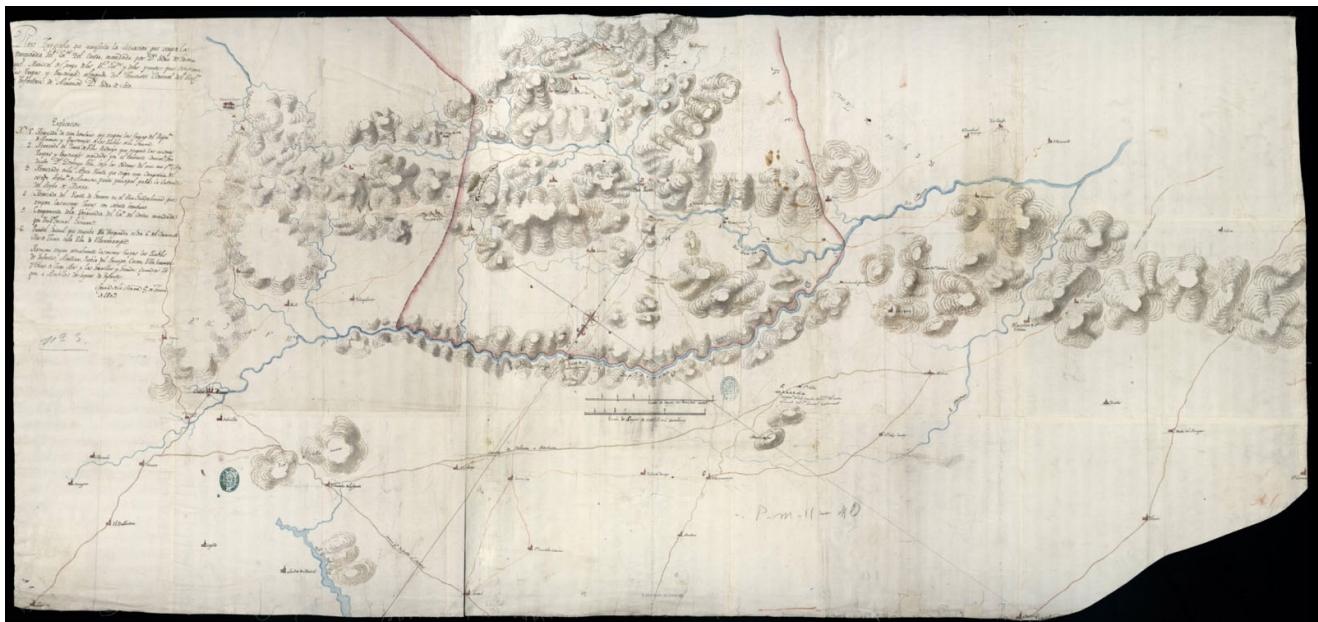
Figure 3. Topographic plan developed to plan military outposts during the War of Independence, 1809 [Beas de Segura Council].

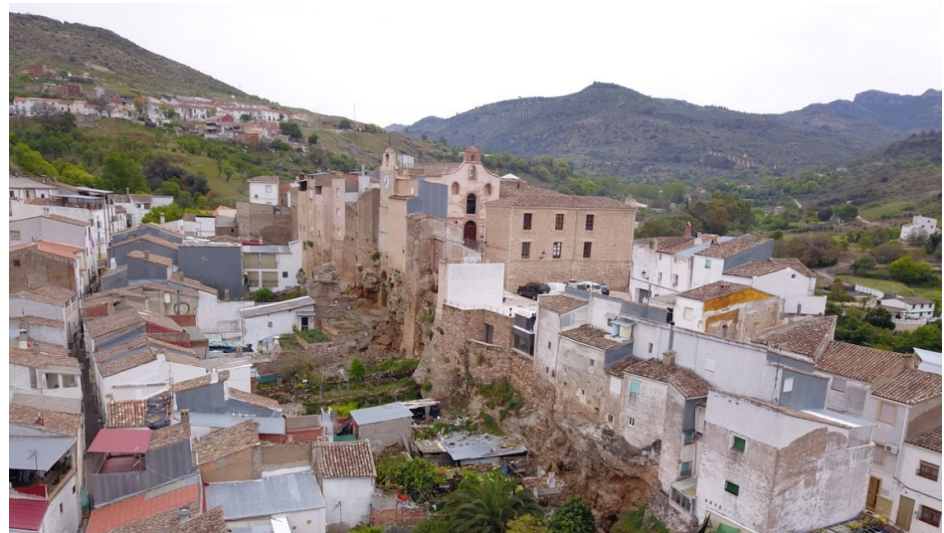
Figure 7. Present state of the remains of the walled enclosure and the urban fabric, a cause of important heritage degradation [taken by the authors].

In modern times, with the arrival of developmentalism and hygienic trends, the urban paradigms of healthy cities sought the opening of new and large avenues, as well as an idealisation of high-rise housing. Beas was no stranger to these movements and thoughts, and the population began to descend from the steep topographic peaks to the plains which, although occupied by orchards and crops, due to their proximity, were being replaced by large apertures. It is from this new urbanism, typical of the 19th century, when the abandonment of the areas delimited by the walled enclosures, accentuates the depopulation and a migratory movement to the lower areas of the municipality. Until that time, the documented elements of losses were not of great magnitude, as the different residential spaces coexisted without great affect. It would be from the industrialisation of construction when numerous elements and structural evidence for the construction of houses were eliminated (Figure 7) (Table 1).

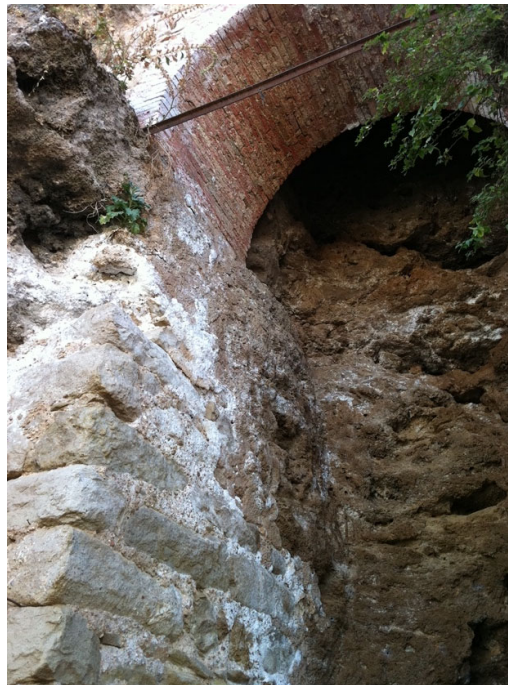
Figure 8. Detail of the pathologies caused by the use of uncontrolled materials. Photo details of the Torre del Reloj [taken by the authors].

The object from which we started was the walled enclosure and castle of Beas de Segura, declared a site of Cultural interest, according to the Decree of 22 April 1949 [35], by which all walled enclosures in Spain are given the greatest protection. From that moment, to the present day, the walled enclosure has not had any conservation intervention. Only urgent action has been taken, with specific conservation interventions. The lack of a plan that could organise all of these actions has generated significant deterioration, not only of the material asset but, above all, of the social asset. The population that inhabits this context of the municipality has not found, in these heritage elements, any memory that would encourage them to protect it, so the construction of new houses, or the refurbishment of existing ones, have further accelerated the degradation of the complex (Figure 8).

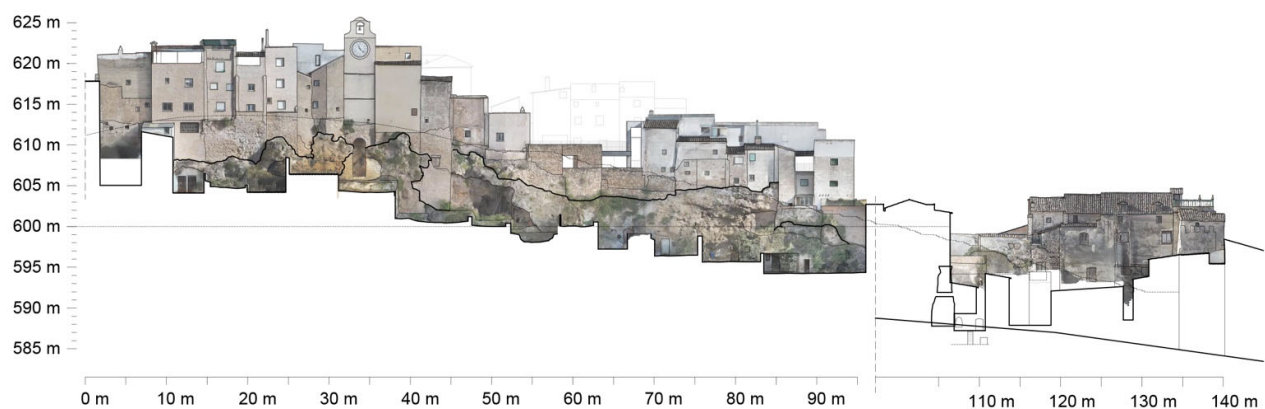
The north section of the Villavieja wall is formed by a great palimpsest of times, interventions and constructions, which makes it extremely difficult to understand the original system but which, in turn, has formed a singular and complex heritage structure. The disparity of masonry and structures has been the cause of the length of this research, as it required parallel readings between the graphical expression that we were obtaining, together with the material and historical reading (Figures 9 and 10).

Figure 9. Photogrammetry. North section elevation [authors' own drawing].

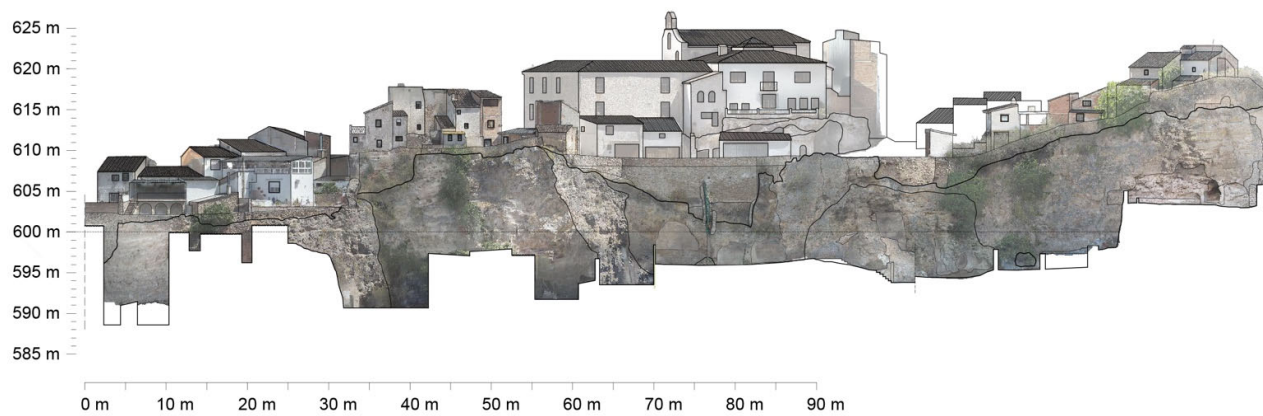
The south section of the wall has a casuistry similar to the north, recognising the same three structured edges: the geological base of tuff, the walled section, and the residential level. Nevertheless, the proportions of one or other edges vary with respect to the north section, as the rock acquires great prominence compared to the other two, and the walled areas have been mostly altered in recent interventions (Figures 11 and 12).

Figure 11. Photogrammetry. South section [authors' own drawing].

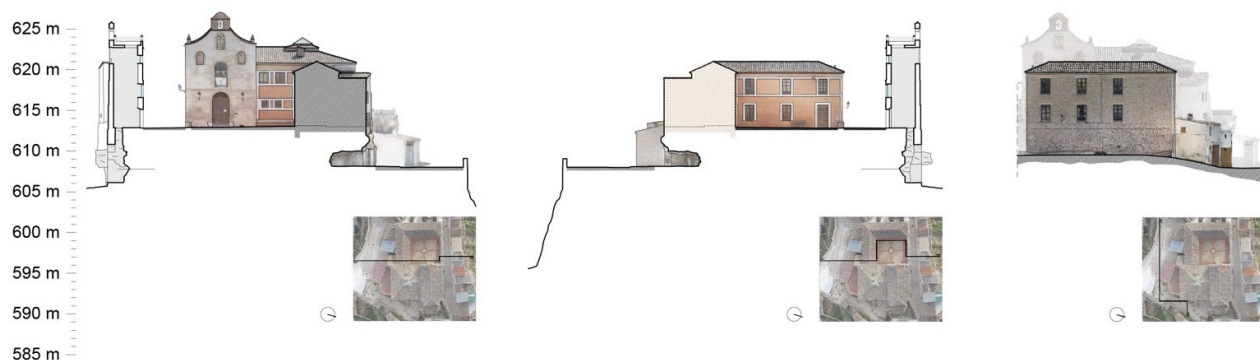
The remains of the church of the Virgin de la Paz, originally a hermitage and currently attached to the Interpretation Centre of Villa, is a construction where, according to the hypotheses, the castle of the Villavieja stood, and consists of different diachronic buildings that have arisen from the different extensions. Four pieces are distinguished, essentially the hermitage of La Paz, a square-plan body with a central tower that houses the old restaurant and part of the museum, an L-shaped body that separates the Plaza de la Villa from the Plaza de la Ermita and houses the rest of the museum, and a small body of stairs attached to the south façade (Figures 13 and 14).

Figure 13. Photogrammetry of the structure of the sanctuary, area of the old castle [authors’ own drawing].

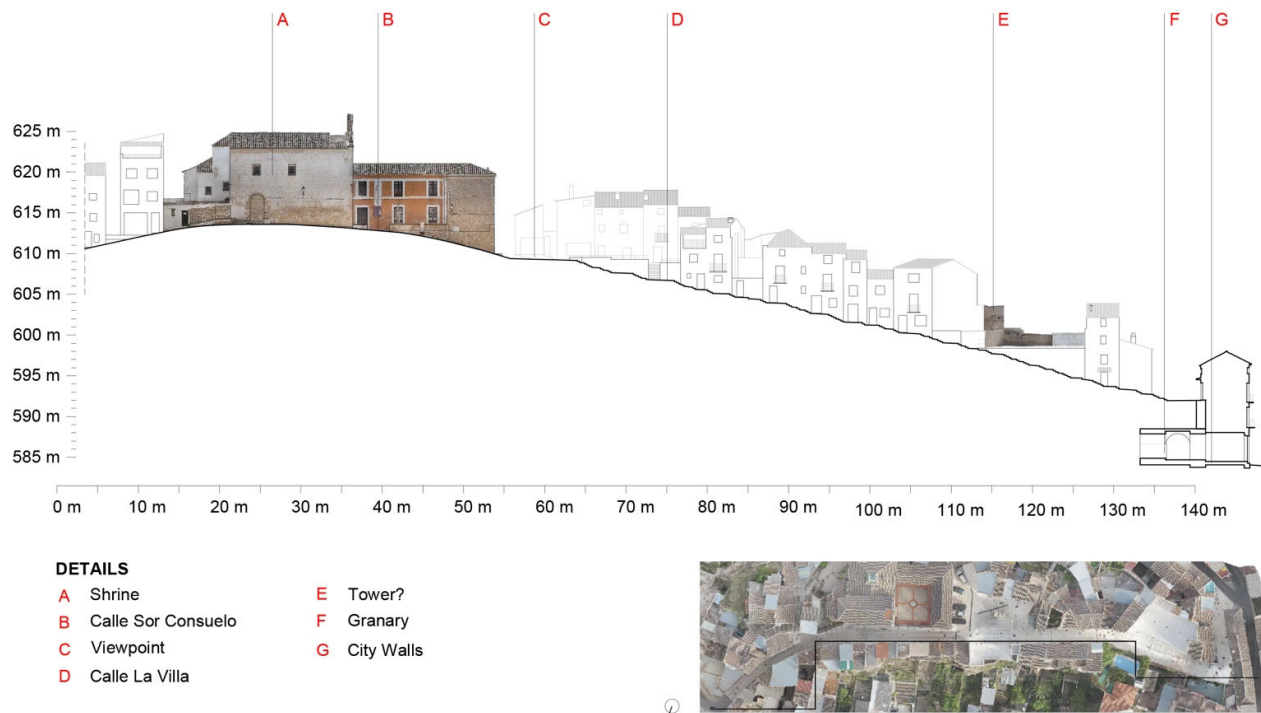
Figure 16. Photogrammetry. Cross-sections of the fortified enclosure [authors' own drawing].

The process of surveying the walled enclosures, as well as the rest of the castle, has been a technical and technological challenge that has resulted in a series of cartographies, never seen until now. All the documentation of the various caves and cavities that are hidden in the lower levels, the remains of the wall structures from the Almohad and Christian periods, or simply actual topographic sections, with the location of all the existing elements, has been subjected to a profound analysis, with the purpose of bringing the existence of this castle to light, the structure of which was unknown until now (Figures 16 and 17).

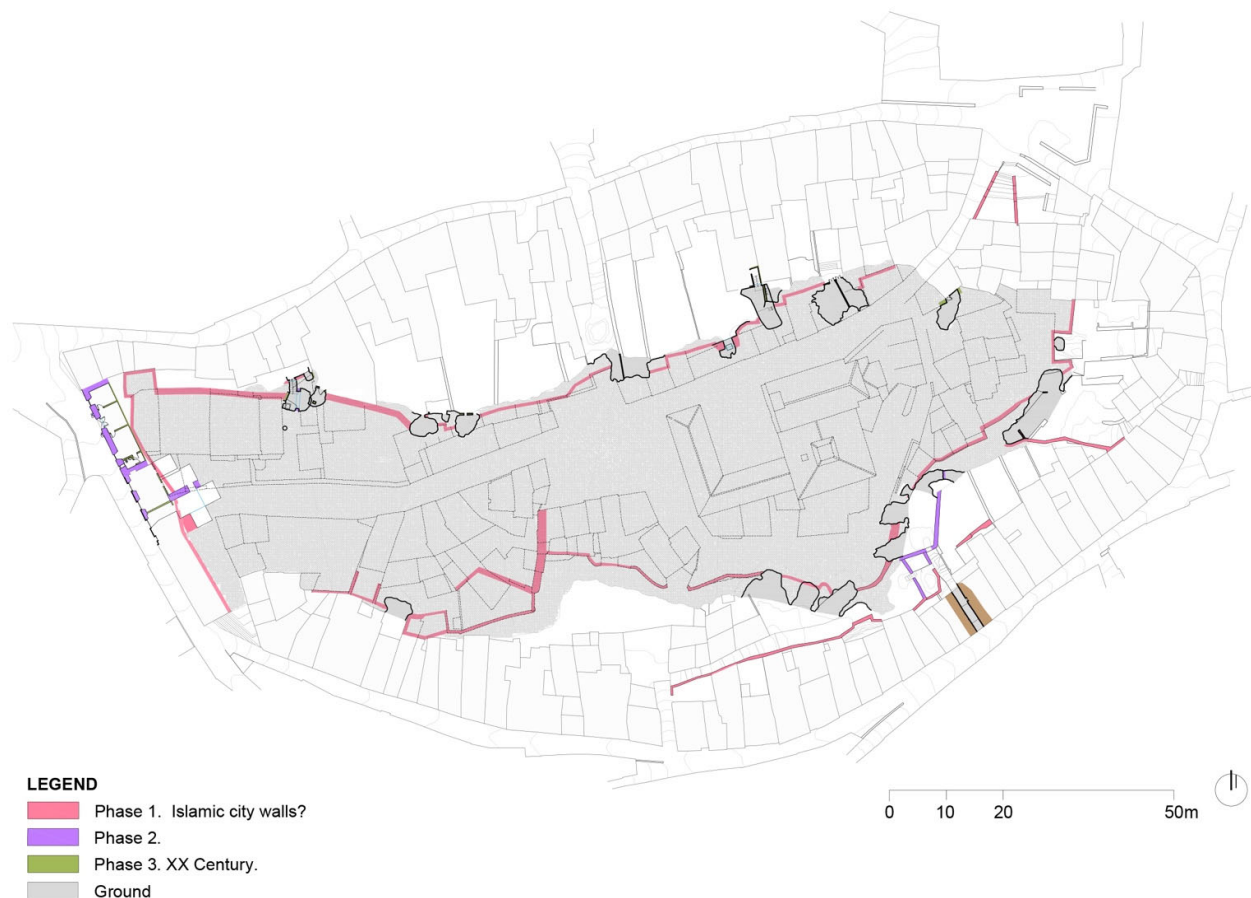
Figure 18. Floor level -1. Large number of caves and cavities existing under the walled enclosure that have been discovered and can be observed after the photogrammetric survey [authors' own drawing].

- Multidisciplinary team: Given the complexity and sensitivity of the territory on which the activities were planned, from the first moment, all the necessary disciplines were incorporated to address this reality, from architecture, archaeology, and history, to topography, anthropology, biology, and geology. A complex team of people who, starting from the common basis of establishing a sustainable framework of activities in the context of Castillo and fortress, knew how to bring together the needs of each of the disciplines. Thus, the graphic tool became the common nexus to them all. For this reason, the first development of the project was the accomplishment of an important graphic documentary source as a starting support for all the later heritage discourse (Figure 18).

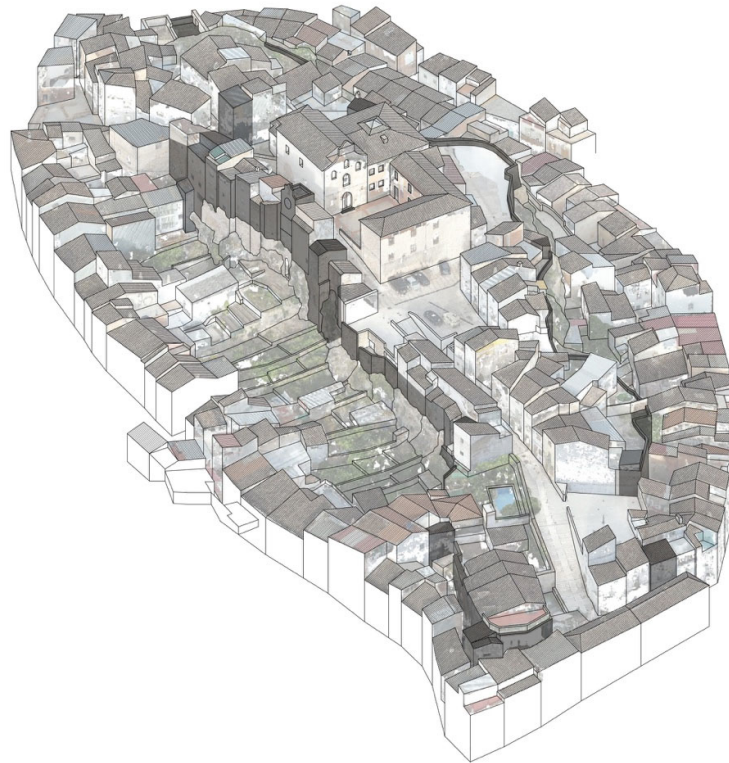
Figure 19. 3D volumetry of the studied enclosure. This volume has allowed us to be able to identify each of the houses that affect the walled enclosure, as well as the pathologies caused by them [authors' own drawing].

All these points have determined the initial objectives of the graphic documentation process, as they have delimited the action, established the question and proposed the hypotheses. From all the work carried out and collected here, it has been possible to establish the certainties that now allow us to continue working (Figure 19).
