Proceedings of the
3rd International Conference
on Preservation, Maintenance and Rehabilitation
of Historical Buildings and Structures

The relative value of the architectural heritage in seismic hazardous countries: the Severín library (Valparaíso, Chile)

ABSTRACT: In Chile, the value of the heritage concept is relative. The seismic reality has granted a condition of fragility to any architecture built. However, this quality requires a process of cultural adaptation, typological, materials, which has accelerated the search for new forms of construction for conservation. While the seismic hazard temporarily narrows the built, it develops technologically. The city of Valparaíso, declared a Historic-Cultural Heritage Site by UNESCO in 2003, was set as one of the main ports in the South Pacific since the opening of the route through Cabo de Hornos, establishing himself as one of the most important cities the country and getting itself to designate as the "Jewel of the Pacific". However, the city was not without disasters due to its location on the so-called "ring of fire", one of the areas with the greatest seismic hazard worldwide. The earthquake of August 1906 destroyed almost the

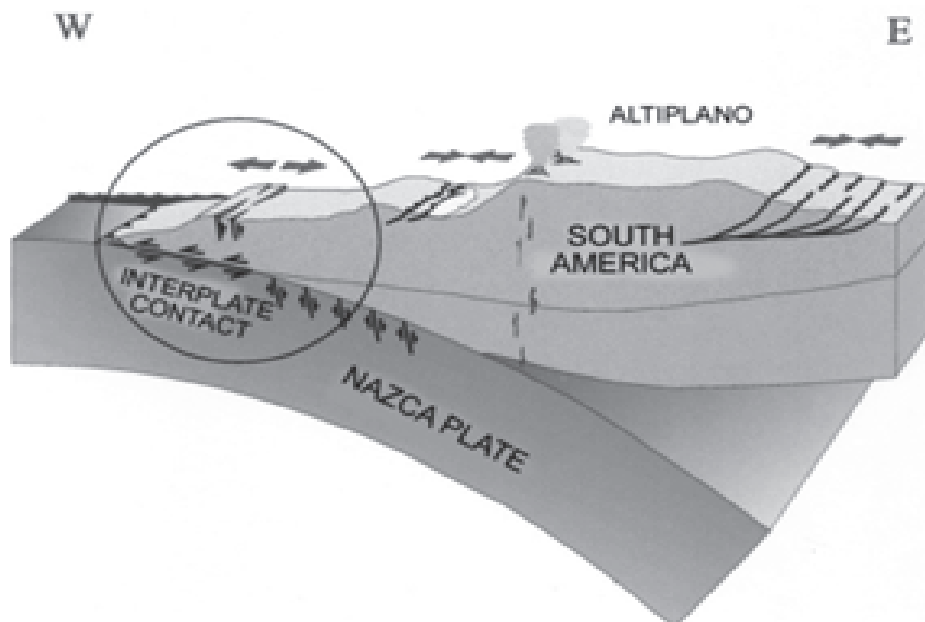
Figure 1. Scheme of Subduction of the Nazca plate under the South American plate. The contact between plates corresponds to an inverse fault in which the continent rises on the ocean floor. In the Cordillera de Los Andes, we can see the volcanic zone and the compression faults. Source Cisternas, A. (May 2011). The most seismic country in the world. Scientific journal anales, seventh series, 17-34p.

Most earthquakes recorded, with a significant magnitude in Chile, are under the type of Interplate; which are caused when the net force of the plate is greater than the friction that tends to block the subduction. Therefore, when it is able to move, the earthquake is generated and its magnitude is consequently proportional to that movement. It is useful to note that, when the phenomenon generates a rupture in the ocean floor, tsunamis occur. Dramatic examples are the

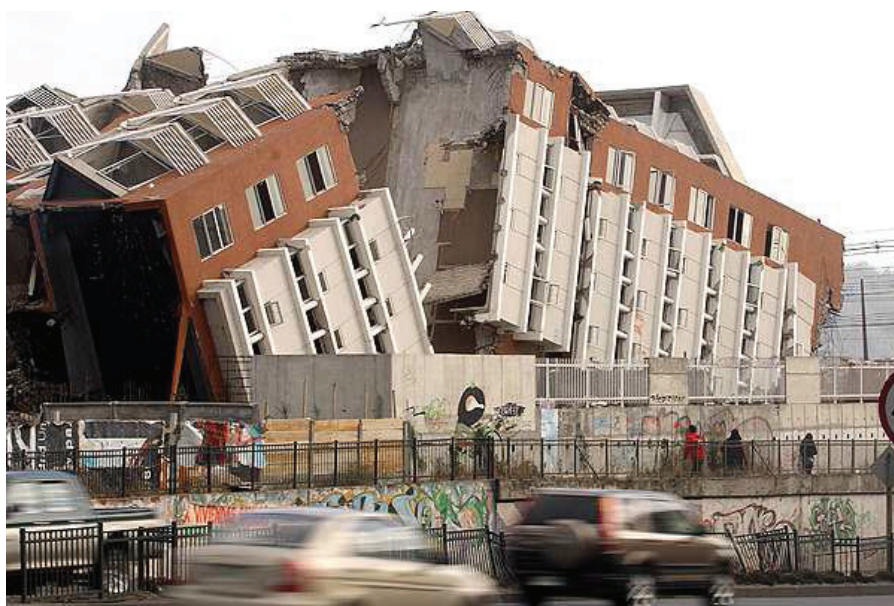
Figure 5. Alto Rio Building, after the 8.8 Mw earthquake in the city of Concepción. Source: emol.cl.

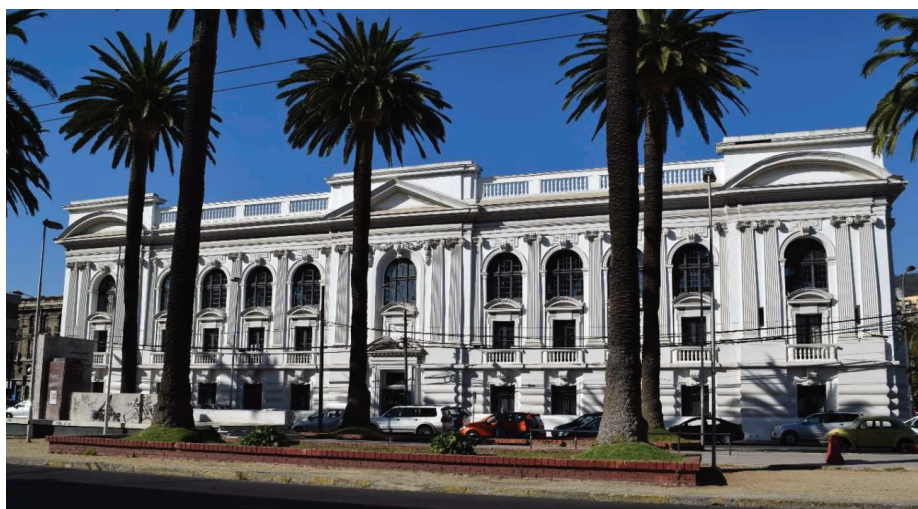
Figure 7. West facade. Source: authors photography.

Its style is of late historicist character with elements of the neoclassical and neo renaissance style. The facades are symmetrical with accentuation in the accesses and ends, which have termination in the upper tympanum and remarked pilasters of Ionian order. The window openings are differentiated by level, where the third one has arches of a half point, the second has a segmental arch and the first of straight ending. The first level is characterized by having a continuous cushioning while the latter is crowned with perimeter balusters.

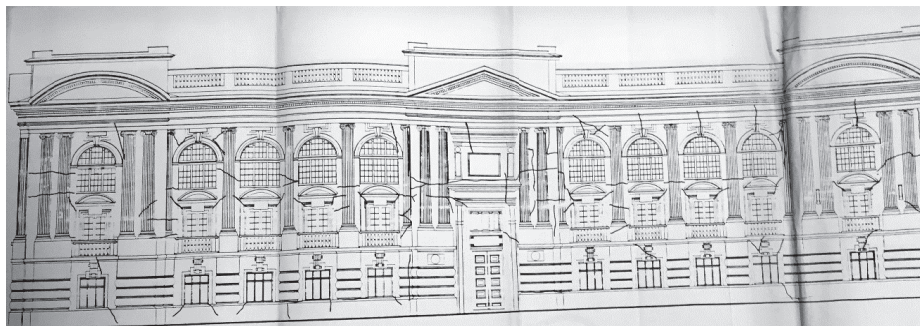
Figure 10. Elevation Yungay street fissures lift, year 1987. Source DOM.

The library was not exempt from afflictions from the successive earthquakes. The first one of the year 1985, whose restoration was completed in 1989, with a total cost of 250 thousand US of the time and consisted in the installation of a rigid diaphragm that complemented its structure. A structure of bracing was incorporated to the building, this structure gave rigidity to control the deformations in the plane of the south and north facades.
