# THE PROCESS OF DIGITAL FABRICATION AND 3D PRINTING AS A TOOL IN THE STUDY OF HERITAGE PATHOLOGIES: CARCABUEY CASTLE (CORDOBA)

## EL PROCESO DE FABRICACIÓN DIGITAL E IMPRESIÓN 3D COMO HERRAMIENTA EN EL ESTUDIO DE PATOLOGÍAS PATRIMONIALES: EL CASTILLO DE CARCABUEY (CÓRDOBA)

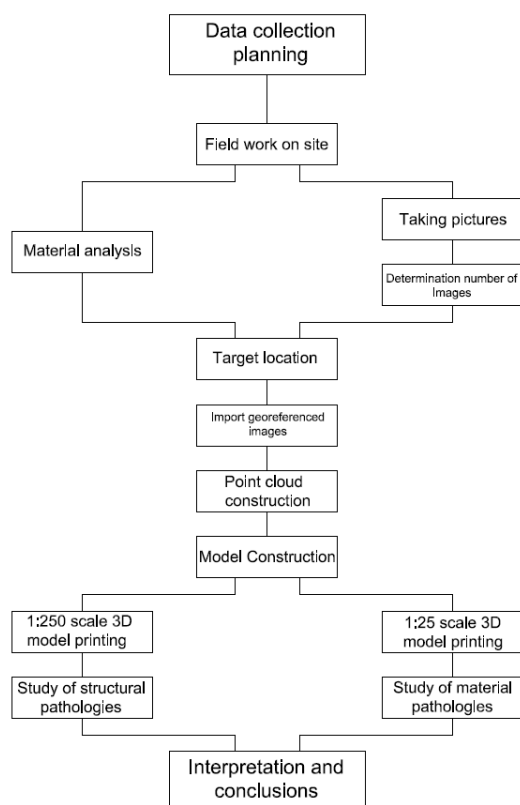
**Figure 1:** Research work scheme.

In recent years, Carcabuey Castle has had interventions due to urgent consolidation processes. These small, decontextualised incursions, promoted by the local Council, have been undertaken as an unavoidable necessity, due to the state of conservation of the building. These interventions are in addition to those previously carried out, which have led to a complicated reading of the history of the site. Faced with this situation, a request was made for a draft of the global restoration project, in phases, a Master Plan. Given the lack of documentation and prior information on the state of conservation of the monument, it was decided to focus on the first phase of in-depth data collection, which would allow the launch of the different working lines and hypotheses. For this, a very dense point cloud was generated, which would allow the generation of a digital elevation model (DEM), and a subsequent detailed 3D printing. It was possible to identify the most deteriorated and critical areas of the castle to directly focus the material study. It was planned that team members would undertake the work that was most appropriate to their discipline, and that the architect would integrate the work of the field and study teams, attempting to ensure that all the work was transversely synchronized (Fig. 1).

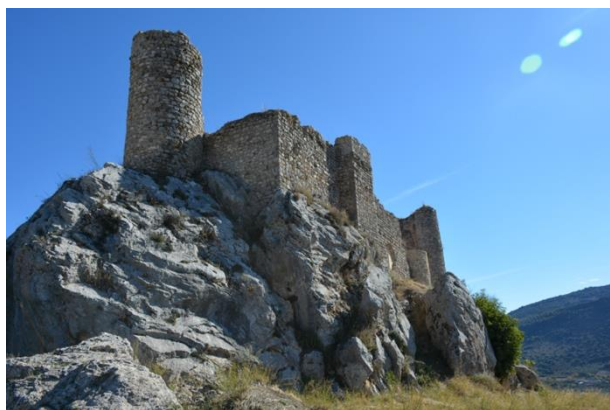
Figure 8: Current state of the Carcabuey castle (2022).

During the 17<sup>th</sup> and 18<sup>th</sup> centuries, no citations or documentation of the Castle are recorded, only the renovation of the Hermitage of the Virgen del Castillo towards the end of the 18<sup>th</sup> century, noting a baroque design and a new altarpiece by Francisco Javier de Pedrajas from Priego, dated 1770 (Osuna, 2002). At the beginning of the 20<sup>th</sup> century, there were a series of repairs to the walls of the Castle, attributed to Rafael Ramírez Arellano in his descriptions of the fortified site (Ramírez, 1982) (Figs. 7 & 8).

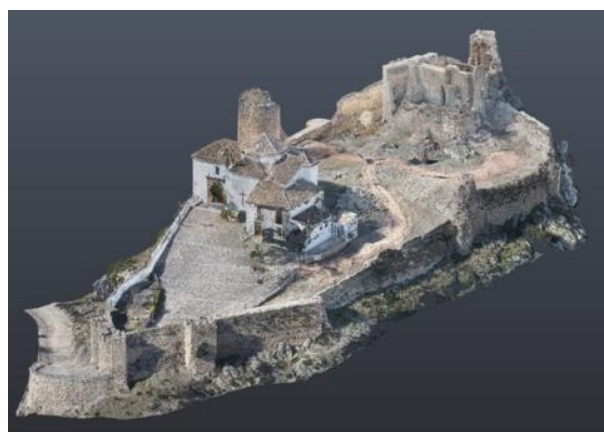
Figure 10: 3D model of the castle with the point cloud and mapping of high-resolution photos.

Stage 2: Carry out a new georeferencing, photogrammetric survey and 3D laser scanning of the entire fortified area. It was possible to build a network of geodesic points, a cloud of points, and a 3D model that allowed millimetre definition measurements. These enabled an exhaustive analysis of the different superficial and structural pathologies that the Castle has been developing over the last centuries, as well as the production of a planimetric set of the whole heritage asset (Figs. 9 & 10).

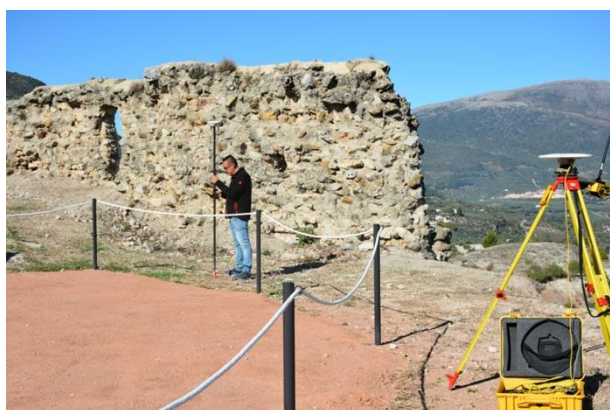
Figure 9: Data collection in situ.

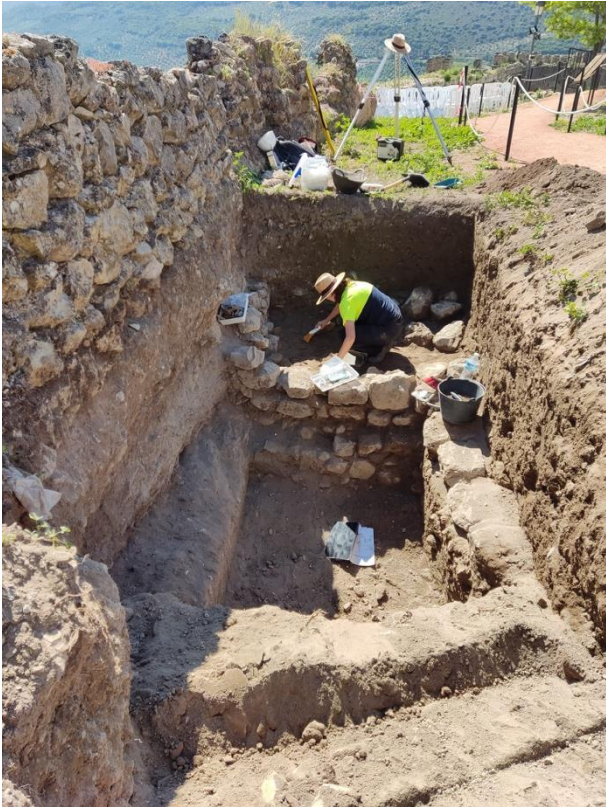
**Figure 11:** Photograph of the archaeological excavation for the documentation of construction elements.

Stage 3: Analyse the Castle by printing the 3D scan at two scales: One of the whole complex, and another of particular elements, to be able to analyse all the construction phases and material incursions that the Castle has had throughout its history. This enabled the determination of bonds, stone morphologies, brick infills and original elements, as well as a profound analyse of the material layers that make up the wall sections. These are composed mostly of a rammed earth interior, lined on both sides with limestone masonry from the quarries of the Subbetica of Cordoba, and material brought from previous constructions (Figs. 11 & 12).

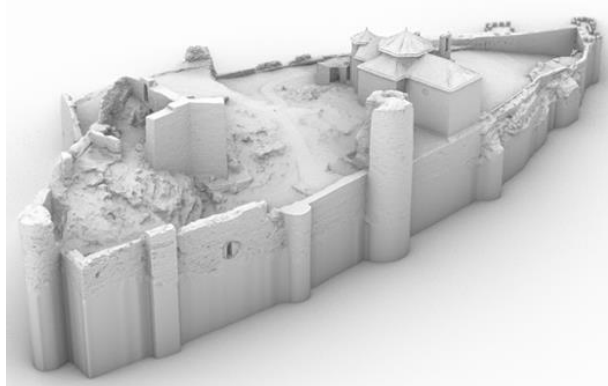
**Figure 13:** Digital model ready to be printed without photography assignment. North view (a) and south view (b).

Stage 5: Use the 3D printed physical medium to make a study and in-depth analysis of all the superficial and structural pathologies from which the Castle currently suffers, supported by the photogrammetric surveys carried out and the partial impressions of each part of the protected complex. This support material will provide the necessary rigor when documenting and planning the necessary interventions to alleviate all existing pathologies, as well as to anticipate others that are still very difficult to record and delimit due to their degree of development (Fig. 13).

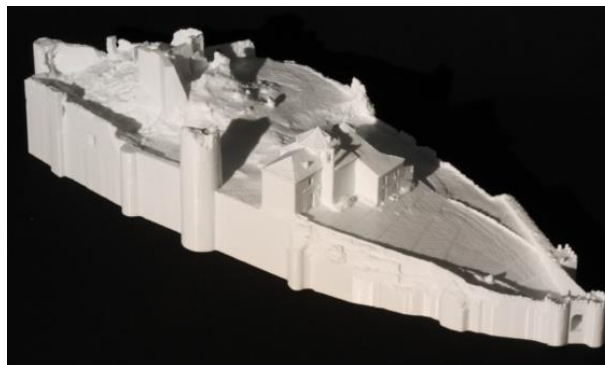
**Figure 14:** Initial 3D model of the castle of Carcabuey printed in high-resolution for the study of pathologies.

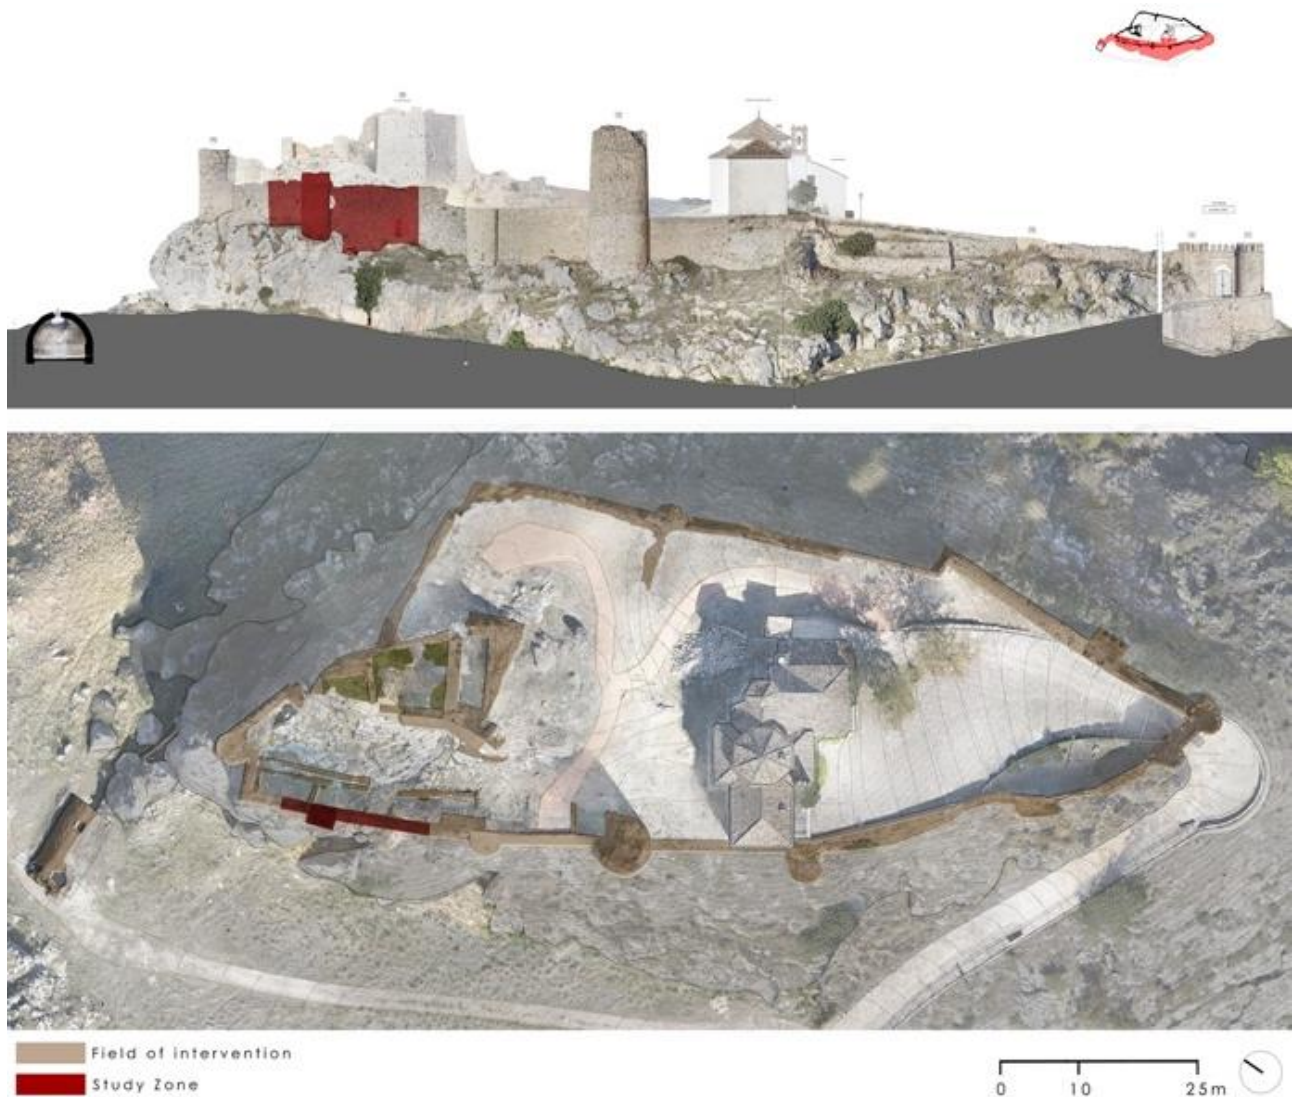
**Figure 16:** Orthophotos for the location of the study area in detail (plan and elevation).

In addition to the 1:250 scale model of the hill and Castle complex, and after an initial analysis of the casuistry and general structuring of the pathologies and construction phases observed, a series of partial models of various specific parts of the fortress were made at a 1:25 scale. In order to make this model on a larger scale, the model was worked using vector modelling software, eliminating inaccuracies obtained in the scan. After that, the points were selected where the greatest number of general problems converged, and where the entire construction sequence could be found repeated throughout the enclosure (Fig. 16).

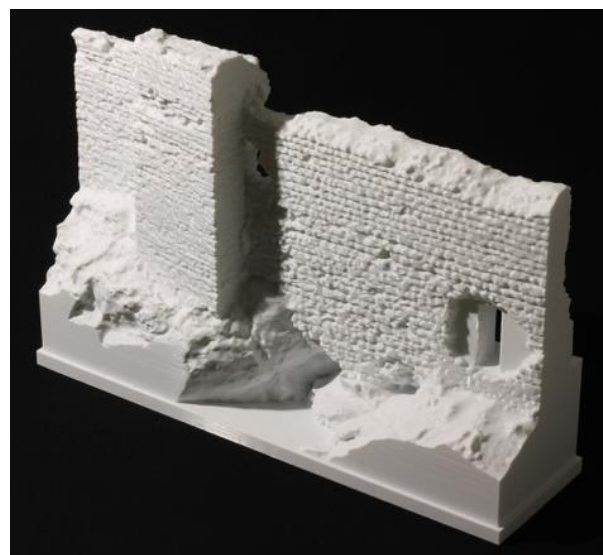
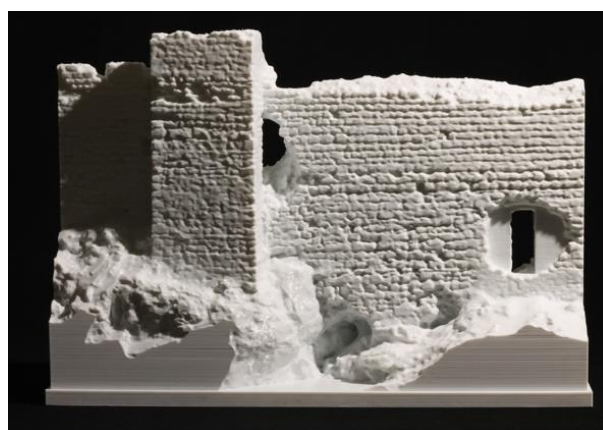
Figure 17: High-resolution 3D printing : (a) Perspective view; (b) Front view (b).

Printing this section on a large scale has allowed a repeated pattern of pathology to be detected throughout the Castle (Fig. 17). The first to be detected were those due to the general washing of mortar and the volumetric losses of the capping, with similar rates in all the joints between walls and towers. There were cracks due to material joints between elements of a different nature (towers and adjoining walls) and, due to contact between different construction phases, with different compositions of stones and mortars.

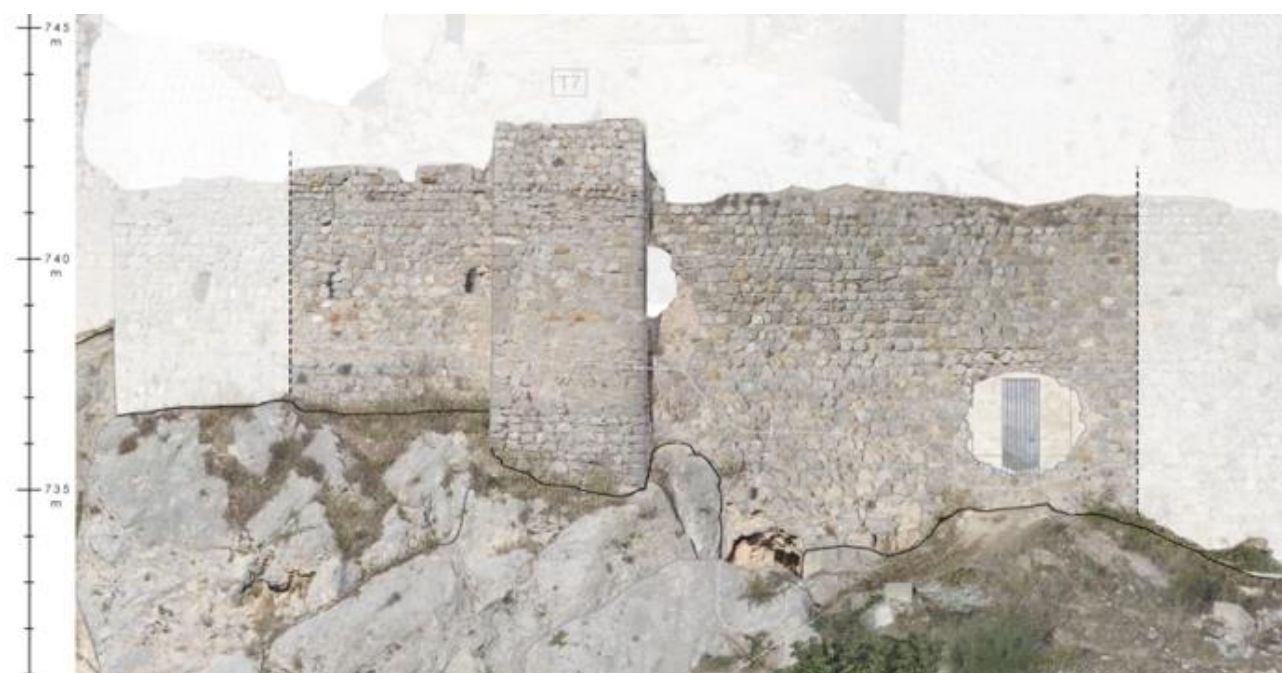
Figure 18: Orthophoto of the elevation of the detail of the study.

High resolution orthophotographs (1 mm/pixel) can be extracted. These results allowed moving from printing on paper at a normal survey scale, to post-production with 3D modelling software. This permitted the move to 3D printing, with a millimetre level of detail for the study of pathologies, stone stereotomy or material granulometry. With various models at various scales, it was possible to analyse not only the hypothesis of the evolution of the monument, but also the actual material study of what remains (Fig. 18).

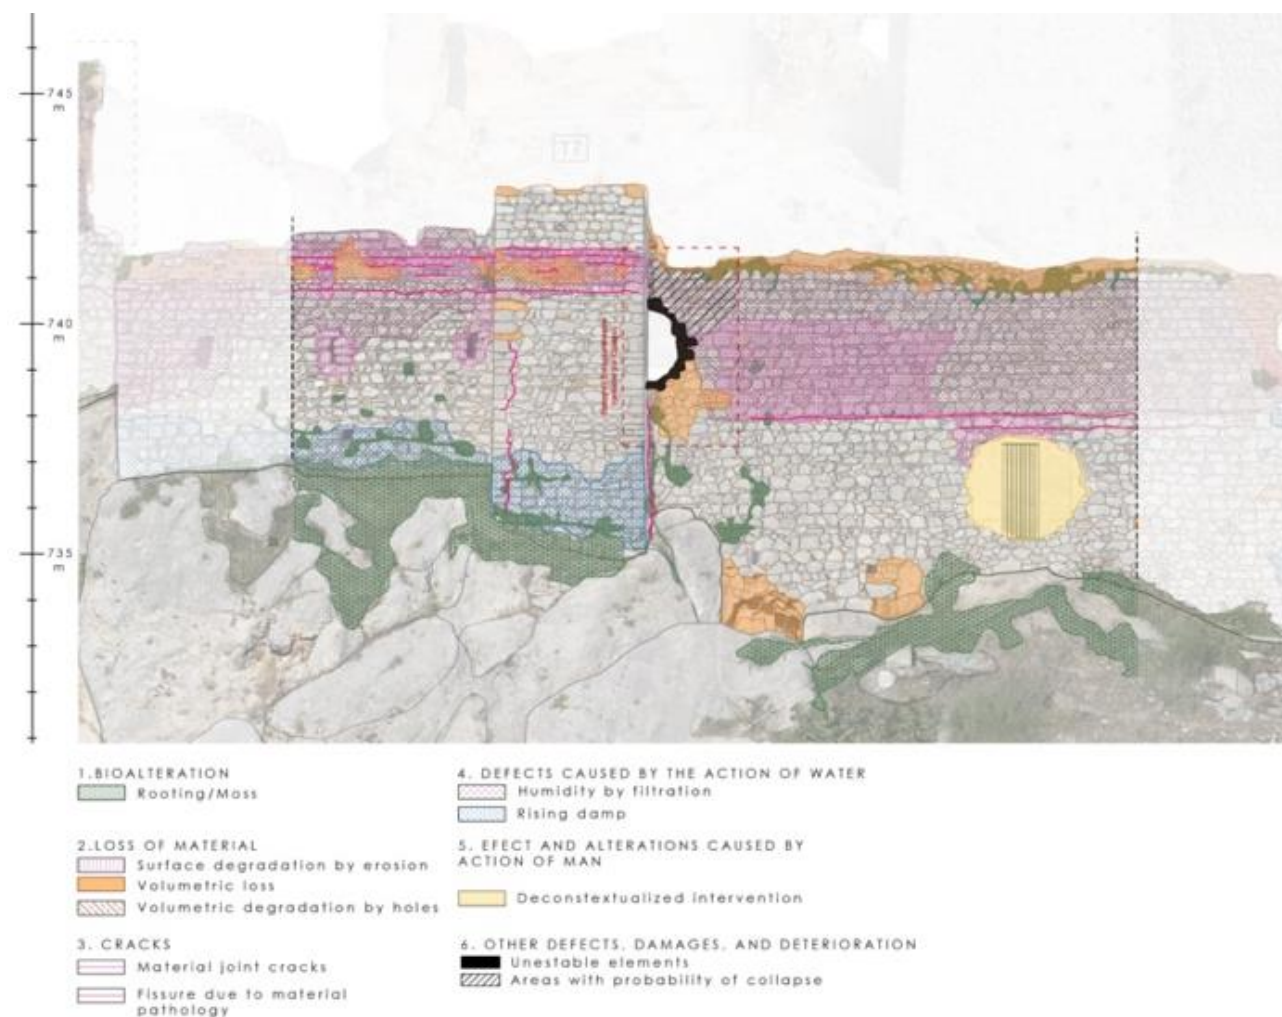
**Figure 21:** Study of material pathologies of the detail fragment of the wall studied from the model printed in high-resolution by the stereotomy of the construction.

The results obtained from both the point cloud and the 3D printing have corroborated most of the hypotheses raised about the various construction phases of the complex. The interpretation of the data obtained has allowed classification of the types of ashlar and mortars according to their stereotomy, this was decisive in order to classify the different construction phases. The use of mud walls which seemed relegated exclusively to the Almohad period, has been seen not to be the case, and Christian phases with this type of construction system have been verified. Similarly, the reinforcements of amorphous masonry did not correspond only to a defensive issue against artillery, but rather a reinforcement operation in the lower levels of the walled enclosure and Castle (Fig. 2

1). The results obtained from the orthophotos, together with the dense point cloud, show a more complex construction process than previously thought.

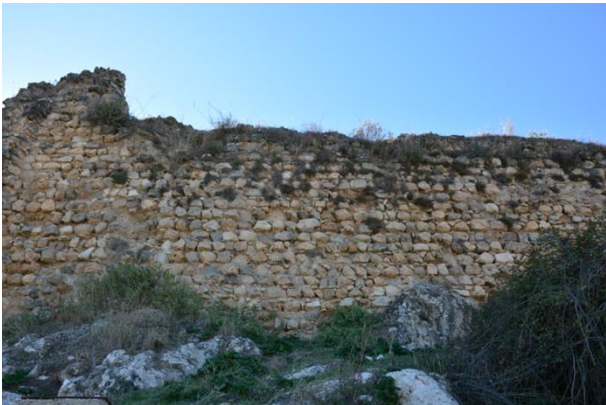
**Figure 22:** Photograph of the current state in detail of the pathologies suffered by the castle.
