Surveying in Architectural Intervention of the Collapse of the International Style. The Case of the Puerta de la Carne Market

Federico Arévalo Rodríguez^(✉) and Eduardo Martínez Moya

ETSA Seville, University of Seville, Seville, Spain
farevalo@us.es

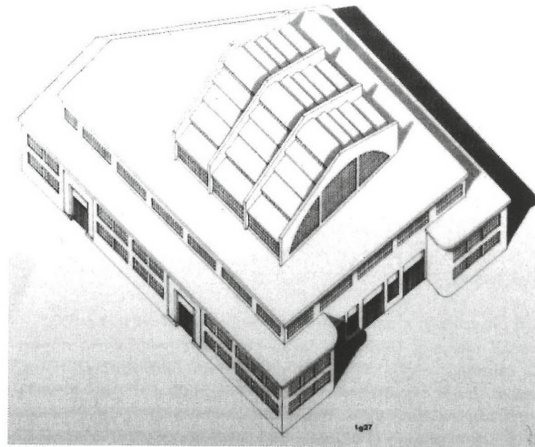
Fig. 2. Market volumetry according to the initial project. Source: Jiménez Ramón 1999, p. 129.

A paradigmatic example of this is one of the first works of rationalism in Andalusia. It is the Puerta de la Carne Market, designed in 1927 by architects Gabriel Lupiáñez Gely and Aurelio Gómez Millán. The building is configured volumetrically with a two-storey perimeter piece as a response to the smaller-scale urban environment (Fig. 2 and 3). In the centre of the building stands, with great geometric purity, the central nave of the building, which, with its cylindrical vault shape, housed the market stalls (Fig. 4). This space is the piece with greatest architectural interest, defined internally only by its structure and illuminated from above and from the side.

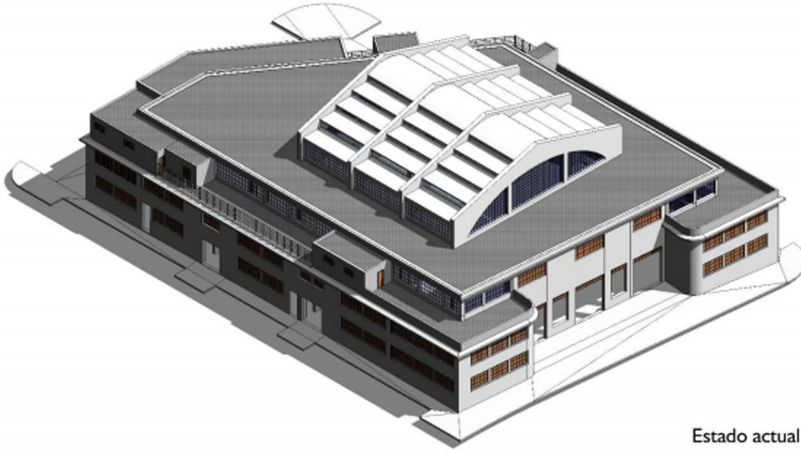
Estado actual

Fig. 3. Market volumetry in its current state. Authors: Roque Angulo Fornos and José Antonio Alba Dorado (2015).

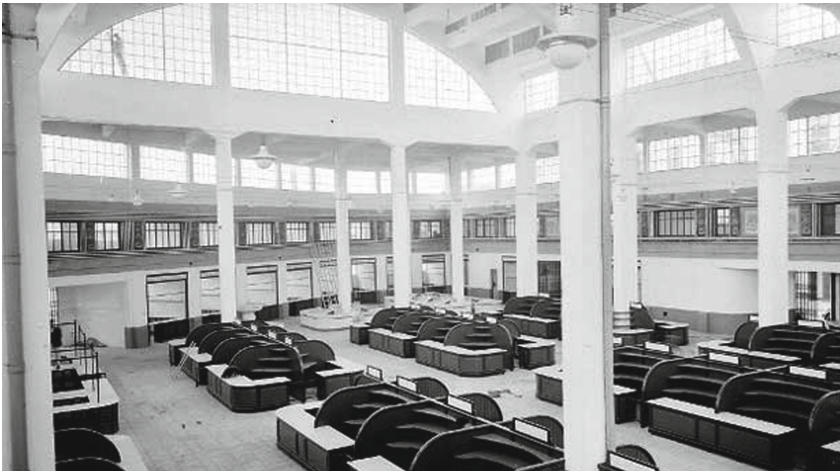
Fig. 4. Interior of the Puerta de la Carne Market (1927). Source: Jiménez Martín 2018, p. 10.

Regarding the choice of using reinforced concrete, Jiménez Ramón indicates that it was a frequent option at that time, as all the architects who entered the competition did so. The greatest contribution of the project lies in the use of concrete as an expressive material, used in such a way that this “expressive intention is fundamentally evident in the great parallel arches that not only qualify and give personality to the main space of the building, but also look out and create a decompositive image of the body through a gable roof” (Jiménez Ramón 1999, p. 133).

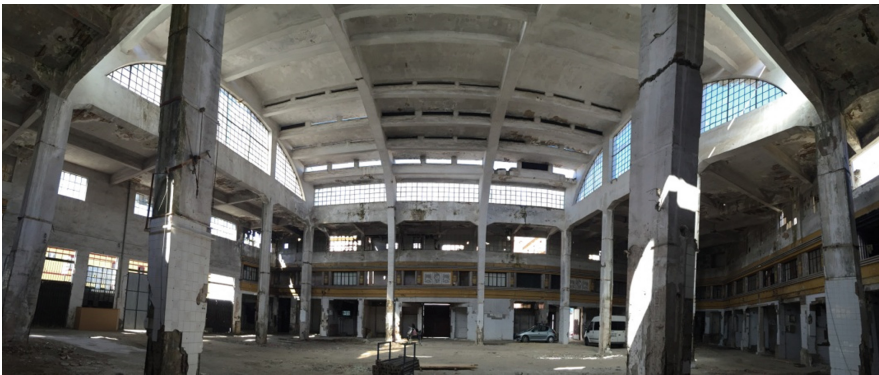
Fig. 5. Current state of the market. Photography: Federico Arévalo.

In order to maintain the central zone of the building in the intervention project—which is the most recognisable element and where the heritage values are based, fundamentally due to the lightness of the concrete structure and to spatiality (Fig. 5)—the introduction of a large metal orthopaedic structure that would reinforce the reinforced concrete structure was initially proposed. This would be a metal structure that would surround each reinforced concrete element, both columns and beams. In reality, this would be a metal structure to which all the building’s stresses would have to be transferred, since the strength of the existing concrete structure must be considered to be zero.

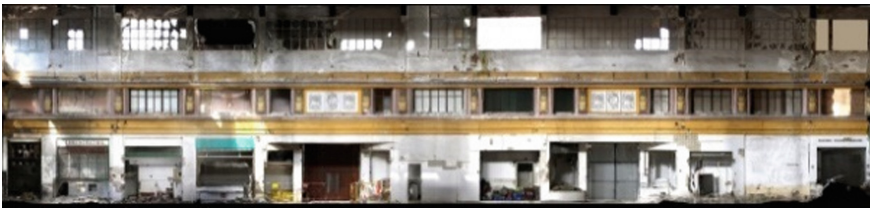
Fig. 6. Preliminary photogrammetric capture. Orthophoto of the interior façade. Author: Antonio Almagro Gorbea (2015).

To carry out the survey of the building, two digital captures were made using SFM (Structure From Motion) photogrammetric techniques. A preliminary one (Fig. 6), less exhaustive and without metric support, for which the collaboration of Dr. Antonio Almagro Gorbea was requested, the main objective of which was to obtain orthophotos of the exterior and interior façades that allowed an initial examination of the building’s state of conservation.

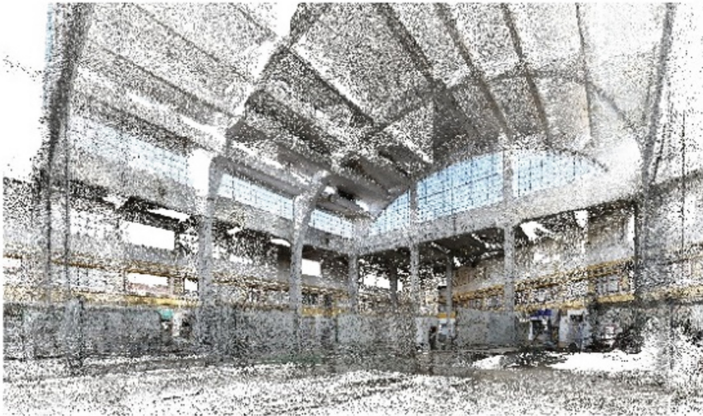
Fig. 7. Final photogrammetric capture. Point cloud perspective view captured. Author: Roque Angulo Fornos (2015).

The restitution phase, prior to the final survey, involved the unification of the captured point clouds and their coordination with the photogrammetric model, previously oriented, obtaining a unified cloud (Fig. 7); as well as the generation, based on the previous data, of a textured three-dimensional model of the building that served to obtain orthophotos of the different façades and interior spaces in their current state (Fig. 8 and 9). Lastly, as a final product of the architectural survey of the building, based on a combination of the complete point cloud and the orthophotos obtained, a three-dimensional model of the building was developed using software based on BIM technology, which allowed to obtain and edit the projections of all the floor plan, elevation and section views necessary for their exhaustive description (Fig. 10).

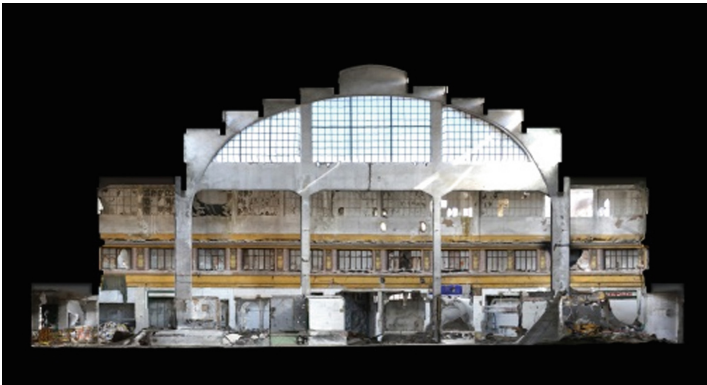
Fig. 8. Final photogrammetric capture. Orthophoto of the cross-section through the central space. Author: Roque Angulo Fornos (2015).

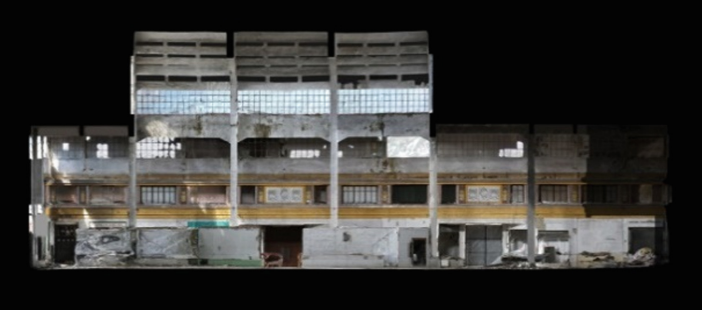
Fig. 9. Final photogrammetric capture. Orthophoto of the longitudinal section through the central space. Author: Roque Angulo Fornos (2015).

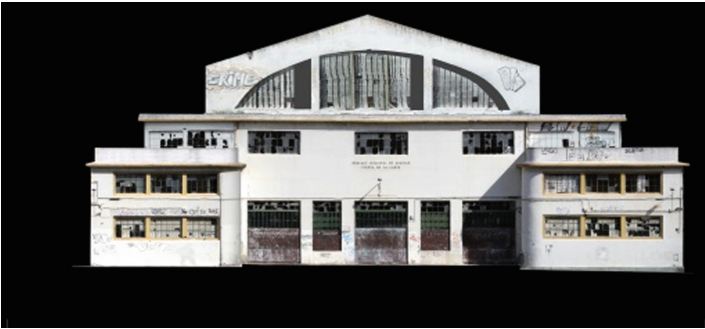
Fig. 10. Final photogrammetric capture. Orthophoto of the main façade. Author: Roque Angulo Fornos (2015).
