Impact of Maintenance, Rehabilitation, and Other Interventions on Functionality of Heritage Buildings

A. J. Prieto, Ph.D.¹; J. M. Macías-Bernal²; María-José Chávez³; F. J. Alejandro⁴; and A. Silva⁵

Author keywords: Functional service life; Heritage buildings; Fuzzy logic; Preventive maintenance; Historical records.

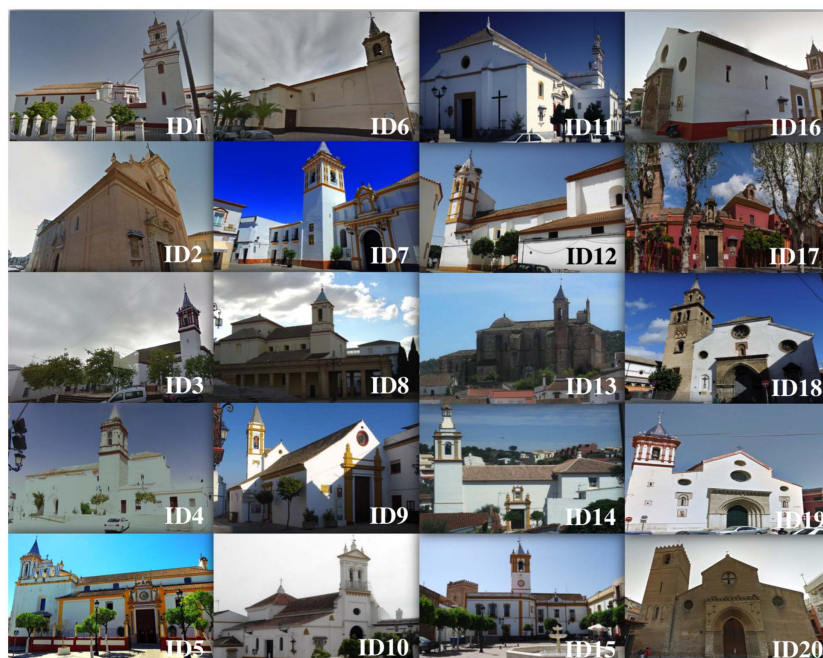
Fig. 1. Case studies considered: ID1, San Pablo, Aznalcázar; ID2, Santa María de las Nieves, Benacazón; ID3, San Miguel Arcángel, Castilleja del Campo; ID4, Nuestra Señora de la Asunción, Huévar del Aljarafe; ID5, Santa María la Mayor, Pilas; ID6, Nuestra Señora de la Granada, La Puebla del Río; ID7, Nuestra Señora de la Estrella, Coria del Río; ID8, Los Sagrados Corazones, San Juan de Aznalfarache; ID9, Nuestra Señora de la Estrella, Palomares del Río; ID10, Nuestra Señora de la Antigua, Almensilla; ID11, Nuestra Señora de la Granada, Guillena; ID12, Santa María de Gracia, Almadén de la Plata; ID13, San Juan Bautista, El Castillo de las Guardas; ID14, Divino Salvador, El Ronquillo; ID15, Santa María de las Nieves, La Algaba; ID16, San Julián, Sevilla; ID17, San Lorenzo, Sevilla; ID18, Ómnium Sanctorum, Sevilla; ID19, San Román, Sevilla; ID20, Santa Marina, Sevilla. (Images by A. J. Prieto.)

This study is based on available data regarding the state of conservation of 20 heritage buildings in the province of Seville, Spain, in an area of 14,000 km². The geographical region extends from the mouth of the Guadalquivir River in the southwest to the Sierra Norte Natural Park in the north. The buildings analyzed have religious features, with a great variety in terms of their monumental and artistic value. In terms of their construction style, all the buildings had homogeneous characteristics, sharing similar cultural and regulatory aspects (Fig. 1). These churches were built in the Mudejar-Gothic, Renaissance, and Baroque styles between the thirteenth–fourteenth and eighteenth centuries (Ortiz et al. 2017). A large number of churches were erected in a short time, and the available workers were mainly Mudejar (subjugated Moors), who were familiar with other construction techniques, such as timber roofs and brick walls. This gave rise to the Mudejar-Gothic style, with churches whose most representative points (presbytery and portals) are built of stone, following the Gothic style, whereas the body of the church has brick walls (Girón et al. 2017).

The structure of the buildings under analysis is constituted of thick brick walls around the perimeter and in the central pillars, which are organized in two rows parallel to the longitudinal axis of the church (Girón et al. 2017; Ortiz and Ortiz 2016). The three naves of the church are covered with a coffered timber structure. The central nave has two slopes and a greater height. The two lateral naves have a single slope and a more reduced height. The main chapel is covered with a carved stone structure, symbolizing the relevance of the enclosure (Vigil-Escalera 1991).

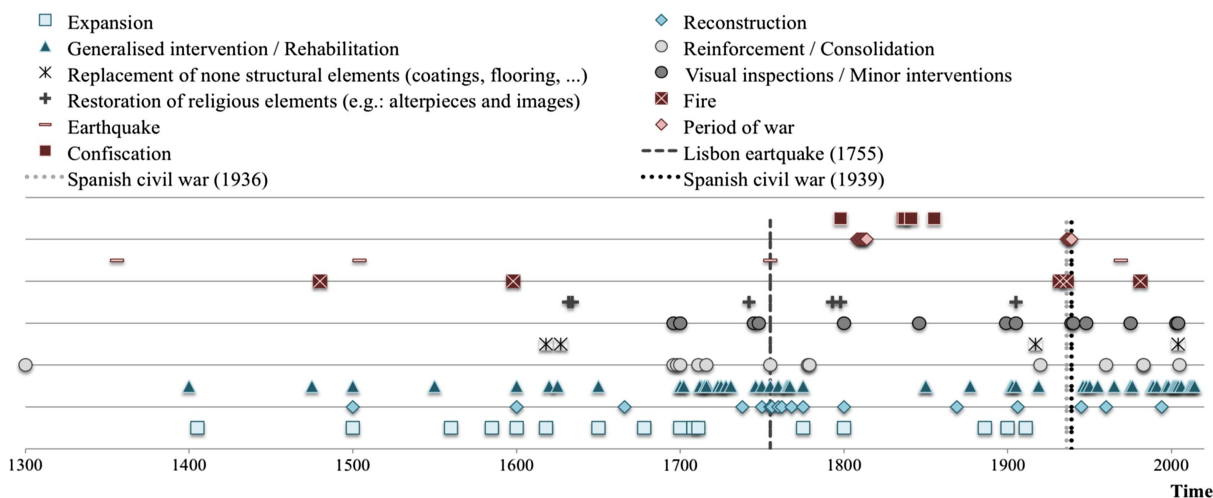
Fig. 3. Global overview of the main buildings' interventions considered over time, including catastrophic events.

Fig. 3 shows the global overview and the evolution of the principal maintenance actions, generalized interventions, natural hazards (e.g., earthquakes), and anthropic risk (e.g., fires and periods of war or confiscation) to which the set of heritage buildings selected is subject. The statistical analysis of the maintenance and

In the 19th century, the Napoleonic invasion (1810–1812) and the ecclesiastical confiscation of 1836 (Confiscation of Mendizábal) represented a great loss of cultural heritage in Spain (Charneco 2014; López 2015). For this century, information concerning the performance of maintenance actions is scarce due to these historical events. These kinds of actions, i.e., confiscations, were promoted by the Spanish government's seizure and sale of religious properties from the late eighteenth century to the early twentieth century (Hernández Navarro et al. 2008). It was a historical, economic, and social process beginning with the so-called Confiscation of Godoy in 1798. After this event, the Confiscation of Espartero (1841) and the Confiscation of Madoz (1855) followed (Fig. 3).

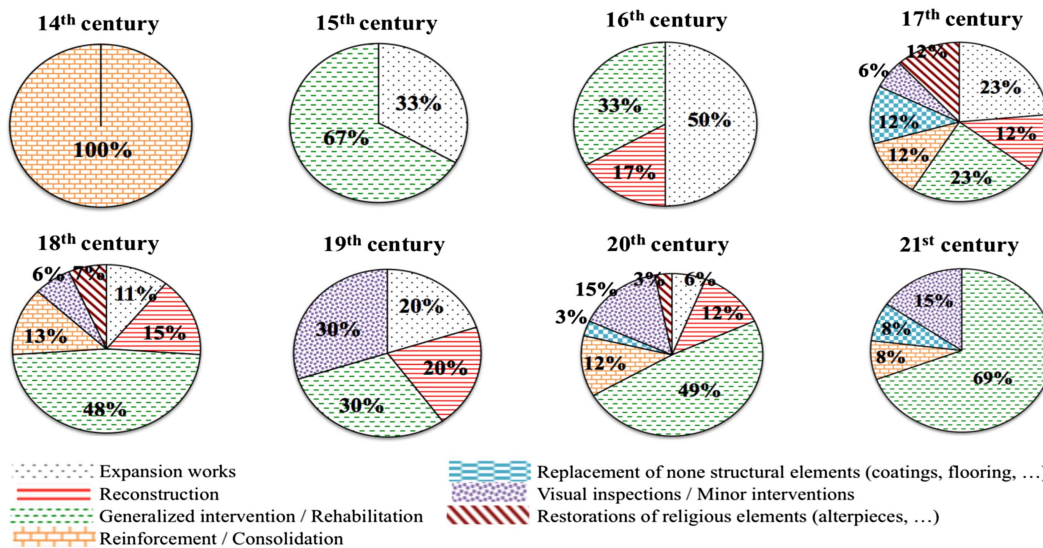
Fig. 4. Statistical analysis of the maintenance and conservation actions performed in the heritage buildings analyzed.

conservation actions carried out over the centuries in the heritage buildings analyzed is presented in Fig. 4. The next sections organize the information registered into four periods, and provide some historical explanations to understand why certain decisions were made in relation to maintenance actions, as well as a pattern of intervention based on historical, political, and natural hazards contexts (Prieto et al. 2015).

In the seventeenth century, records related to preservation and maintenance activities increased significantly. The key actions outlined by the records were related to generalized intervention/rehabilitation (23%), expansion works (23%), and the restoration of altarpieces (12%). On the other hand, visual inspections/minor interventions (6%) had the smallest role (Fig. 4).

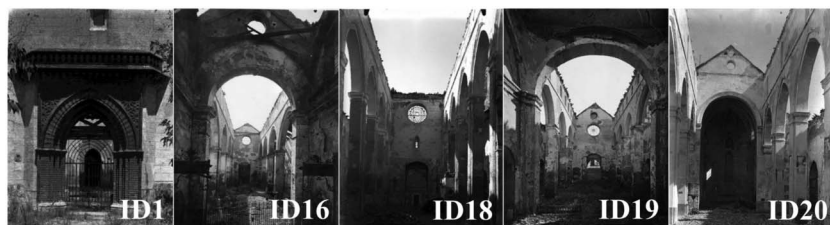
Fig. 5. Five case studies after an anthropic risk (Spanish Civil War, 1936–1939). IDs are defined in Fig. 1. (Images courtesy of University of Seville.)

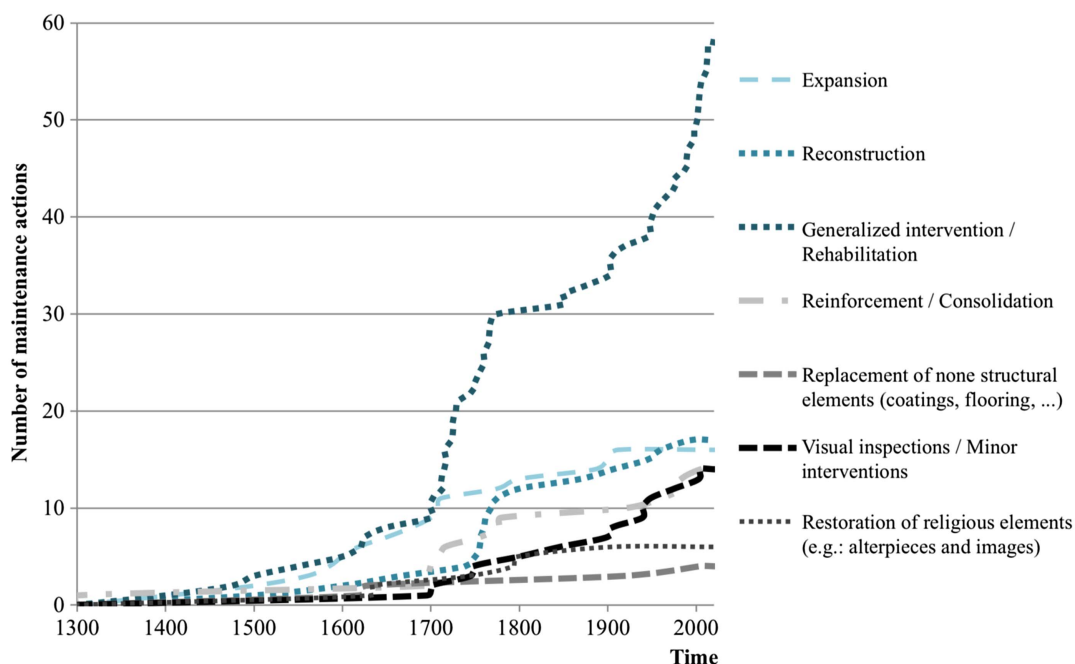
Fig. 6. Number of maintenance actions from 13th through 21st centuries.

- In the first centuries after their construction (Fig. 6), churches are not subject to relevant interventions and rehabilitation actions, because it is expected that the buildings still have adequate functional levels and do not yet show any significant deterioration that justifies intervention. Moreover, users' and stakeholders' demands have changed over time, i.e., in ancient times, the lack of funds, the occurrence or threat of wars, and less-demanding levels of functional performance naturally led to a lower number of interventions and rehabilitation actions. Nevertheless, it is important to note that there is always a possibility that some maintenance or even important rehabilitation actions could have been performed that were not been recorded in the historical records collected (Charneco 2014; López 2015). Prieto et al. (2017b), after an exhaustive analysis of historical records, concluded that in 85% of the buildings under analysis, the time of refurbishment actions after a disastrous event was between 1 and 20 years. This result is a first approximation of the possible path in terms of intervention time in historical constructions in Seville (Spain) after disastrous incidents, revealing that usually, after a calamity, stakeholders recognize the importance of intervening in order to restore the functionality of the building. In some cases, when funds are not available, the restoration occurs many years later, which also reveals the subjective criteria that affect the decision to intervene.

- The other maintenance and preservation actions have a homogeneous behavior, except the restoration of religious elements and the replacement of none structural elements (Fig. 6), which had the smallest number of actions (García 2014; Carmona 2014) because they are not directly linked to the buildings' functionality.
