Plasterwork in the Ambassadors Hall (Salón de Embajadores) of the Real Alcázar of Seville (Spain): Graphic reconstruction of polychrome work by layer characterization

F.J. Blasco-López^a, F.J. Alejandro^a, V. Flores-Alés^{a,*}, I. Cortés^b

^a Universidad de Sevilla, Dpto. Construcciones Arquitectónicas II, Av. Reina Mercedes nº4, 41012 Sevilla, Spain

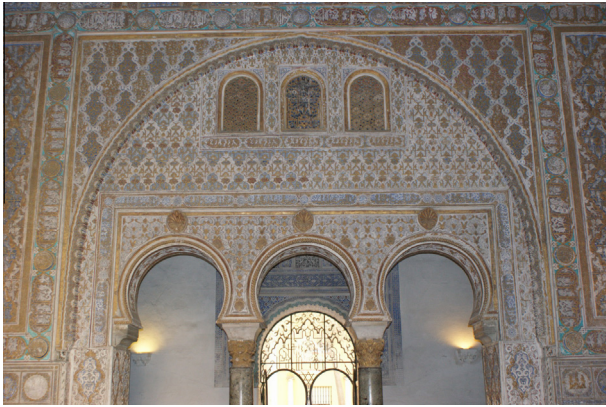
Fig. 1. Plasterwork arch facing west in the Ambassadors Hall.

[1] [2]. Plant motifs in plasterwork cover the corners of the room and the spandrels of the decorative (poly-lobed) arches that frame the keyhole arches separating the adjoining rooms and the rear hall. Above these arches are three tracery windows with geometric elements [3]. The hall's columns and capitels are caliphate-style (Fig. 1).

In the PG (Fig. 4c), the gold derives from the use of gold-leaf for decorating the plasterwork in the Ambassadors Hall (Figs. 1 and 2). Gold-leaf was applied on a plasterwork base, which accounts for the occurrence of gypsum and anhydrite in the sample in addition to the gold. Cerussite is a mineral consisting of lead carbonate (PbCO_3), and its use as a secant suggests the use of oil-based binders which, together with the plasterwork, could comprise the preparation of the gold-leaf [4]. The data show that the gilt was applied on mixture, a procedure that entails fixing the gold-leaf on a prepared layer called mordant or mixture [29]. The mordant consists of a mixture of linseed oil with compounds of lead and manganese oxides. In addition to making the mixture visible, these products aid in rapidly drying the oil.

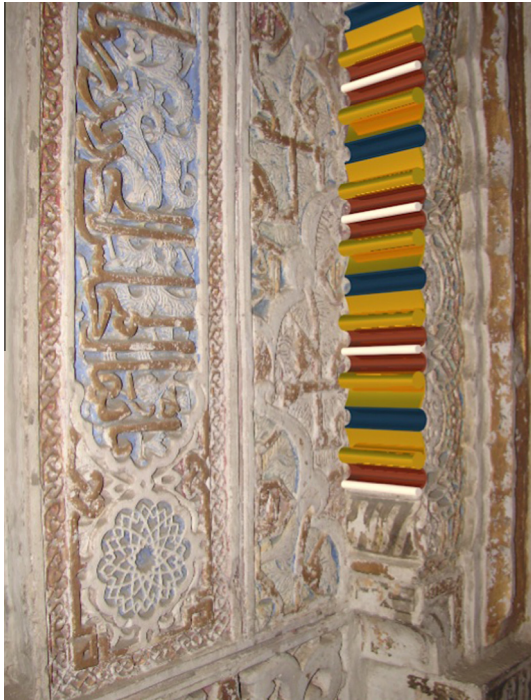
Fig. 9. Current state idealized reconstruction of the polychromies with no deterioration.

For this case, the color samples were taken directly from the actual photograph of the arch scallop (Fig. 2), which shows the final version of this polychromy. In this case, the colors are blue (24/52/74), white (255/255/222), gold (206/142/16), and vermilion (181/81/49).

It is not easy to imagine the state of the restored arch given the deterioration of certain motifs in the scallop and the dirt deposited over the colors. The Fig. 9 shows an idealized reconstruction of the polychromies found, with no deterioration.
