Study of the Influence of Limewash on the Conservation of Islamic Plasterworks through Weathering Tests

F.J. Alejandro, F.J. Blasco-López, V. Flores-Alés, R. Villegas & M.T. Freire

Durability; Gypsum; limewash; plasterwork; Real Alcázar of Seville

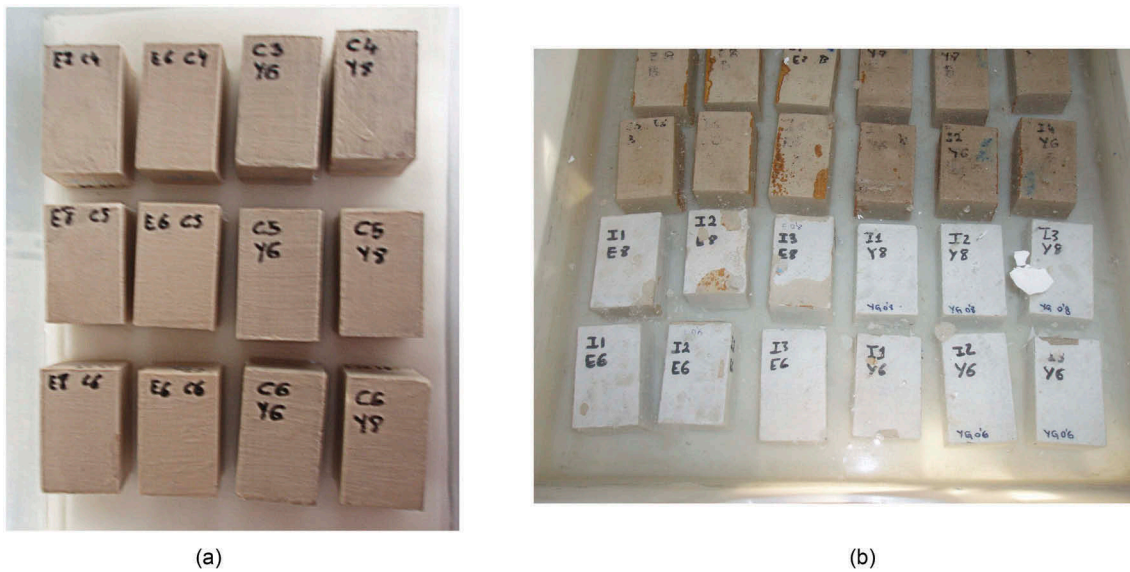
Figure 3. Weathering tests: a) Capillary water absorption, b) Absorption by immersion.

Pieces measuring 4x4x7 cm painted on five sides (type C) were placed in a container, with the unpainted side over a 1 cm layer of blotting paper soaked in water. The same procedure was applied to unpainted pieces (Figure 3a). The rise of water by capillarity occurs from the contact side towards the free sides where it evaporates; creating a continuous flow of water that can solubilize small amounts of calcium sulphate and transport them to the surface, where they will precipitate. Water was periodically added to maintain a constant level. The test lasted 40 days at ambient temperature ($20 \pm 2^\circ\text{C}$). The specimens were weighed every two days being water saturated.

The purpose of the accelerated weathering test due to water absorption by immersion was to simulate the effect of contact with large amounts of water, alternating with drying periods. The thermo hygrometric test employed to study treatments for stone materials was adapted (Villegas 2000), using a lower drying temperature to avoid changing the equilibrium phase of calcium sulphate. The test comprised 13 cycles consisting of 6 hours of immersion in water at $20 \pm 2^\circ\text{C}$, oven drying at $40 \pm 2^\circ\text{C}$ for 41 hours, 1 hour for cooling and weighing. Ultrasonic pulse velocity was measured at the end of the procedure (Figure 3b). Three pieces Type D painted on every side and three unpainted pieces used as reference were submitted to this test.

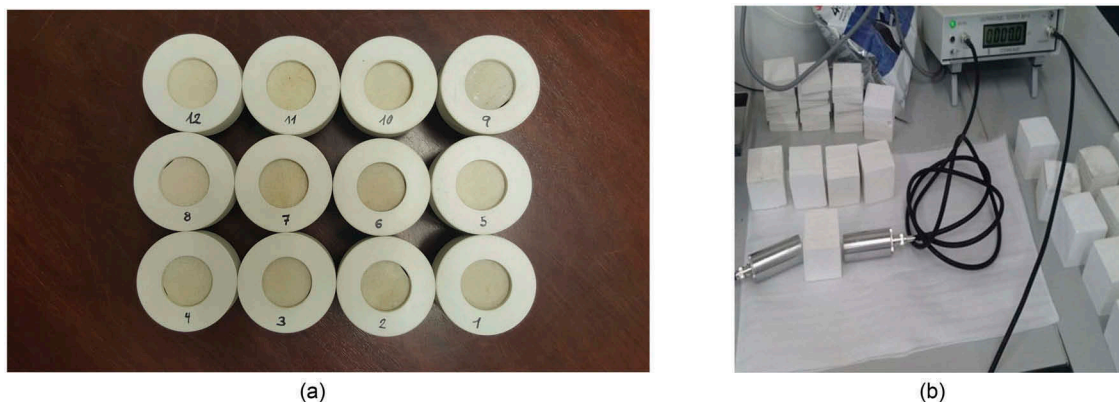
Figure 4. a) Containers with specimens for water vapour permeability test, b) Ultrasonic pulse velocity measurement.

water vapour that enters or leaves the container, which maintains drier or more humid hygrometric conditions than the environment. In this case, the “wet glass” method was used which is based on the measurement of the water vapour flux through the sample due to the pressure differential between the internal (relative humidity approximately 100%) and the external surface conditions (a temperature of $20 \pm 2^\circ\text{C}$ and a relative humidity of $50 \pm 5\%$). It involved the use of a container filled with water until its level reached 20 mm below the inner surface of the test piece applied on the top. The contained was perfectly sealed so that water vapour could only go out by passing through the gypsum piece (Figure 4a). The permeability coefficient is defined as the amount of water vapour flowing through the specimen per time unit and per unit area, and can be calculated from the

The **ultrasonic pulse velocity test** consisted on the measurement of the velocity of high frequency sound waves passing through the material. Vibration was generated and received by an electromechanical recorder. This technique measured the interval of time between the introduction of vibration and its reception. Knowing this data and the distance between the probes, the transmission rate of the sound waves was calculated. Velocity is related to the elastic modulus and increases with the latter, so one of the applications of this measurement is to indicate gypsum physical or mechanical deterioration. Six measurements have been made in each case. These measurements were taken by an Ultrasonic-Tester BP5 device, measuring the test pieces of 4x4x7cm in longitudinal position, placing the two probes at each end of the piece and using modelling clay as a coupling (Figure 4b). The samples were dried at $40 \pm 2^\circ\text{C}$, until constant weight, before the measurements.

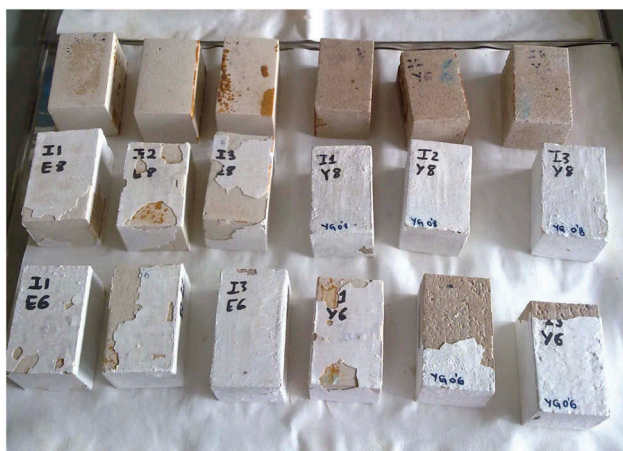
Figure 9. Specimens Type D after immersion test.
