Climate change impacts on cultural heritage building foundations in Western Andalusia

ABSTRACT: The purpose of this study is to present the consequences of climate change, especially temperature increase, drought, sea-level rise, and coastal flooding or earthquake increase, in the foundations of four heritage buildings in Andalusia, to enhance the importance of risk assessments of heritage to contribute to disaster resilience.

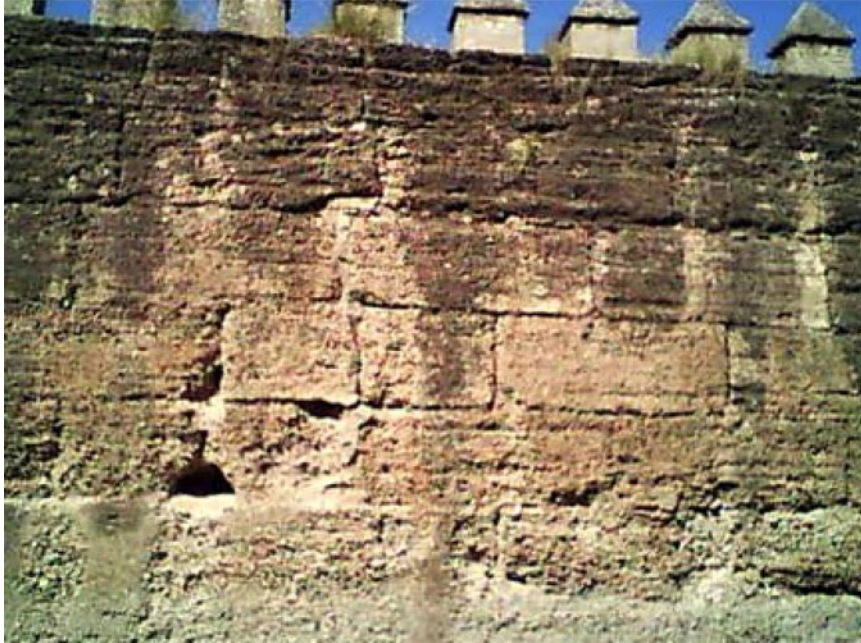
Changes in humidity influence the growth of microorganisms in stone and wooden heritage materials. The growth of small plants can contribute to the biodegradation of these elements. The photograph above shows the growth of small plants in the battlements and several stains of humidity on the wall. Loss of mass is also quite significant in certain areas, as can be seen in the photograph (Figure 1).

Figure 1. Biological degradation in the Macarena wall.

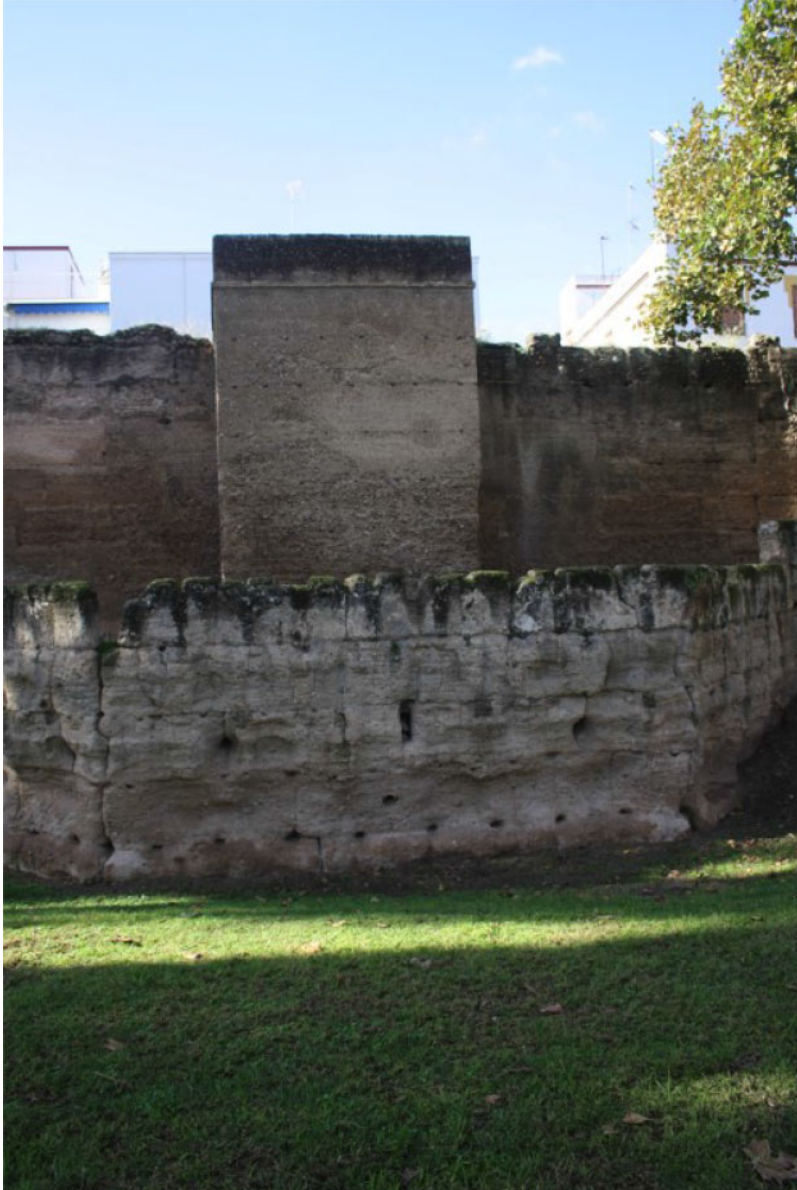
Figure 8. Seville ramparts could be affected by the earthquakes.

One of the monuments that may be most affected will be the Almohad Wall of Seville in the Macarena area since it is composed of the earth as a construction material. There is no masonry foundation, and it is simply buried 2 meters into the ground. The location of the Almohad wall of the Macarena is just north of the city centre and the closest to the Rinconada (Figure 8).
