**jmr&t**  
Journal of Materials Research and Technology  
journal homepage: [www.elsevier.com/locate/jmrt](http://www.elsevier.com/locate/jmrt)

# Experimental investigation of polycarbonate sheets deformed by SPIF: formability, micro-mechanisms of failure and temperature analysis

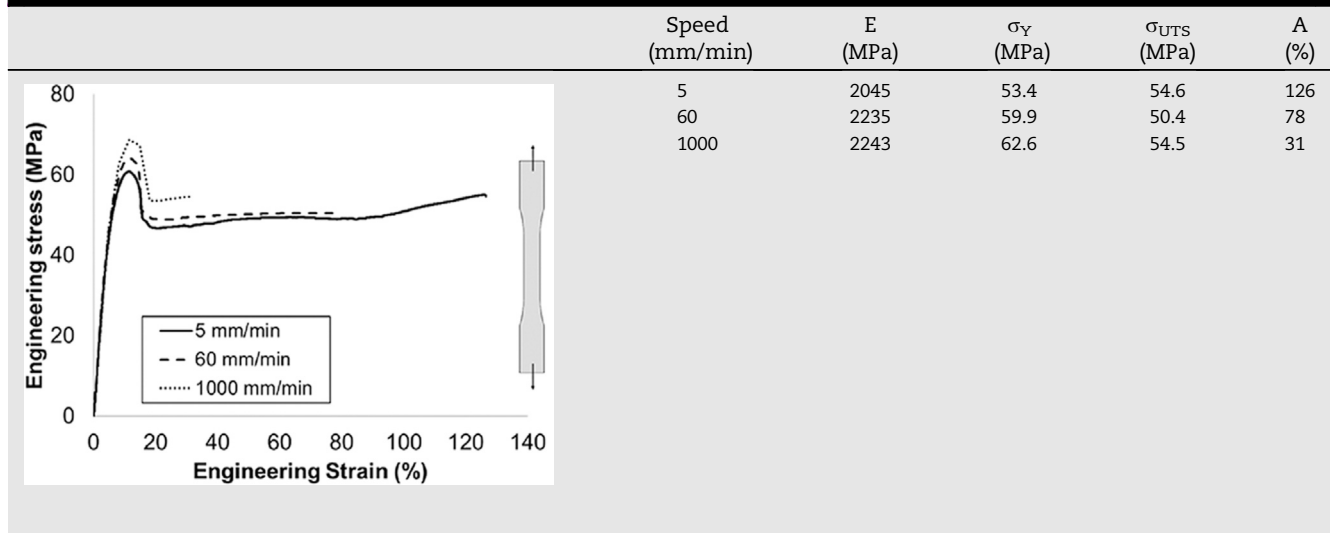
**Table 1 – Average true stress-true strain curves obtained and mechanical properties from tensile tests.**

corresponds to the identical speed employed in the Nakajima tests. Furthermore, additional tests were conducted at velocities of 5 mm/min and 1000 mm/min to investigate the material's response under different speeds. In order to ensure repeatability, three repetitions were conducted, and Table 1 presents the average response of the PC material when subjected to a simple uniaxial load at different testing speeds. Table 1 provides the modulus of elasticity (E), the yield strength ( $\sigma_Y$ ), the ultimate tensile strength ( $\sigma_{UTS}$ ), and the elongation at break (A), at 5, 60 and 1000 mm/min.

As anticipated, the Young's modulus and yield stress of PC demonstrate an upward trend with higher velocity values (60 and 1000 mm/min), whereas lower velocity values (5 mm/min) result in a decrease in both the Young's modulus and yield stress, leading to enhanced ductility in the material. This strain-rate and temperature dependent behaviour is commonly observed in thermoplastic materials.

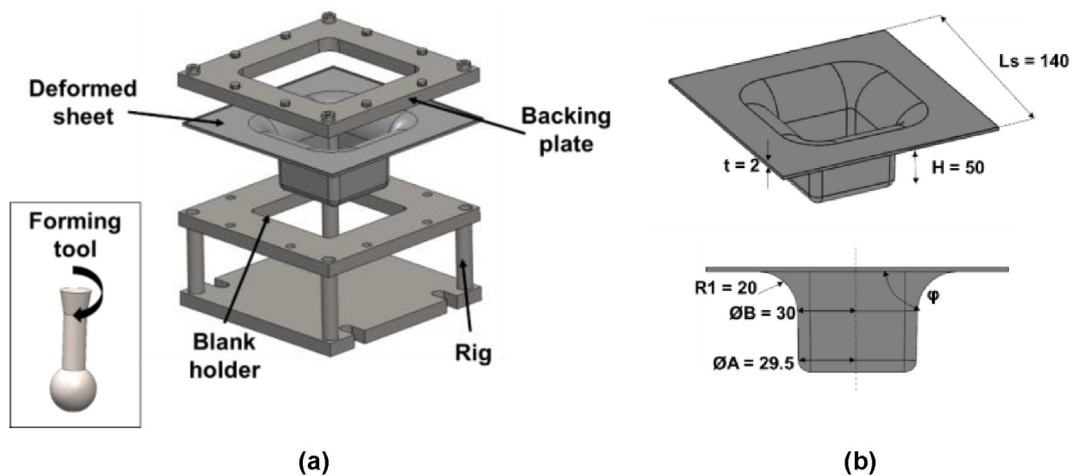
Fig. 2 – Schematic view of (a) the assembly of the SPIF setup and (b) the frustum pyramid testing geometry including its final dimensions.

A schematic view of the assembly of the SPIF setup is represented in Fig. 2a. The undeformed PC sheet is placed and clamped between the backing plate and blank holder and then the forming tool performs progressively the programmed trajectory allowing the manufacturing of the actual frustum pyramidal testing geometry. All the tests were performed until the instant in which failure occurred. The schematic representation of this frustum pyramid testing geometry including its final dimensions is presented in Fig. 2b. The radius of the top of the pyramid is 20 mm (R1 in Fig. 2b) and the radius of the bottom of the pyramid is defined by the tool radius. The angle  $\varphi$  can be determined by the ratio between  $\varnothing A$  and  $\varnothing B$ , which can be close to 90° in the limit case, i.e. when  $\varnothing A = \varnothing B$ .

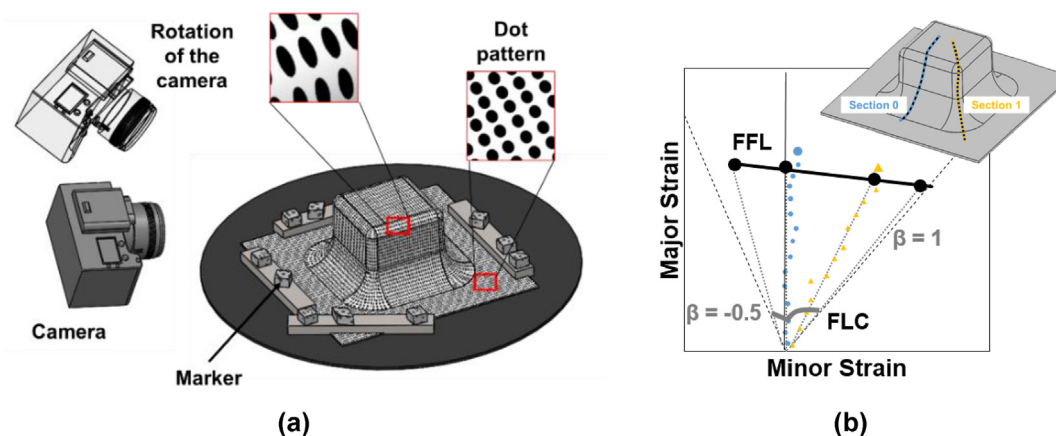
**Fig. 3 – Schematic view of (a) the utilisation of the CGA system ARGUS®, (b) the final SPIFed specimen depicting 2 sections of analysis and the resulting strains within the material FLD.**

schematic Fig. 3a represents the utilisation of the CGA system ARGUS®, showing the “circular barcode markers” that are needed as a reference by the system. These markers should be placed in the region of the interest and are required for calculating the camera position with respect to the object for each picture. On the other hand, to measure the strains at the surface of the final part, it is necessary that the circle grid is clearly visible on the final specimen. For this reason, a circle pattern of 0.75 mm diameter was carefully printed prior to the tests on the sheet blank surface by means of an ink printing process.

Fig. 3b depicts the procedure sequence for obtaining the contour of the principal strains on the outer surface of the testing geometries. To this regard, Fig. 3b shows two selected longitudinal sections to be analysed by ARGUS® labelled as section 0 and section 1, corresponding to plane strain and biaxial strain conditions, respectively. Fig. 3b depicts a schematic representation of the material FLD obtained independently via Nakajima tests using different strain loading paths, thus providing the conventional forming limits at necking (FLC) and fracture (FFL). Along with this schematic FLC, an illustration of the expected contour of the principal strains along the selected sections attained on the surface of the final testing specimen deformed by SPIF is also

provided. As can be seen in Fig. 3b, pyramidal testing geometries produce strain states close to plane strain on the pyramid wall (blue points in Fig. 3b) and also biaxial strain conditions close to the pyramid edges (orange points in Fig. 3b).

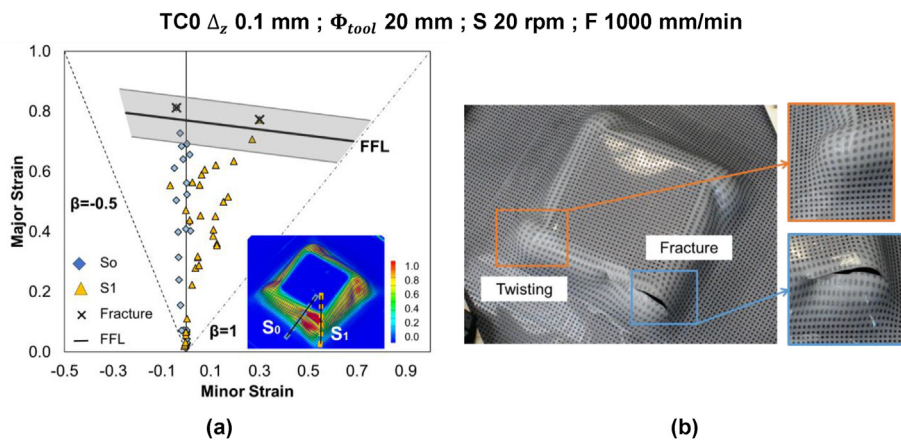
**Fig. 4 – SPIF reference test condition (TC0): (a) FLD along with the contour of major principal strain and (b) the final tested specimen.**

In order to establish a general framework for assessing formability and the mode of failure attained for each set of the process parameters considered, Fig. 4a depicts the Forming Limit Diagrams (FLD's) for the case of the test of reference TC0 (see the set of parameter corresponding to the test in Table 3).

As explained schematically above, the pyramidal frustum geometry considered allowed analysing within the FLD's sections at 2 differentiated zones corresponding both to the principal strains states until fracture in (i) plane strain conditions (labelled as "S0" in Fig. 4a) on the flat lateral surfaces and (ii) biaxial strain states (labelled as "S1" in Fig. 4a) in the region close to the pyramid edges. In addition, along with the FLD's, the contour of the major principal strain provided by ARGUS® onto the final tested pyramid specimen is also represented in Fig. 4a. The FFL's (black lines in the FLD's) determined by means of the Nakajima tests explained in section 2.1 are represented together with a scatter band corresponding to an interval of  $\pm 10\%$  due to the experimental uncertainty. On the other hand, Fig. 4b depicts the final testing specimen, highlighting the zones where twisting and fracture occurred for the case of the test of reference TC0.

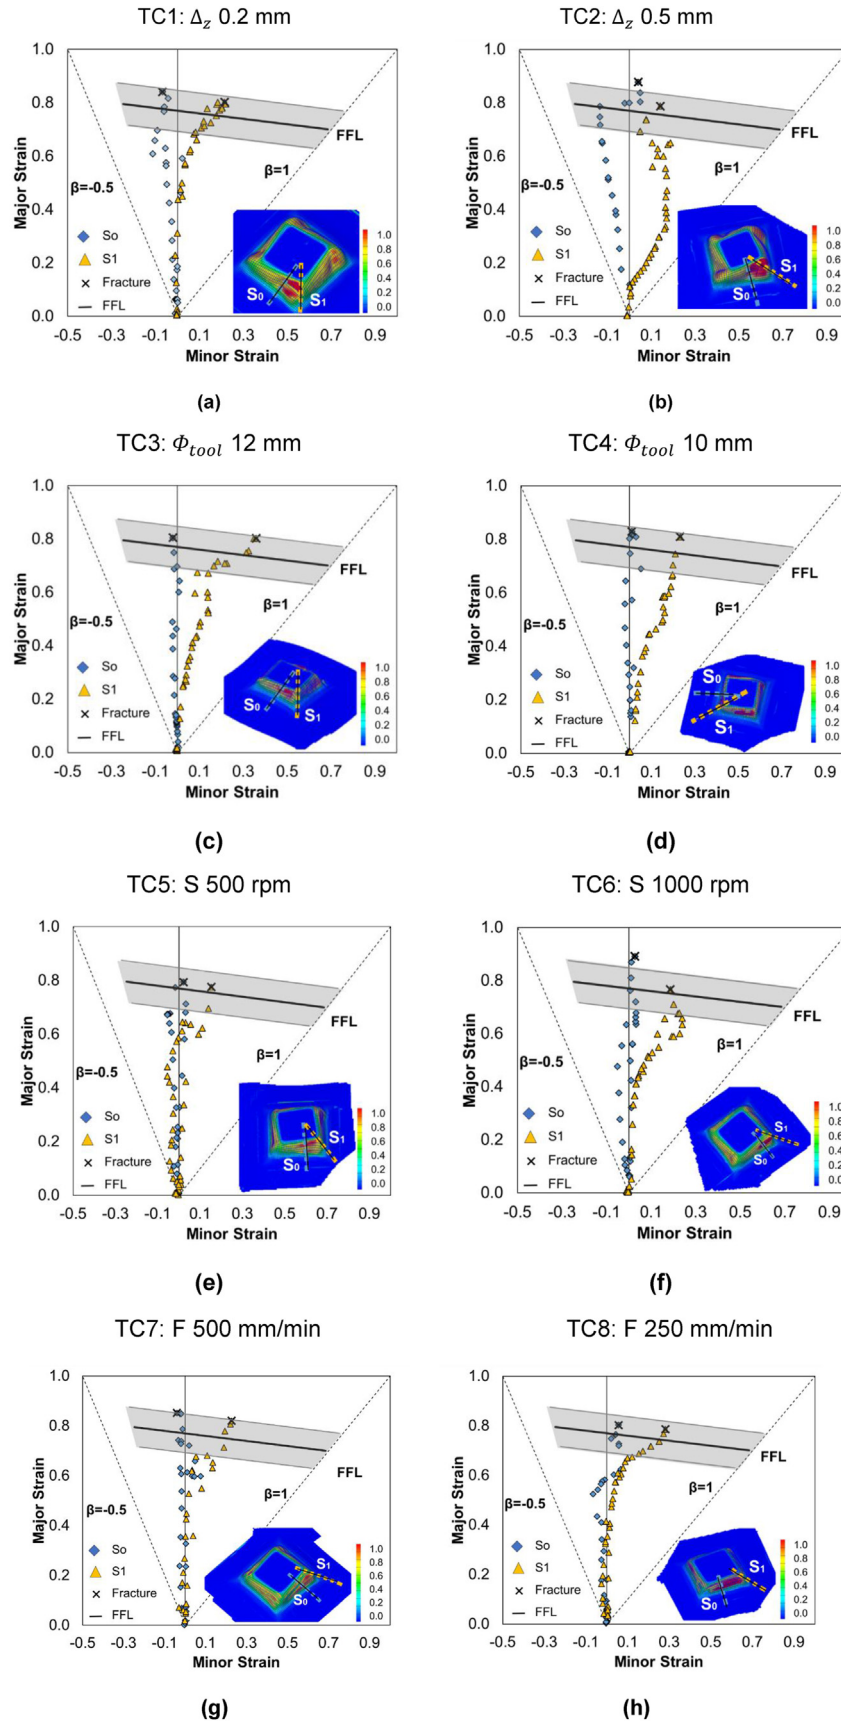
Fig. 5 – FLD's along with the contour of major principal strain on the final tested specimen for each of the SPIF testing conditions considered: from (a) TC1 to (h) TC8.

Analogously to the case of the test TC0, Fig. 5 shows the resulting FLD's of the rest of the specimens tested, i.e. from test TC1 (see Fig. 5a) to test TC8 (see Fig. 5h). Below is an analysis and discussion of the results obtained from the SPIF tests both in terms of conformability and distribution of observed strains.

To this regard, Fig. 5a and b presents the results corresponding to the variation of the step down concerning test conditions TC1 (0.2 mm) and TC2 (0.5 mm), respectively, presenting both tests twisting combined with later fracture. In the case of TC1, the principal strains corresponding to S0 and S1 are in conditions of nearly plane strain and biaxial strain, respectively, showing the effect of twisting in this principal strain distribution. As can be seen in Fig. 5a for TC1, the strain distribution corresponding to plane strain (S0), has tension and compression states in the pyramid wall zone, deviating the principal strains along S0 to negative values of the principal strain ratio ( $\beta$ ) due to the appearance of twisting. In the same sense, section S1, located by the pyramid corner, showed a change in the strain distribution along the section from plane strain to biaxial strain states, i.e. the strains along S1 show a deviation towards higher positive values of  $\beta$  prior to reaching fracture. In this regard, Fig. 5b shows a more noticeable effect on twisting in the strain distribution along the sections due to the increase of step down of TC2 (0.5 mm) compared to TC1 (0.2 mm) and TC0 (0.1 mm). This result can be also observed in the principal strains distributions along sections S0 and S1 depicted in Fig. 5b (test TC2). On the one hand, the minor strain along section S0 has significant negative values corresponding to the tension-compression states exited by twisting at the pyramid wall. On the other hand, the strain evolution along S1 presents a clear non-linear progression because of the effect of twisting by the pyramid wall. In conclusion, it can be pointed out that the step down has a notable effect in the appearance and in the level of the twisting effect, and this level of twisting reached prior to fracture is also rather more visually accused for higher values of the step down.

In addition to that, in terms of formability the strain distributions along the selected sections for TC1 and TC2 analysed using ARGUS® also showed that an increase in the step down produces a slightly increase in the sheet SPIFability. Indeed, as a result of the increase of the step down from TC0 towards TC1 and TC2, an increase of the achievable wall angle, and in consequence an increase in formability is produced. This result is consistent with Davarpanah et al. [9], who studied how the step down in SPIF affects formability in the case of thermoplastic polymers (PLA and PVC). In that work, it was concluded that a greater step down results in an enhancement of spifability up to a certain limit, as far as an excessive step down may lead to premature failure due to the occurrence of twisting. In the same sense, in a previous work by the authors [16] including SPIF tests of PC truncated conical geometries, the results also showed this effect, with twisting occurring for step downs of 0.2 and 0.5 mm, but not for 0.1 mm.

Fig. 5c and d shows the results corresponding to a variation of the tool diameter for the tests TC3 (12 mm of diameter) and TC4 (10 mm), presenting both tests twisting combined with fracture. Nevertheless, the macroscopic analysis of these specimens showed that the twisting effect was not as intense as for tests TC1 and TC2. In TC3, sections S0 and S1 were analysed, again corresponding with the pyramid wall zone and pyramid corner, respectively. In this regards, Fig. 5c showed that the minor strain along S0 presented values close to zero, i.e. corresponding with nearly plane strain. Concerning S1 corresponding to TC3, a slight variation in the strain distribution along the section is attained, deviating the strain state from biaxial to plane strain for high values of the major strain due again to the twisting effect. Concerning the test TC4 (10 mm), the section S0 (wall zone of the pyramid) presents a linear strain distribution within plane strain, whereas along S1 (corner) the strain state evolves in biaxial conditions showing a slight deviation for medium values of the major strain due to a minor twisting. Consequently, it can be concluded that the decrease in tool diameter, which produce a smaller contact area between the tool and the sheet, resulted in a lower twisting effect. This experimental result was more noticeable for TC4 in the sections (S0 and S1) represented in the principal strain space (Fig. 4d), where no negative values corresponding to tension-compression states are attained for S0, and a more linear evolution of the principal strain distribution along S1 (biaxial condition) can be observed. In addition to that, the analysis of TC3 and TC4 using ARGUS® also showed that the decrease in the tool diameter produced an increase in spifability. In this sense, the use of smaller tool diameters concentrates the deformation in a smaller zone, inducing a certain bending effect in the contact zone between the sheet and the tool. This result is consistent with previous works by Martins et al. [9] and Marques et al. [25], in which it was found that the formability of thermoplastics in SPIF is decreased with the increase of tool radius. Nevertheless, it must be also pointed out that other investigations showed the opposite effect, decreasing the material formability in SPIF for smaller tool radii. This is the case of previous research studies by Formisano et al. [26] and Durante et al. [14], in which the formability of PC sheet was slightly enhanced with an

On the other hand, Fig. 5e and f depict the results in terms of principal strains corresponding to a variation of the spindle speed: TC5 (500 rpm) and TC6 (1000 rpm). In terms of the modes of failure attained, TC5 presented twisting and fracture and TC6 showed twisting, fracture and crazing. As can be seen in Fig. 5e, the minor strain along the pyramid wall S0 presents slightly negative values matching the tension-compression states occurred by the effect of twisting. The analysis of the strain distribution along S1 (by the pyramid corner) presents states close to plane strain with very slight deviations towards biaxial strain at high values of the major strain (about 0.6) due to the low effect of twisting by the pyramid wall. As mentioned above, test TC6 (1000 rpm) attained an additional mode of failure beyond fracture and twisting: crazing. As depicted in Fig. 5f, the minor strain along S0 present again negative values as a consequence of twisting, whereas along S1 the strains show a clear trend towards positive values of  $\beta$  for values of the major strain above 0.4 approximately. In addition, the experimental results of TC5 and TC6 indicated that an increase in the spindle speed produced an increase in formability in SPIF. It must be also pointed out that during these two experiments a significant increase of temperature was observed in the specimens, as will be discussed in section 3.3. This fact was also observed in previous work by Bagudanch et al. [27,28], demonstrating that higher values of spindle speed increase formability as a result of increasing the forming temperature. In agreement to that, TC6 (spindle speed of 1000 rpm) achieved a higher level of formability than TC5 (500 rpm). Nevertheless, TC6 was affected by the appearance of the effect of crazing. In this sense, Conte et al. [29] studied the effects of the process temperature of PMMA sheet in SPIF and, according to this work, the appropriate values of the spindle speed should be set in order to not achieve brittle fracture and excessive springback during the process. In sections 3.2 and 3.4 a more detailed discussion of

Finally, Fig. 5g and h presents the results obtained by modifying the feed rate with respect to TC0, being the feed rate 500 mm/min for TC7 and 250 mm/min for TC8, respectively, and presenting both tests twisting and fracture. The analysis of the principal strains distributions for TC7 along sections S0 and S1 is represented in Fig. 5g. The minor strain along section S0 was close to zero corresponding to close to plane strain conditions at the pyramid wall, whereas S1 presents a non-linear progression by the pyramid wall from plane strain to biaxial conditions. In the case of TC8, Fig. 5h depicts similar strains distributions of sections S0 and S1 than previous cases. To this regard, the minor strain along section S0 presents negative values whereas the strain distribution along S1 evolves from plane strain to biaxial strain states, as because result of twisting. The comparison between the results obtained for TC7 (500 mm/min of feed rate) and TC8 (250 mm/min) allow concluding that an increase in the feed rate results in an increase of the formability in SPIF. In this sense, some researchers have studied the combined effects of different parameters on formability, as is the case of Le et al. [12] who proved that a combined increase of the step down and the feed rate resulted in a decrease of formability for polypropylene (PP) sheet. To the same regard, the study by Hussain et al. [30] concluded that the formability of PVC sheets increased with the rising ratio between spindle speed and feed rate.

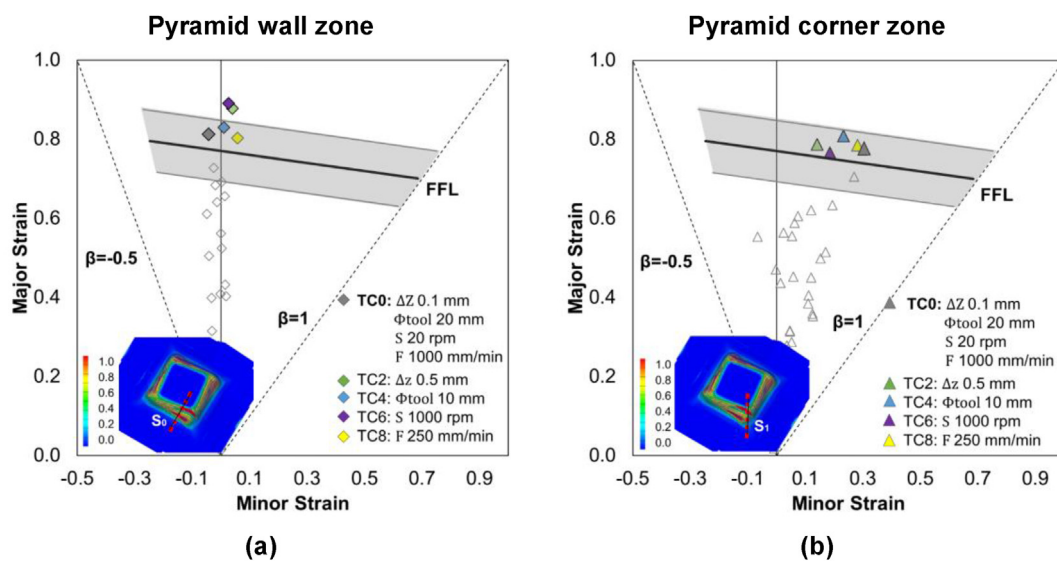
Fig. 6 – FLD for TC0 along with the maximum principal strains at fracture for tests TC2, TC4, TC6, and TC8 in (a) plane strain condition (S0) and (b) biaxial condition (S1).

To sum up this analysis of the material formability in SPIF for the 2 mm thickness PC sheet considered, Fig. 6 presents a comparison between the reference test (TC0) and the tests with more different values of process parameters, i.e. with TC2, TC4, TC6, and TC8. In this sense, Fig. 6a presents the results in terms of principal strains corresponding to sections

S0 (by the pyramid wall zone) and Fig. 6b the results corresponding to sections S1 (by the pyramid corner). These Figures depict the strain distribution along the corresponding sections by means of the fracture points for the tests described above (filled dots in Fig. 6a and b), being the strains along S0 and S1 for test TC0 represented in grey colour. It can be seen in Fig. 6a that the two tests achieving the maximum level of major principal strain at fracture were TC2 (increasing the step down from the 0.1 mm of TC0 to 0.5 mm) and TC6 (increasing the spindle speed from the 20 rpm of TC0 to 1000 rpm). Thus, these results revealed that the most relevant parameters in terms of formability were the step down and the spindle speed. On the other hand, the two tests that achieved a minimum level of strain were TC0 and TC8 (feed rate 250 mm/min). In addition to that, it must be also pointed out that except TC2 and TC6, all the fracture strains were within the  $\pm 10\%$  scatter band of the FFL, not varying too significantly the levels of fracture strains attained.

In the case of Fig. 6b, the results for the sections S1 of the different tests analysed at the pyramid corner are depicted. In that case, the maximum levels of major strain at fracture were for TC4 (decreasing the tool diameter from the 20 mm of TC0 to 10 mm) but with very small difference with respect to the other tests. Indeed, all the tests showed a non-remarkable difference in terms of the maximum strains at fracture achieved for the case of biaxial strain state conditions.

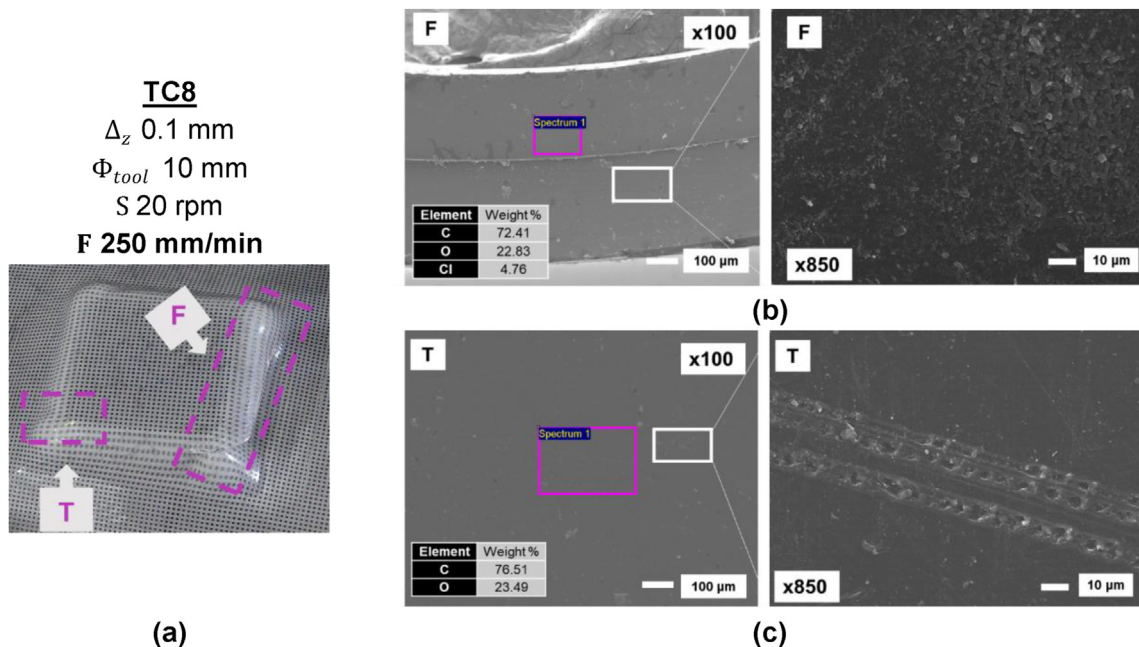
Fig. 11 – TC8 mechanism of failure showing: (a) final specimen, and the failure SEM analysis with a magnification of  $\times 100$  and  $\times 850$  along with EDS of (b) fracture and (c) twisting.

Finally, Fig. 11 presents the results of test TC8, obtained by decreasing the feed rate from 1000 rpm (TC0) to 250 mm/min. Fig. 11a indicates the two modes of failure presented in TC8, i.e. twisting and fracture. As can be macroscopically seen in Fig. 11a, the specimen clearly presents a mild twisting. This fact might be related to the duration of the test and the temperature results that will be discussed in section 3.3. Fig. 11b shows the  $\times 100$  (left) and  $\times 850$  (right) SEM magnifications of the fracture surface (“F”). The fracture surface of TC8 exhibited a uniform morphology formed by irregular structures, and also, it was similar to the TC4 (see Fig. 9b). On the other hand,  $\times 850$  magnification showed an area with degradation of the material similar to the prior case of TC6 depicted in Fig. 10b. As

mentioned, this fact may be related to the total duration of the test, as a result of the effect of the prolonged contact with the lubrication. The twist visible at TC8 was more moderate, consistent with the  $\times 100$  magnification presented in Fig. 11c showing a smoother surface. In addition, the  $\times 850$  SEM magnification depicted in Fig. 11c illustrates the presence of holes in the surface. This fact may be related to the environmental stress cracking (ESC) due to the lubricant effect, and is aimed to be studied in more detail in future research by the authors.

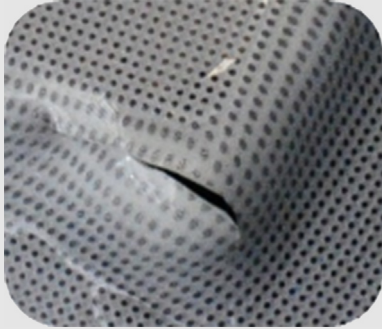
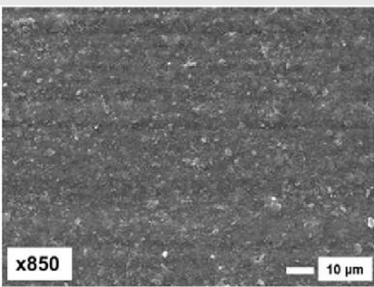
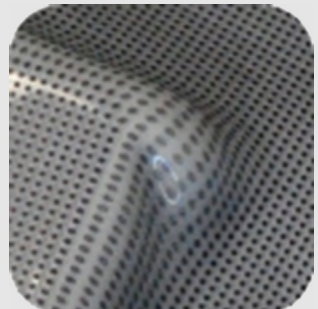
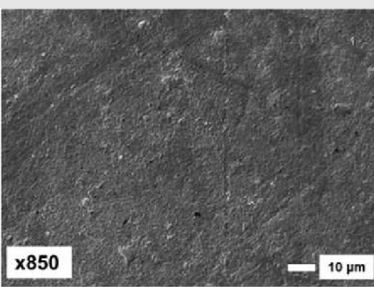
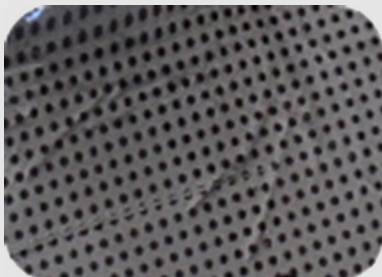
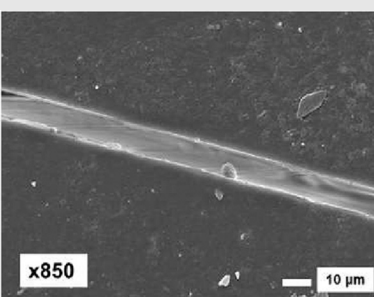
**Table 4 – Comparative analysis of the failure modes indicating the main microstructural similarities and differences between the various SPIF tests.**

<ul style="list-style-type: none"> <li>- Irregular surface</li> <li>- Orbed shapes</li> <li>- Spherical shapes</li> </ul>	<ul style="list-style-type: none"> <li>↑ <math>\Delta_z</math> ↑ Stretched fibrils structures</li> <li>↓ <math>\Phi_t</math> ↑ Size of granular shapes</li> <li>↑ S ↑ Crazes holes</li> <li>↓ Size of granular shapes</li> <li>↓ F ↑ Degraded granular shapes</li> </ul>
<p>Twisting</p>

<ul style="list-style-type: none"> <li>- Uniform surface</li> <li>- Smooth Zones</li> <li>- Oval shapes</li> </ul>	<ul style="list-style-type: none"> <li>↑ <math>\Delta_z</math> ↑ Smoothness</li> <li>↓ Size of granular shapes</li> <li>↓ <math>\Phi_t</math> ↑↑ Smoothness</li> <li>↑ Uniformity</li> <li>↑ S ↑ Crazes</li> <li>↓ Uniformity</li> <li>↑ Presence of holes</li> <li>↓ F ↑ Crazes</li> <li>↓ Uniformity</li> </ul>

<p>Crazing appears when ↑ S</p> <ul style="list-style-type: none"> <li>- Cracks</li> <li>- Nucleation of voids</li> <li>- Cavities spread</li> <li>- Fibrils</li> <li>- Cavitation hole</li> </ul>

To sum up, Table 4 presents a comparative analysis of the three modes of failure attained, i.e. fracture, twisting, and crazing. To this respect, the test TC0 is used as a reference for carrying out the comparison with the other SPIF tests. Table 4

shows the macroscopic view (of TC0) corresponding to the failure mode as well as the SEM image (In the TC0 specimen  $\times 850$  magnification) together with the main morphological features observed on the surface. In addition, Table 4 shows a series of observations extracted from the other SEM tests assuming the following notation for variation with respect to TC0:  $\uparrow \Delta_z$  (increasing the step down, TC2),  $\downarrow \phi_t$  (decreasing the tool diameter, TC4),  $\uparrow S$  (increasing the spindle speed, TC6) and,  $\downarrow F$  (decreasing the feed rate, TC8).

In the case of the failure mode by twisting in Table 4, the SEM analysis of the twisting surfaces revealed much greater uniformity than in the case of the fracture surfaces. Indeed, twisting

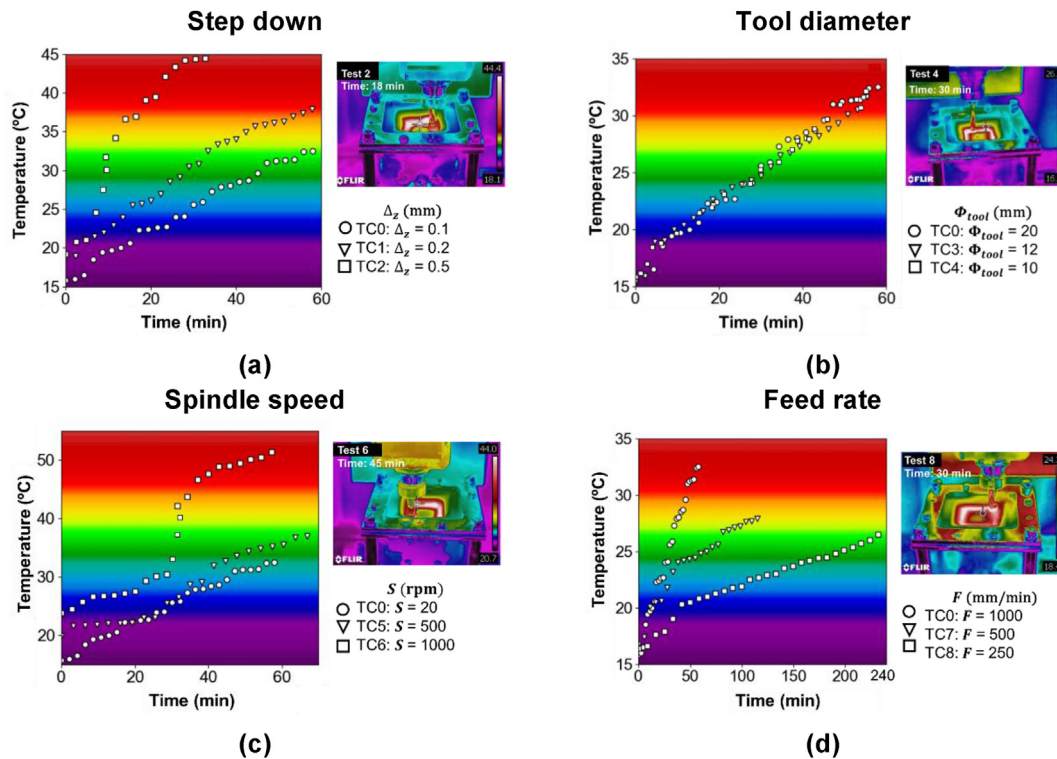
**Fig. 12 – Evolution of temperature versus time of each test varying with respect to reference test TC0: (a) step down, (b) tool diameter, (c) spindle speed and (d) feed rate.**

20 mm) is again represented with circles, for TC3 with inverted triangles (tool diameter 12 mm) and for TC4 (tool diameter 10 mm) with squares. In this case, the tool diameters for TC3 and TC4 were very similar, and consequently they did not show a significant change in the evolution of testing temperature. The comparison between TC0 (tool diameter 20 mm) and TC4 (tool diameter 10 mm) did not either show a significant variation in temperature, presenting though TC0 a slightly higher level of temperature than TC4. This fact may be related to friction, as far as higher tool diameters produce a larger contact area between the tool and the sheet, making it more difficult to dissipate the heat generated as a result of this friction. According to Bagudanch et al. [37], the UHMWPE sheet presented an increase of temperature rise with the tool diameter. To this regard, Hussain et al. [30] studied the effect of temperature variations on the ductility of PVC and PE. This work used the parameter  $\Delta T/m_p$  (where  $\Delta T$  is the rise in temperature and  $m_p$  is the melting point of the polymer) as an index to indicate the softening caused by processing heat. The formability increased with the parameter  $\Delta T/m_p$  depending on the polymeric material, i.e. for PVC formability increased with it, but in the case of PE, formability was contrarily reduced [30].

Thirdly, Fig. 12c shows the evolutions of temperature obtained for the variation of the spindle speed compared to the reference test. In this case, the temperature evolution for TC5 was represented with inverted triangles (spindle speed 500 rpm) and for TC2 (spindle speed 1000 rpm) with squares. The evolutions of temperature for TC0 and TC5 were similar, although TC5 reached a higher level of temperature. On the other hand, TC6 showed an intense change in temperature, presenting a large change in the slope of the path for about

minute 30. Indeed, as a result of the higher spindle speed of TC6 (1000 rpm), the forming temperature increased sensibly. This effect may be also related with the degradation of material resulting in crazing. In this sense, Bagudanch et al. [37] identified the spindle speed as the key parameter affecting the process temperature, being a remarkable rise of heat generated due to tool-sheet friction produced for different polymer materials. Specifically, the case of UHMWPE experimented a variation of 35–40 °C considering the a variation of the spindle from free to 2000 rpm [37].

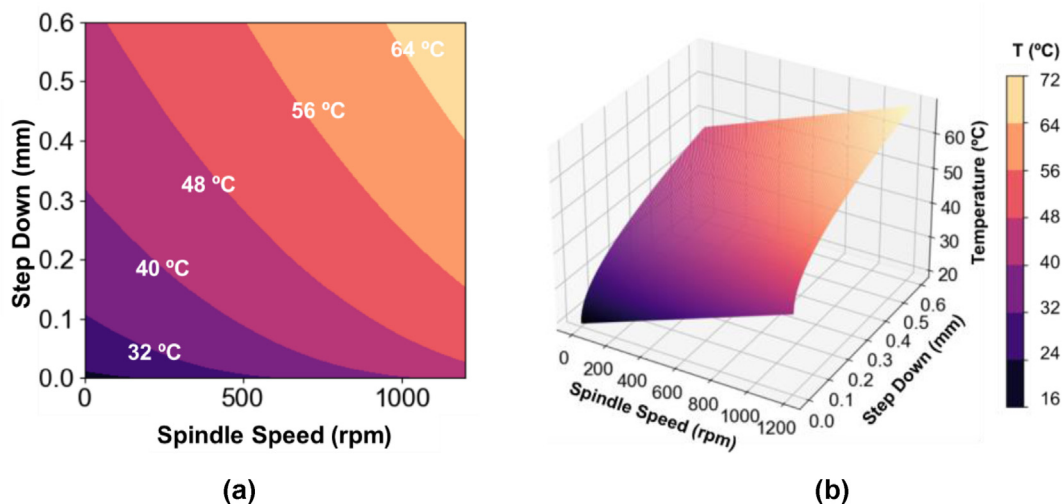
Fig. 13 – The plot of the equation for maximum temperature ( $T_{max}$ ) as a function of the step down ( $\Delta_z$ ) and the spindle speed ( $S$ ) through (a) the 2D contour (b) the 3D logarithmic surface.
