Application of Operational Modal Analysis Method in the Monastery of San Jerónimo (Seville, Spain)

Keywords: Operational Modal Analysis, Cultural heritage, Monastery of San Jeronimo.

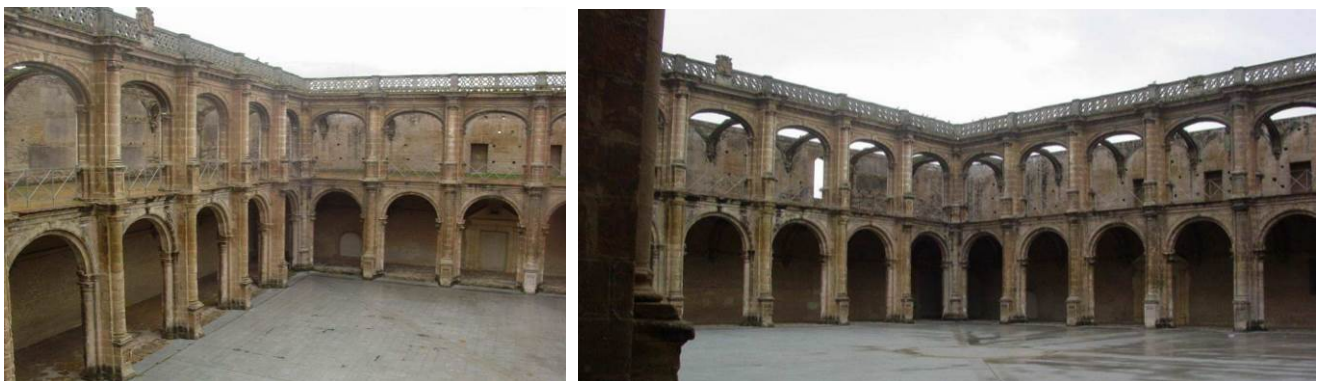
Also in the first third of the sixteenth century, next to the east cloister, the construction of the main cloister was initiated. The works were completed in the first half of the seventeenth century. It is a Renaissance-style building. The patio is composed by calcarenite pillars and semicircular arches. The galleries are bounded by brick walls and covered by ribbed stone vaults. In the upper floor gallery, there are segmental arches (Figure 2).

Figure 2. Views of the main cloister.

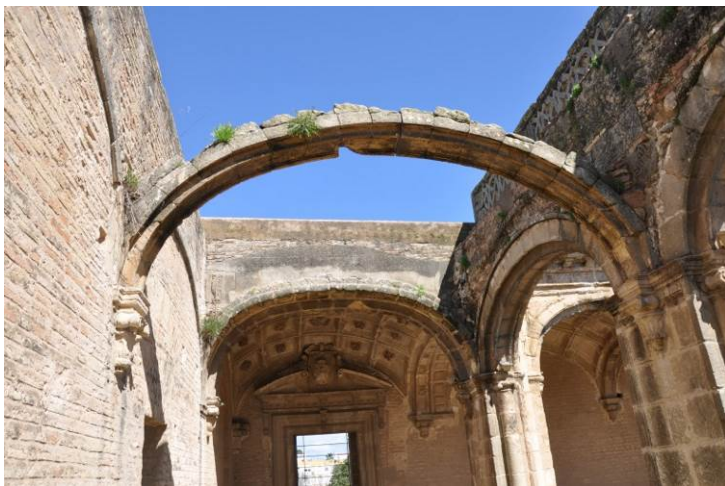
Nowadays, the church and the east cloister are virtually disappeared. Only two chapels and the wall annexed to the the main cloister are preserved [1]. Moreover, the ground floor of the Renaissance cloister is preserved, while on the upper level, only the vertical structure and some covers of the north gallery are conserved (Figure 3). The tower also remains standing, but with internal new elements (Figure 4).

Figure 3. View of the upper gallery.

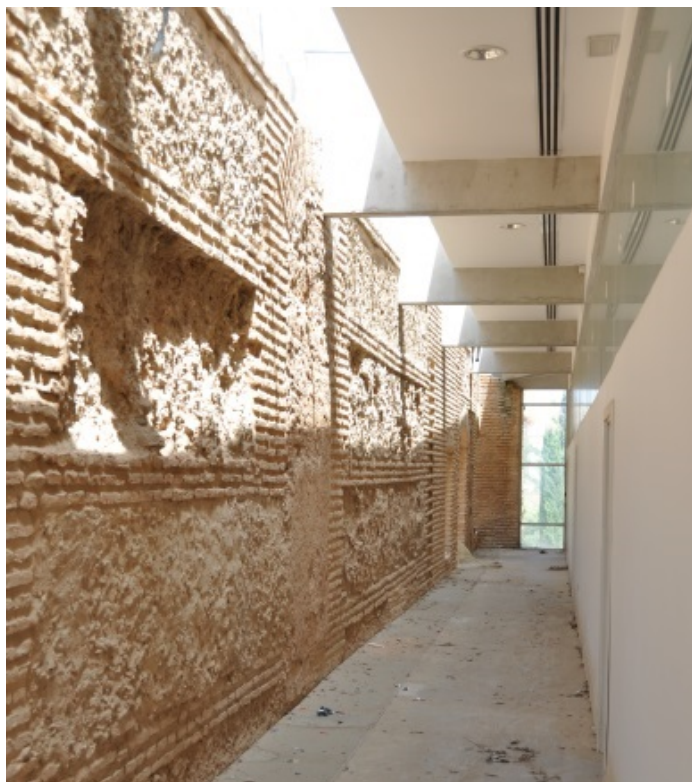
The main premise of the project is to respect the existing historic remains of the monastery in such a way that the contemporary part were recognisable from the historical construction. An architectural neutral language is used in the new buildings [2]. From a structural point of view, a mixed system of load-bearing walls and pillars that support large beams is used to build the new building. (Figure 5).

Figure 5. View of the new construction. Upper floor.

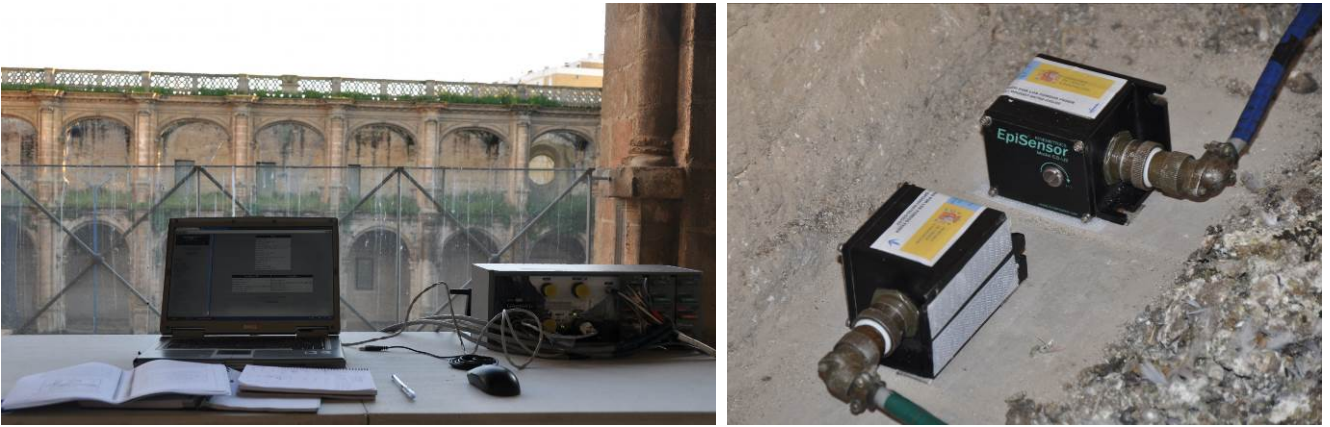
The equipment for the experimental campaign is composed by a 12-channel adquisition system (GRANITE) and 8 uniaxial force balance accelerometers (EPISENSOR). The equipment is manufactured by the company KINEMATRICS (Figure 6). Six campaigns of Operational Modal

Figure 6. Measurement equipment.
