Journal of Building Engineering

LONG-TERM ENVIRONMENTAL MONITORING FOR PREVENTIVE CONSERVATION OF EXTERNAL HISTORICAL PLASTERWORKS

Manuscript Number:	JBE-D-21-03287R2
Article Type:	Research Paper
Section/Category:	Building materials
Keywords:	plasterwork; temperature; relative humidity; architectural heritage; preservation
Corresponding Author:	VICENTE FLORES-ALÉS, Ph.D. Universidad de Sevilla SEVILLE, SPAIN
First Author:	Marta Torres-González, PhD aspirant
Order of Authors:	Marta Torres-González, PhD aspirant Carlos Rubio-Bellido, Ph. D. David Bienvenido-Huertas, Ph. D. Juan Manuel Alducin-Ochoa VICENTE FLORES-ALÉS, Ph.D.
Abstract:	<p>In this study, an analysis of the environmental conditions in a Csa climatic zone for the conservation of plasterwork of the Real Alcázar of Seville is carried out. The measurements obtained from in-situ monitoring are compared with the measurements provided by AEMET (State Meteorological Agency in Spain) during the reference year and the study is completed by estimating future environmental conditions using two alternative approaches: a morphing process from the EPW of the climatic zone and the application of M5P data mining algorithms.</p> <p>An

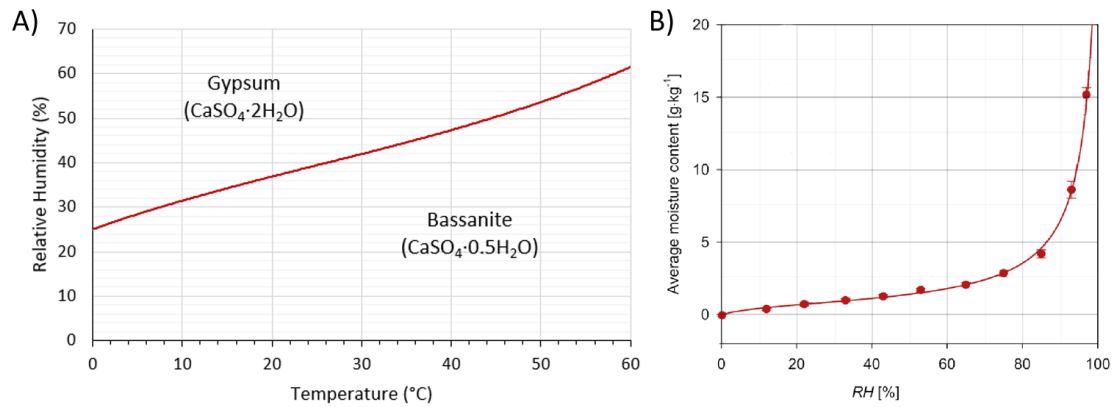
Fig. 1 (A) T-HR ratio for gypsum-bassanite transformation at 1 atmosphere pressure [31] and (B) Relationship between the relative humidity and the moisture content of the gypsum [33].

45 Variations in T and RH can induce phase transitions. In general, gypsum ($\text{CaSO}_4 \cdot 2\text{H}_2\text{O}$)
46 dehydration occurs in dry environments [30], which is the reason why temperature below 40°C
47 is desirable for the correct preservation of plasterwork. However, there may be situations of
48 high temperatures combined with high relative humidity in which there are no alterations in the
49 mineral phases of the gypsum [31]. In this regard, Winkler & Wilhelm (1970) indicated the
50 relationship that must exist between ambient temperature and relative humidity to transform
51 gypsum ($\text{CaSO}_4 \cdot 2\text{H}_2\text{O}$) into bassanite ($\text{CaSO}_4 \cdot 0.5\text{H}_2\text{O}$) [31], In this case, the material is likely to
52
53
54
55
56
57
58
59
60
61
62
63
64
65

lose stability if exposure to these unfavorable environmental conditions is prolonged over time [32] (Fig. 1-A, 1-B).

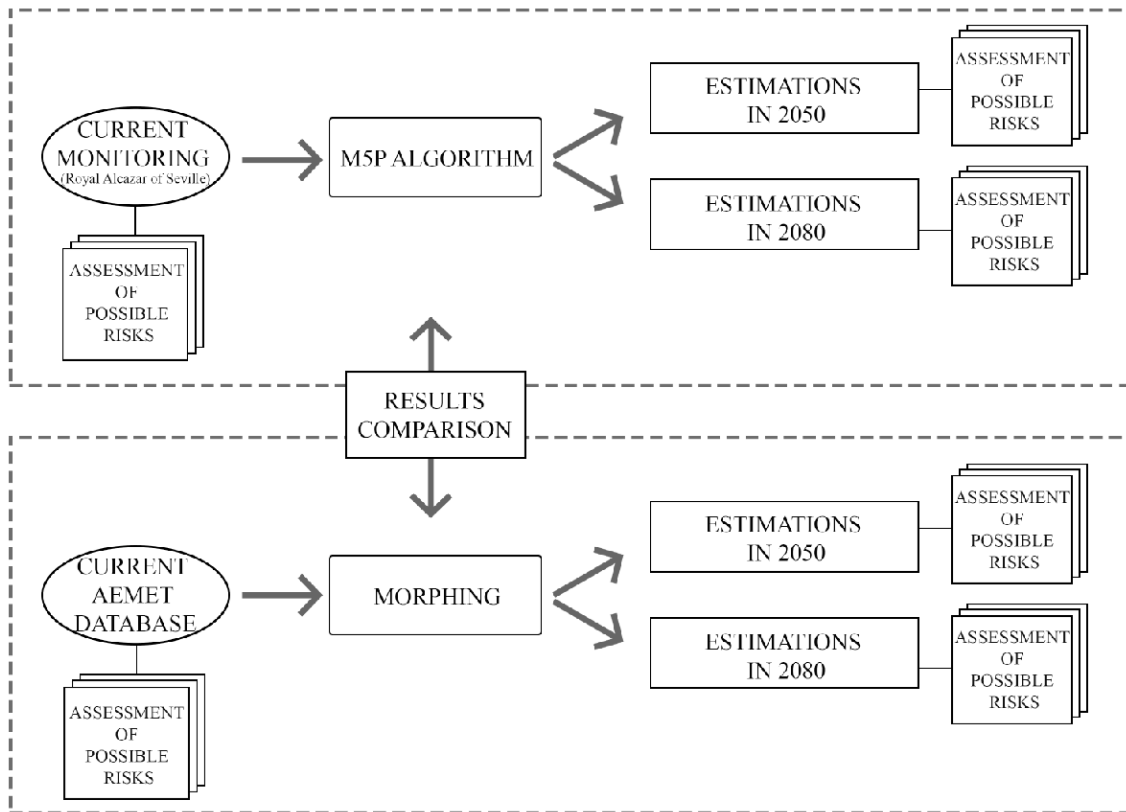
Fig. 2. Flowchart of the steps followed in the study.

34
35
36
37
38 The methodological framework of this research is summarized in Fig. 2. As it can be seen, in
39 this study a measurement process was carried out of an external point of the case study, while
40 the external climate of the city was also monitored. Through these two approaches, the
41 estimates for the years 2050 and 2080 were obtained using different methods. All these sets of
42 environmental data were analyzed to evaluate the conservation risk of the historic plasterwork
43 of the RAS.
44
45
46
47
48
49
50
51
52
53
54
55
56
57
58
59
60
61
62
63
64
65

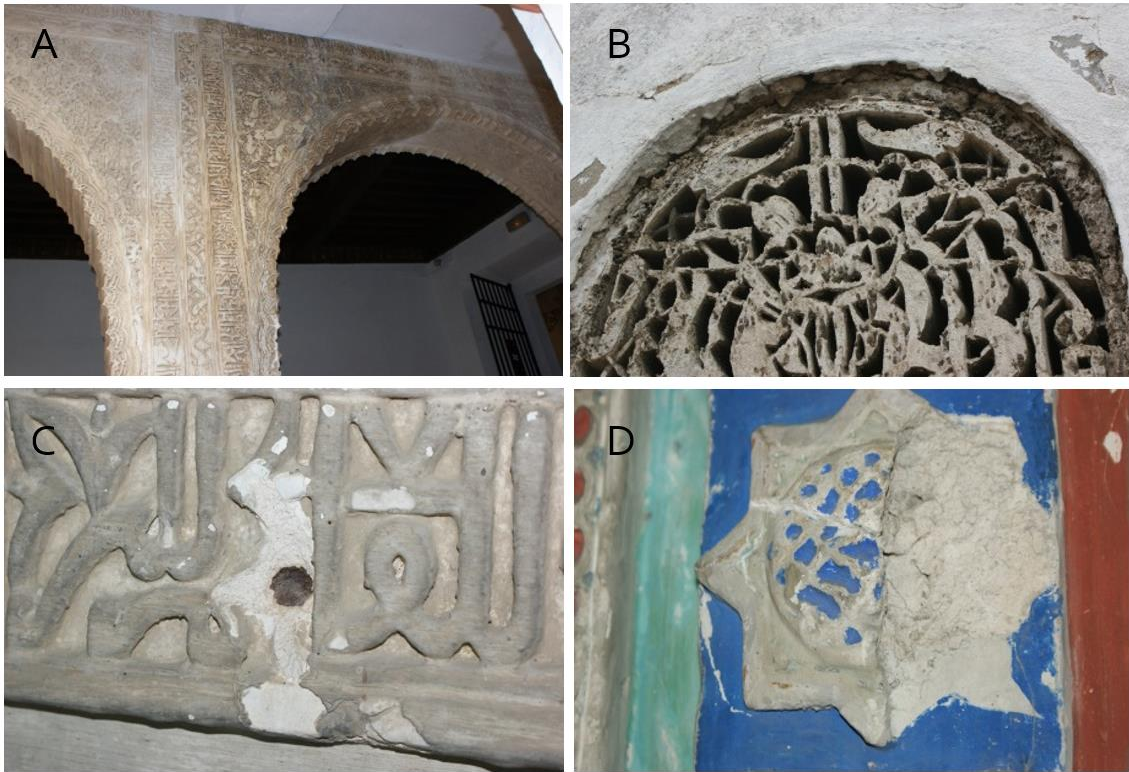
Fig. 4 Deterioration in RAS plasterwork: water seepage (A), direct action of rain (B), detachment after oxidation of the metallic element (C), disintegration of the material (D).

Environmental conditions have a direct influence on the conservation of materials, favoring degradation processes over time. In the case of plasterworks, the alterations are mainly manifested on the surface, which is the physically and mechanically weakest area, favoring deterioration, loss of material and the appearance of stains (Fig. 4). Moisture defects are caused by physical mechanisms, causing bulging, blisters, detachments, stains and even erosions and fissures. But moisture, normally infiltrated, develops a synergistic effect with chemical agents that gives rise to the appearance of injuries, as it can dissolve certain soluble salts contained in plasterwork, transporting them to the outside, evaporating the water in contact with the lower vapor pressure atmosphere and recrystallizing the salts, leading to efflorescence and crypto-efflorescence [29].

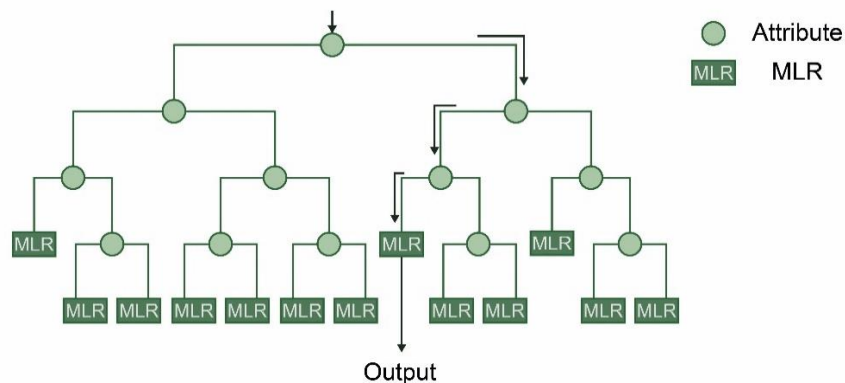
Fig. 7. Scheme of an M5P model.

Where β_0 is the independent term, β_i are the regression coefficients, x_i are the predictor variables, and ε is the error.

The approach designed had a configuration of 6 input variables corresponding to the hourly values of temperature, relative humidity, dew point temperature, horizontal infrared radiation intensity, global horizontal radiation, and direction normal solar irradiance, diffuse horizontal solar irradiance of the time series of the outer point of Seville. The output variables correspond to the relative humidity and the temperature at the interior point of the case study. For each output variable a different M5P was designed.

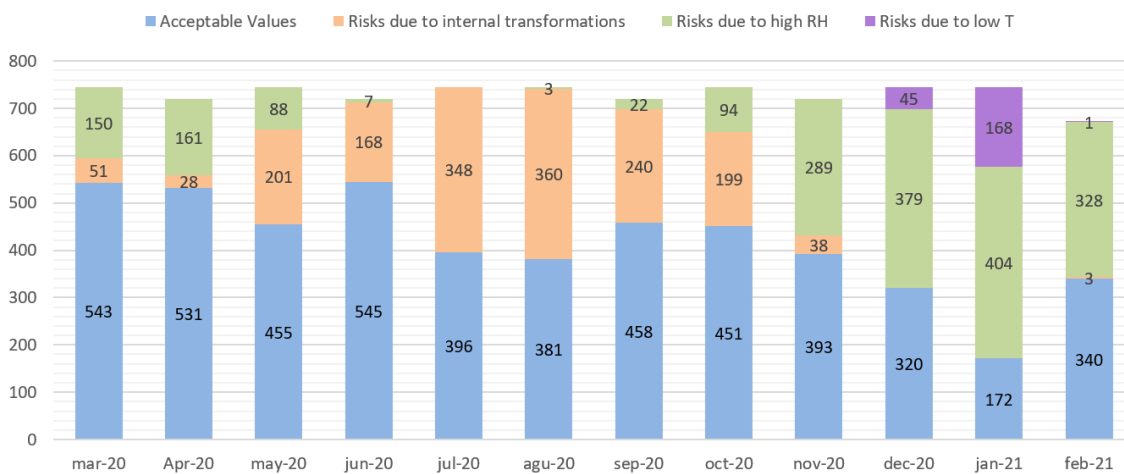
Fig. 12 Monthly representation of the hourly measurements obtained in Seville from March 2020 to February 2021.

While the approach to the analysis of the Courtyard of the Maidens point (with a clear microclimate) presents less severe conditions for the conservation of plasterwork, outside the conditions would be different, presenting a greater risk due to the climate in these elements. Likewise, the variability detected between the two approaches shows the great variation that the analysis approaches of the influence of climate can present on the conservation of plasterwork. Thus, the use of a joint approach to the outdoor climate and microclimates in this type of case study allows us to show a broader perspective of the risk of conservation of plasterwork.

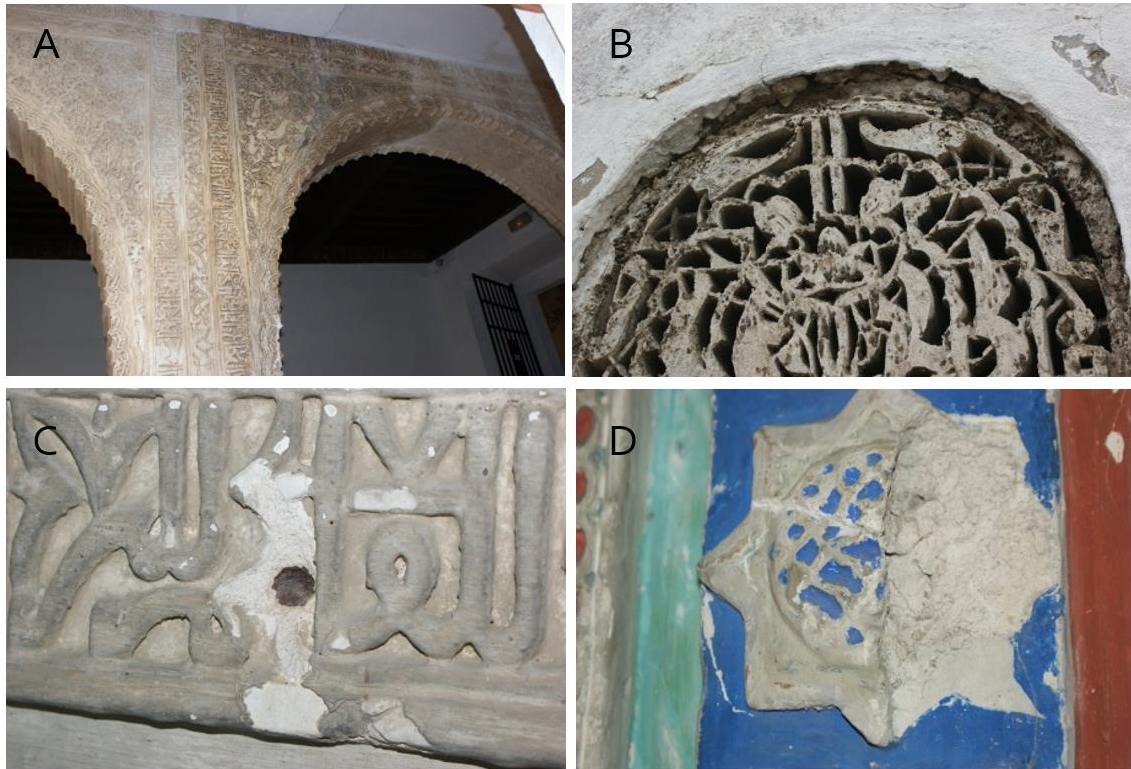
Fig. 4 Deterioration in RAS plasterwork: water seepage (A), direct action of rain (B), detachment after oxidation of the metallic element (C), disintegration of the material (D).

Environmental conditions have a direct influence on the conservation of materials, favoring degradation processes over time. In the case of plasterworks, the alterations are mainly manifested on the surface, which is the physically and mechanically weakest area, favoring deterioration, loss of material and the appearance of stains (Fig. 4). **Moisture defects are caused by physical mechanisms**, causing bulging, blisters, detachments, stains and even erosions and fissures. But moisture, normally infiltrated, develops a synergistic effect with chemical agents that gives rise to the appearance of injuries, as it can dissolve certain soluble salts contained in plasterwork, transporting them to the outside, evaporating the water in contact with the lower vapor pressure atmosphere and recrystallizing the salts, leading to efflorescence and crypto-efflorescence [29].
