Review: Best Practices In Educating
Sustainability and Heritage

Muralla nazari, Alto Albayzín (Nasrid Wall, Upper Albayzin)

(Recovery of the Cerro de San Miguel and the Darro river area. Rehabilitation of the wall of San Miguel Alto and its surroundings)

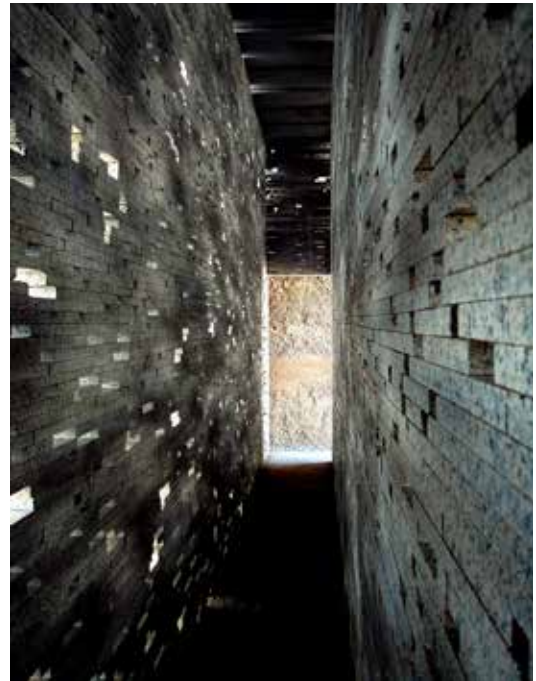
Figure 1. Muralla Nazari (Nasrid Wall)
Authors: David Arredondo and Alberto García, 2006.
Source: Antonio Jiménez Torrecillas Studio.

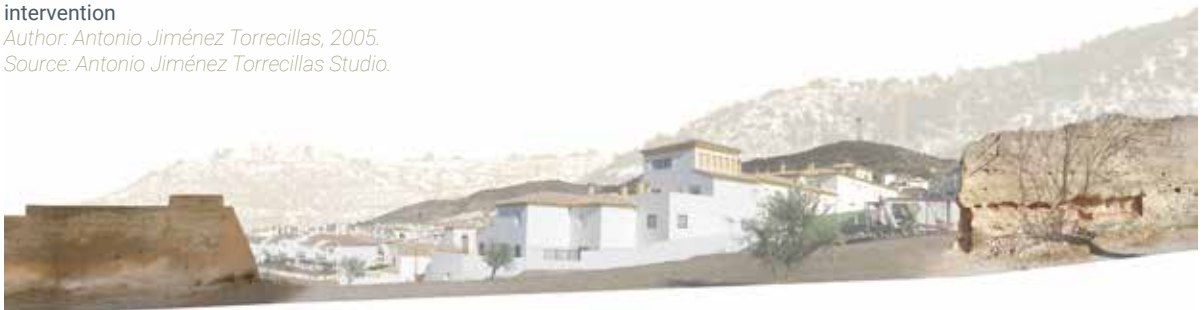
Figure 3. Photomontage of the wall before the intervention

> Destruction of 40 meters of the wall by an earthquake (19th century).
> Brick walls to consolidate the walls (ca. 1950) by Francisco Prieto-Moreno Pardo (architect).

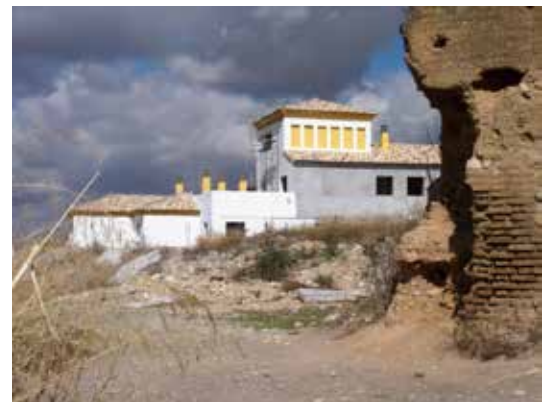
Figure 4. View of the breakage of the wall.

The surroundings, the accesses, and the wall itself were in a high state of abandonment

and deterioration. The San Miguel hill had become an illegal rubbish dump. The wall was in a high state of abandonment, deteriorated and altered by acts of vandalism.

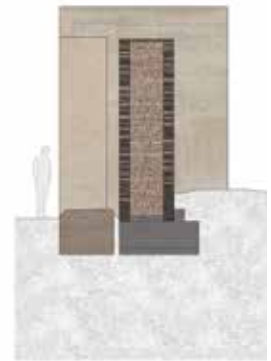
Figure 5. Section.
Author: Antonio Jiménez Torrecillas, 2006.
Source: Antonio Jiménez Torrecillas Studio.

In order to re-establish the linear continuity of the wall and restore the original protection of its interior, a new wall was built on the missing section. Attached to the historic element, it is distanced from it as far as necessary to avoid contact with the Monument and thus guarantee the conservation of the original walls and foundations. A new wall, in the manner of a "dressing", is attached to the open wound. In a later intervention, a gap was made to allow people to pass from one side of the wall to the other, a route that had been consolidated since the loss of part of the wall in the 19th century. The rubble and rubbish on the hill were replaced by planting of pitas and prickly pear cactus.

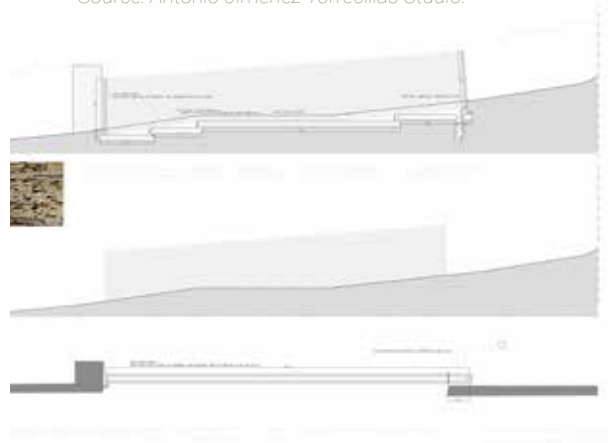
Figure 6. Wall enclosure wall of the wall opening. Section, elevation and plan.
Author: Antonio Jiménez Torrecillas, 2004.
Source: Antonio Jiménez Torrecillas Studio.

- Pink Porriño granite slabs for the new wall.
- Restoration of the cobblestones in the sections where they existed; soft tamped earth paving in the areas lacking paving and stone steps for the steeper sections.

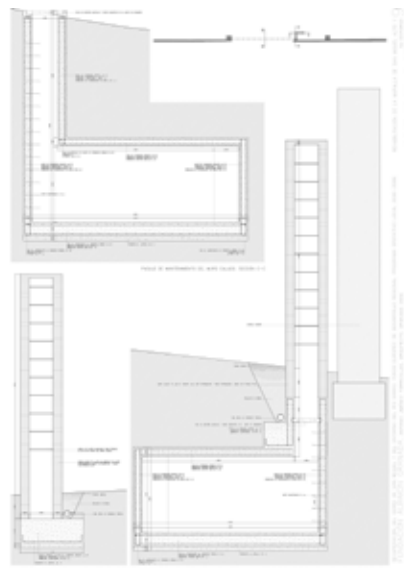
Figure 8. Openwork wall and maintenance passage. Sections.

It prevents the damaging passage of vehicles through the wall, but allows pedestrian traffic between the area outside the walls and the Intramuros area. Initially, the passage was made in a bend, but later it was made with a direct passage. The accesses to the area were also adapted, facilitating communication and relations between the inhabitants of both parts of the wall.

The work of building the new wall, as well as the subsequent opening of the opening, was carried out by hand, trying to alter as little as possible the remains of the foundations of the old fallen wall, and the surroundings.

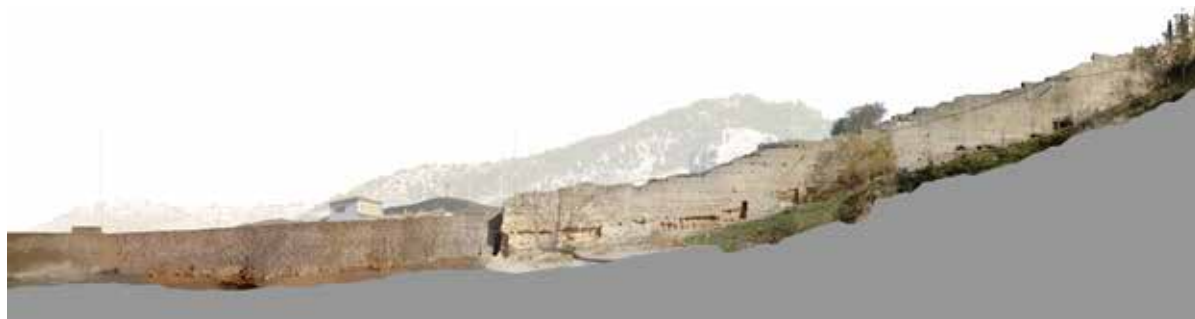
Figure 7. Photomontage of the intramural elevation.
