# SLIDING WEAR RESISTANCE OF SINTERED SiC-FIBRE BONDED CERAMICS

Advanced SiC-based ceramics and fibre reinforced composites are interesting materials for a wide variety of applications involving sliding wear conditions because of their excellent thermomechanical properties. The microstructure and wear resistance of sintered SiC fibre bonded ceramics (SA Tyrannohex) was studied. The material is composed by SiC-fibres in two orientations, with polygonal cross sections and cores having higher carbon content than their surroundings, as observed with SEM. A thin layer of C exists between the fibres. This layer has been found to be a turbostratic-layered structure oriented parallel to the fibre surface. XRD shows that the material is highly crystalline and composed mostly of  $\beta$ -SiC. Unlubricated wear behaviour of the SA-Tyrannohex material when sliding against a  $\text{Si}_3\text{N}_4$  ball in air at room temperature was evaluated. Experiments were performed using a pin on disk apparatus, under different normal loads, 2, 5 and 10 N at sliding speeds of 25, 50, 100 mm/s. A decrease of the friction coefficient with load was found due to the presence of the turbostratic carbon lay

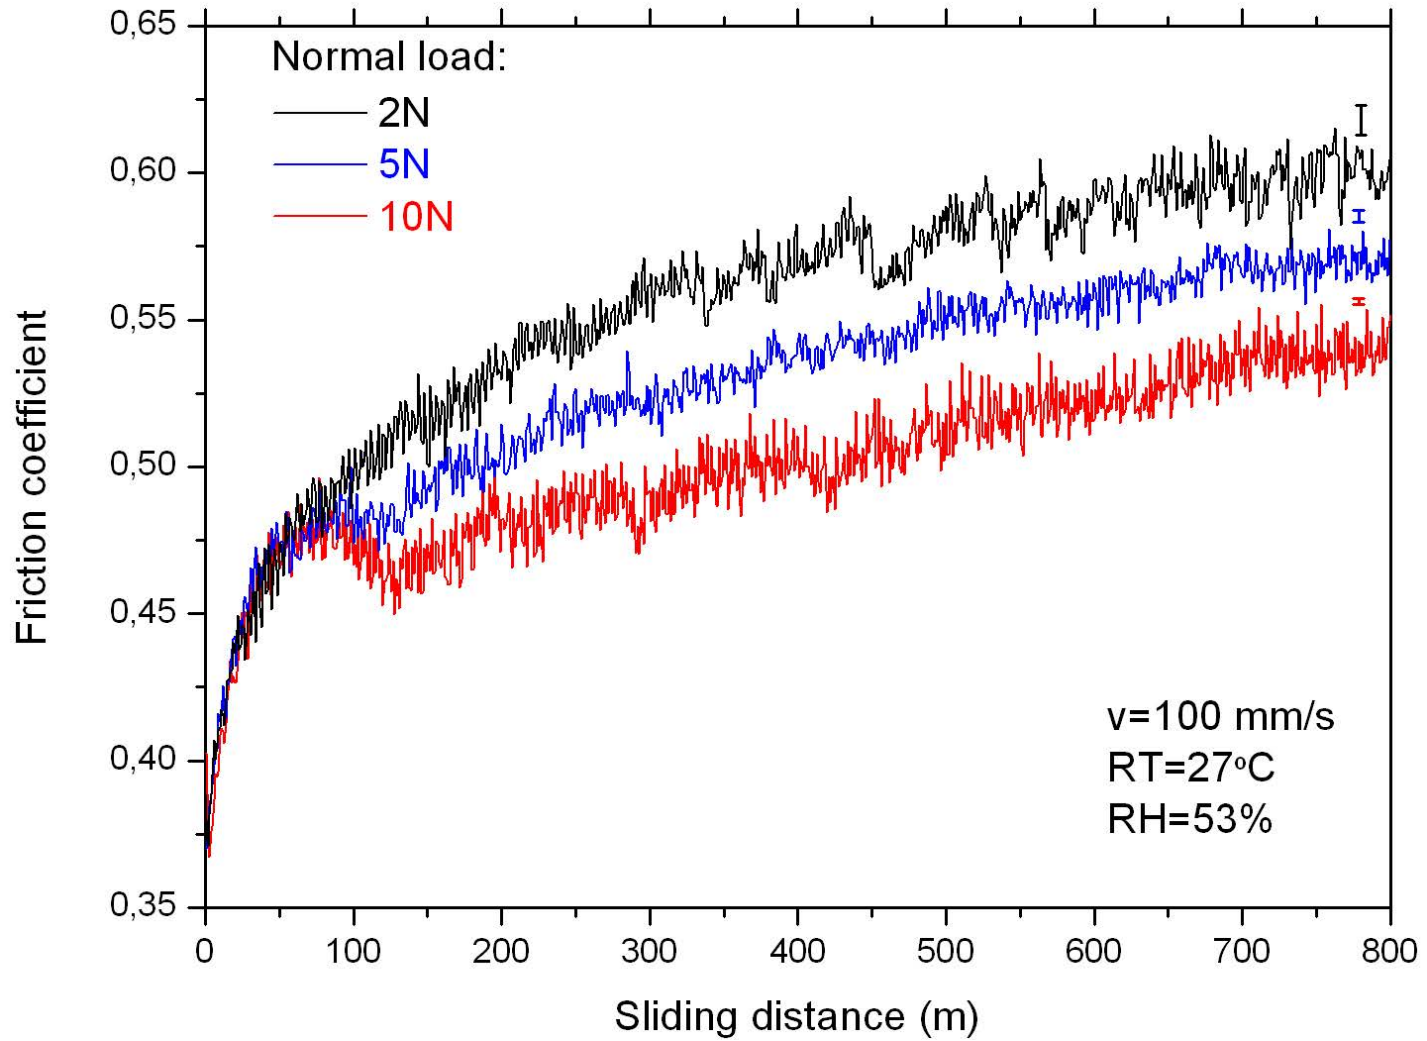
**FIGURE 4**

4. Friction coefficient of the SA-Tyrannohex material against a  $\text{Si}_3\text{N}_4$  ball versus sliding distance under three different applied loads at a sliding speed of 100 mm/s. The value of the friction coefficient decreases with the increase of the applied load.

Figure 4 shows the variation in the friction coefficient of the SA-Tyrannohex material versus sliding distance for the three loads studied where it can be observed that the friction coefficient does not reach a steady value during the tests. This could be attributed to changes in contact geometry during the tests when fibres are fractured, as will be discussed below.. Mean value of the last 20 measurements of the friction coefficient was calculated as  $0.618 \pm 0.009$ ,  $0.570 \pm 0.005$  and  $0.541 \pm 0.007$  for a normal load of 2, 5 and 10N respectively. The response of materials to this kind of experiments

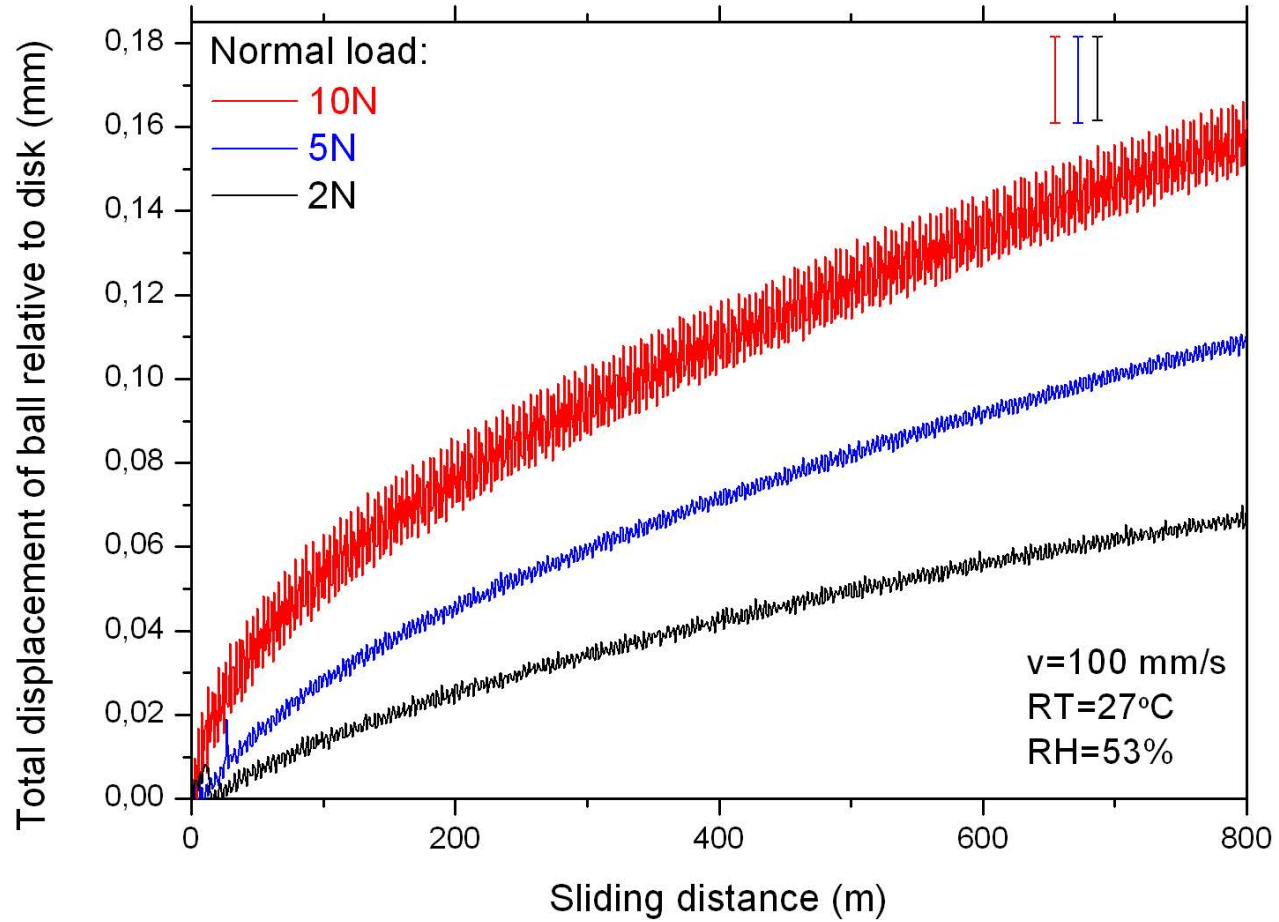
**FIGURE 5**

5. Total displacement of the  $\text{Si}_3\text{N}_4$  ball relative to the SA-Tyrannohex disk versus sliding distance under three different applied loads at a sliding speed of 100 mm/s. The change in the distance between the two triboelements is the sum of the linear wear contributions from both elements.

Figure 5 shows a plot of total displacement of the  $\text{Si}_3\text{N}_4$  ball relative to the SA-Tyrannohex disk versus sliding distance under the different applied loads. The change in the distance between the two triboelements is the sum of the linear wear contributions from both of them (see Figure 1), and increases with increasing load. In an attempt to separate the contribution of each triboelement, balls were observed in an optical microscope. Subtraction of linear wear of the ball to the measurements of the total displacement leads to values of  $\sim 10\ \mu\text{m}$ , which is less than the precision of the displacement sensor ( $\pm 20\ \mu\text{m}$ ). Then, magnitude of wear scar depth of SA-Tyrannohex material is of the order of tens of microns but this technique is not appropriate to quantify it. Apart from this, these measurements does not take into account the fact that the material being removed from a triboelement might also partially be depositing within wear tracks or might be sticking to the counterface. Thus one would actually be measuring only an apparent total displacement between the two triboelements. Finally, that is not a good way to quantify wear. In order to quantify wear rate, surface topography of the disks after the tribological tests was measured with a stylus type

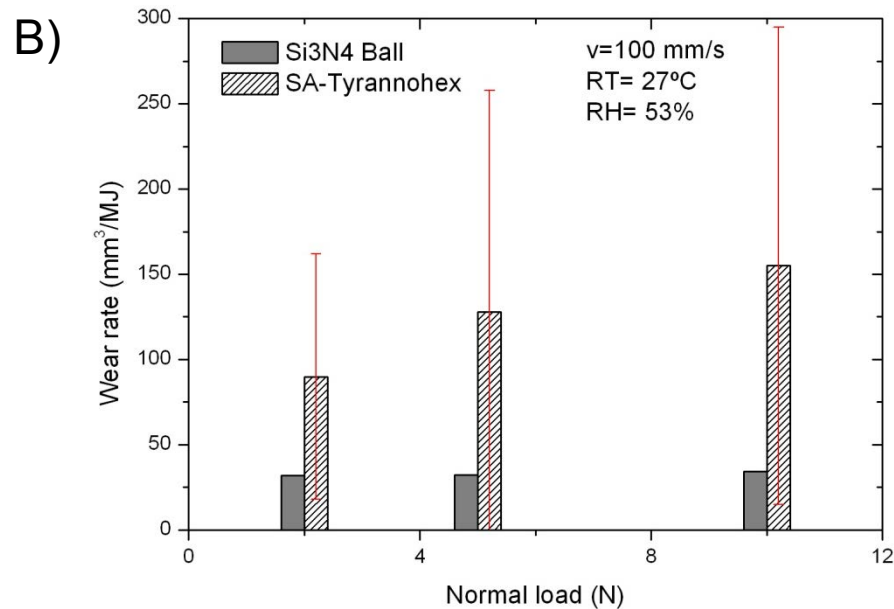
# FIGURE 6

6.a) Surface profile of worn surface of the SA-Tyrannohex material after the tests performed under three different normal loads at a sliding speed of 100 mm/s. Resolution in worn track depth is 1 nm and resolution in distance is 0.5  $\mu\text{m}$ . The worn track depth and width increase with the increase in the applied load. b) Wear rate of the two triboelements versus normal load for the experiments carried out at a sliding speed of 100 mm/s. Wear rate shows no significant dependence with normal load. Wear rate of the  $\text{Si}_3\text{N}_4$  ball is an order of magnitude smaller than that of the SA-Tyrannohex material.

profilometer. Profiles of worn surface of the SA-Tyrannohex material after the tests are shown in Figure 6.a). The worn track depth increases with the increase in the applied load. Ordinarily, a high load implies a high shear stress on the sliding surface which should produce more fracture. This explains the increase in wear with the increase in load if the dominant wear mechanism is microfracture.

Wear rate of the two triboelements versus normal load is presented in Figure 6.b). Inhomogeneity of the microstructure of the SA Tyrannohex material makes the cross section profile of each wear track was highly variable and position dependent. Variation in the profilometer measurements of the worn track depth was  $\pm 10\mu\text{m}$ , due to one more fibre is fractured or not, depending on the position. Worn track depth is the same order of magnitude of the fibres' diameter. This is the origin of the large uncertainty of these measurements. Wear rate of the SA-Tyrannohex material can be considered independent of the applied load when taking this uncertainty into account. No dependence with load is indicative of elastic instead of plastic deformation taking place. Krenkel et al., simulating real conditions of braking systems for C/C-SiC composites [8], found wear rates the same order of magnitude than that of the SA-Tyrannohex,  $\sim 100 \text{ mm}^3/\text{MJ}$ . These values of wear rate are closely related to microstructure of the material. The high fibre volume fraction and the existence of a strictly controlled interphase provides the material with a much higher fracture energy than monolithic ceramics [10]. This structure is effective in preventing the large-scale fragmentation of the material, resulting in formation of small discontinuous fragments and thereby reducing the overall wear rate. Wear rate of the  $\text{Si}_3\text{N}_4$  ball is an order of magnitude smaller than that of the SA-Tyrannohex material but considerable wear occurs due to the fractured SA fibres causing abrasion to the contact surface of the ball.

agreement with the scar depth measured by the profilometer (Figure 6. b)), as fibres are  $\sim 10 \mu\text{m}$  in diameter. In figure 7. f) a fractured fibre is observed. That confirms the dominant wear mechanism of the material is microfracture. In this material, the turbostratic carbon layer between the fibres is easily removed by the friction force and that makes fibres without an interfacial layer to deflect cracks support the high contact stresses until failure. Fischer et al. [18] proposed for  $\text{Si}_3\text{N}_4$  in sliding contact in intermediate humidity air ( $\sim 40\%$ ) wear occurs by a combination of fracture and chemical reactions. In this study, we have used energy dispersive spectroscopy in the SEM to test for the presence of oxidation but we have not observed any tribochemical film on the worn surfaces. If temperatures in the contact area were high enough oxidation of the fibres' surface and/or the free C could occur. In any case, these oxidized fibres will be eventually fractured according to SEM observations, so microfracture and not oxidation will be the main mechanism producing wear. Absence of C between fibres due to oxidation of this interlayer would make fibres' fracture more favourable as explained previously.

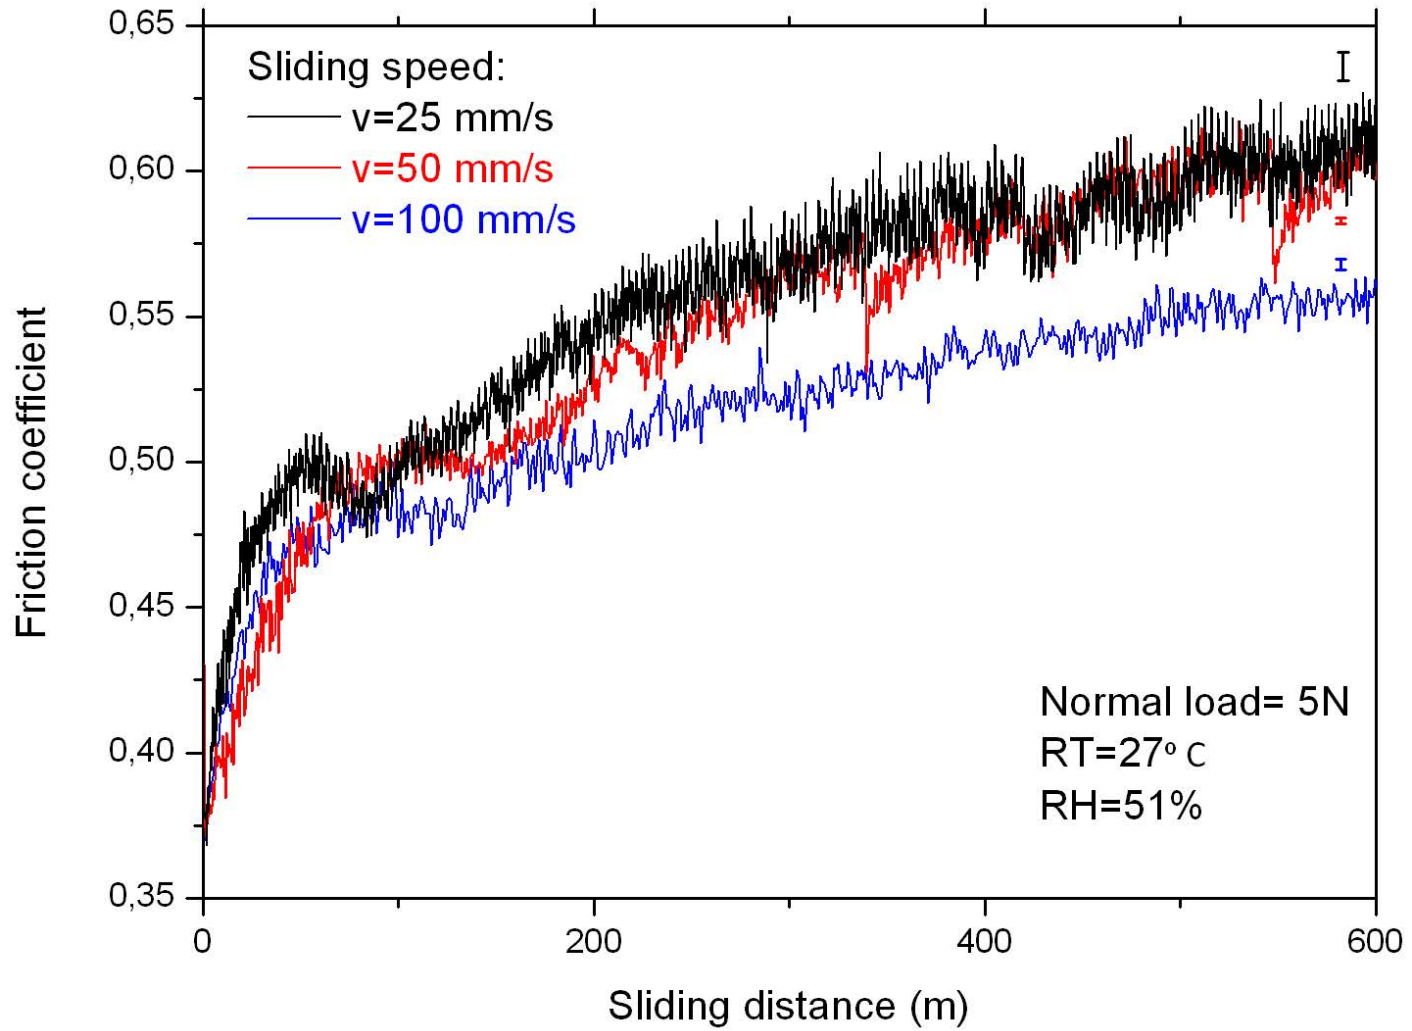
**FIGURE 8**

8. Friction coefficient of the SA-Tyrannohex material against a  $\text{Si}_3\text{N}_4$  ball versus sliding distance at three different sliding speeds under an applied load of 5N. Friction coefficient slightly decreases with the highest speed.

Figure 8 shows the friction coefficient of the SA-Tyrannohex material versus sliding distance for the three sliding speeds tested. Dependence of friction coefficient with sliding distance shows that the lower the sliding speed, the shorter the sliding distance is from beginning to stabilization. The magnitude of the friction coefficient for the speeds of 25 and 50 mm/s are very close and higher than that for the speed of 100 mm/s. Mean value of the last 20 measurements of friction coefficient is  $0.610 \pm 0.009$ ,  $0.614 \pm 0.007$  and  $0.570 \pm 0.005$  for a sliding speed of 25, 50 and 100 mm/s respectively. There are no results in literature for friction coefficient of SiC against  $\text{Si}_3\text{N}_4$  measured in identical conditions as those studied here. For similar tests, results are analogous. A coefficient of friction of 0.6 is obtained by Ajayi et al. [23] for a hot-pressed SiC with a diamond ball as a counter surface, loads between 1 and 30 N and low sliding speeds ( $< 0.1 \text{ mm/s}$ ). When a sliding contact passes a spot on a surface, the temperature on the surface rises due to frictional heating and a rapid cooling down follows due to heat dissipation. The temperature rise will induce thermal strain and therefore compressive stress at the surface. As the sliding speed increases, local temperature elevations at the

wear interface are bigger [24] so fracture induced by thermal shock is more likely. For this reason the friction coefficient might decrease with increasing speed due to material exhibiting less resistance to the sliding ball. In the range of velocities analysed here, the friction coefficient of the SA-Tyrannohex material shows no dependence with sliding speed except a slight decrease with the highest speed, consistent with the data for sintered SiC compiled by Munro [21]. Although high thermal conductivity of the material (77.7-36.4 W/mK in plane and 44.8-23.6 W/mK out plane over RT-1400°C) and relative low thermal expansion coefficient in plane ( $3.20-4.66 \cdot 10^{-6} \text{ K}^{-1}$  over 20-1600°C) might result in high thermal shock resistance and explain no dependence of friction coefficient with sliding speed, fracture induced by thermal shock is a possible wear mechanism due to other factors like high elastic modulus (310-200 GPa over 20-1600°C). It would be necessary to make temperature measurements at the counter surface and further testing at sliding speeds above 100 mm/s in order to find out if there is a critical value of the sliding speed at which thermal shock is an important agent producing wear and causing significant variations in friction coefficient values.

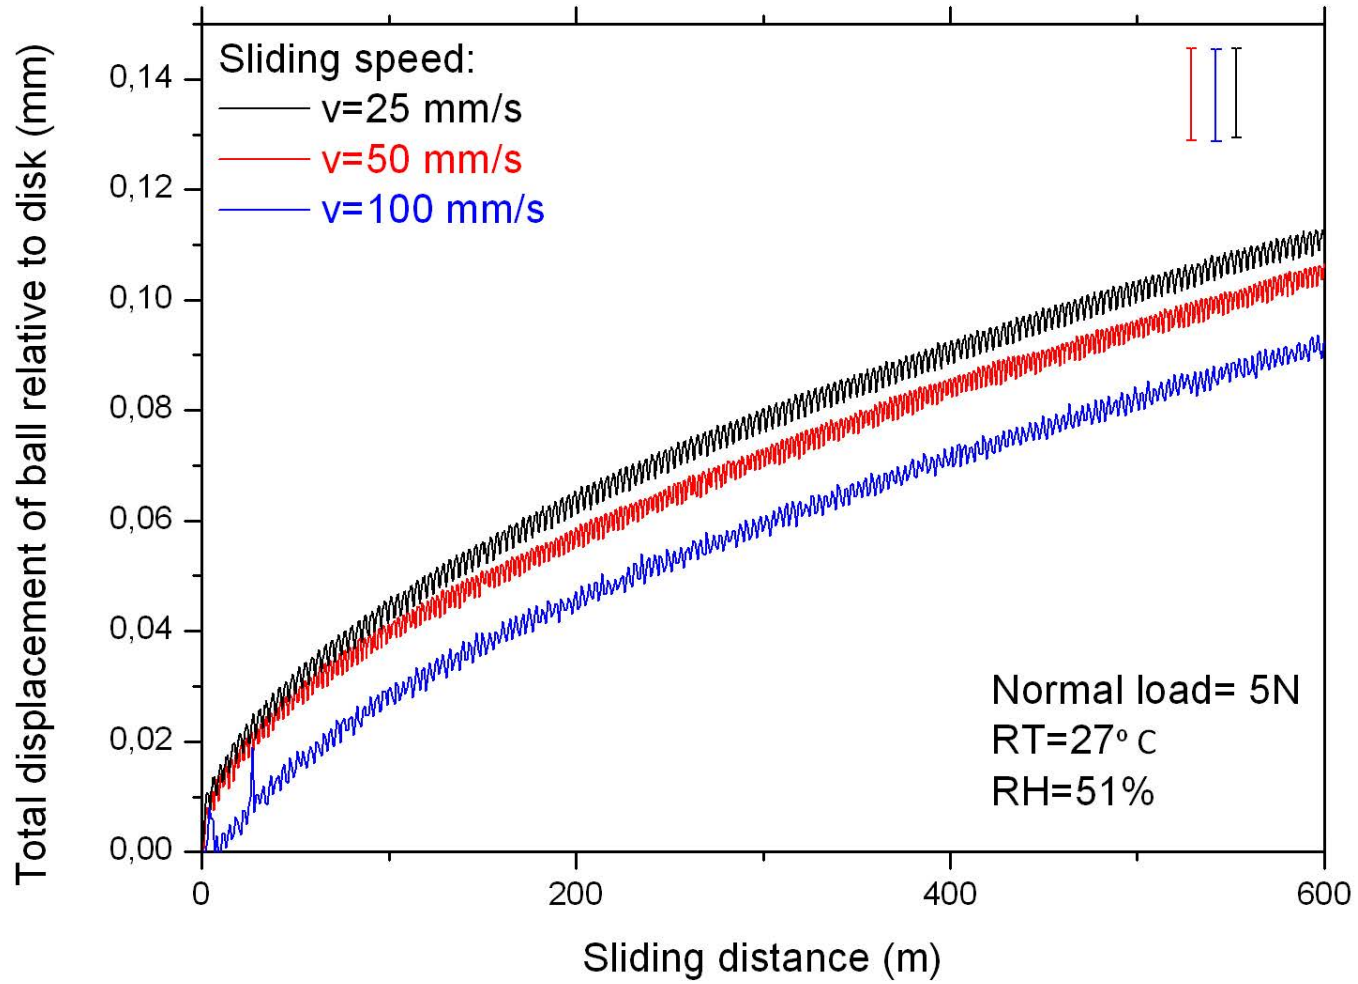
**FIGURE 9**

9. Total displacement of the  $\text{Si}_3\text{N}_4$  ball relative to the SA-Tyrannohex disk versus sliding distance at three different sliding speeds under an applied load of 5N. The change in the distance between the two triboelements is the sum of the linear wear contributions from both elements.

Figure 9 shows total displacement of the  $\text{Si}_3\text{N}_4$  ball relative to the SA-Tyrannohex disk versus sliding distance at the different sliding speeds. This distance decreases slightly when the sliding speed increases but the magnitude of this decrease is smaller than the resolution of the displacement sensor. We can then conclude that the sum of the linear wear contributions from both elements shows no dependence with speed. For the same reasons exposed previously, it is not possible to separate contribution of wear of each triboelement to the change in this distance and it is not a good way to quantify wear. It is necessary to look at the profile meter's measurements to study the effect of sliding speed on wear of the SA-Tyrannohex material. Surface profiles of worn surfaces of the SA-Tyrannohex material after the tests performed under a normal load of 5N show that worn track depths and widths are similar for the sliding speeds of 25 and 50 mm/s and larger for the highest velocity studied(see Figure 10.a)).

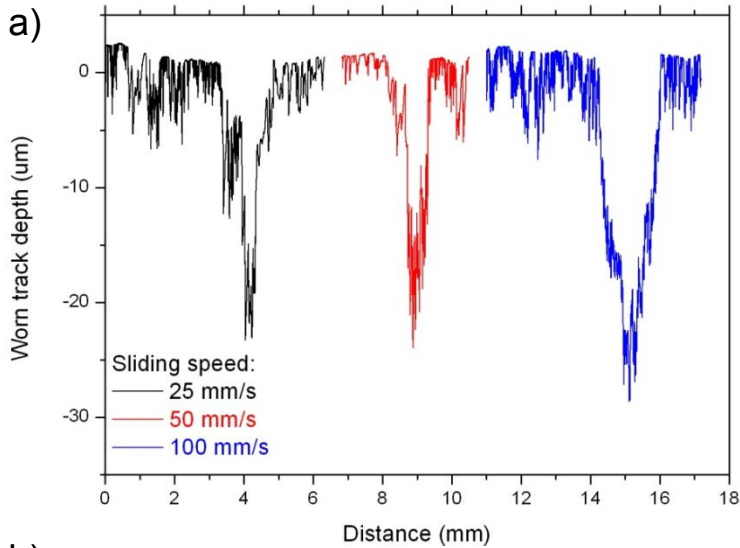
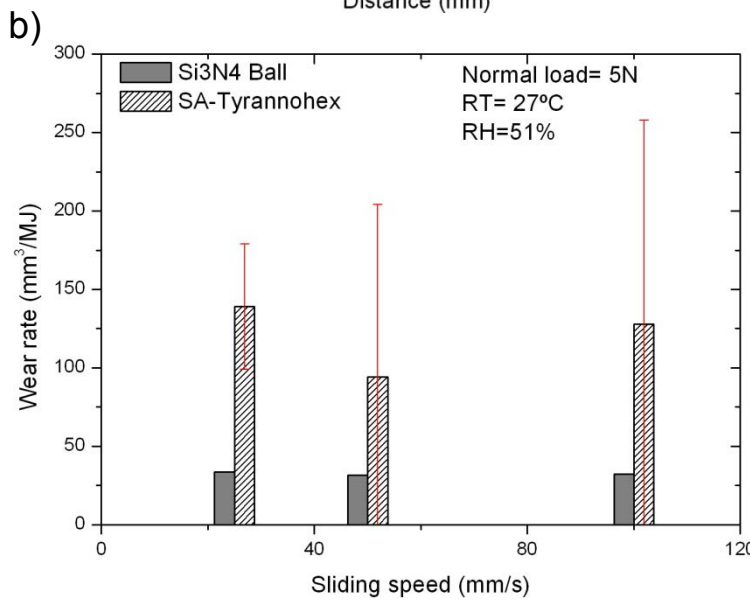
**FIGURE 10**

10.a) Surface profile of worn surface of the SA-Tyrannohex after the tests performed under a normal load of 5N at three different sliding speeds. Resolution in worn track depth is 1 nm and resolution in distance is 0.5  $\mu\text{m}$ . Worn track depth and width are similar for the three different sliding speeds.

b) Wear rate of the two triboelements versus sliding speed for the experiments carried out under a normal load of 5N. Wear rate shows no dependence with sliding speed. Wear rate of the  $\text{Si}_3\text{N}_4$  ball is an order of magnitude smaller than that of the SA-Tyrannohex material. **References**

Wear rate of the two triboelements versus sliding speed for the experiments carried out under a normal load of 5N is presented in Figure 10.b). Uncertainty is due to reasons previously explained. Wear rate of the SA-Tyrannohex slightly decreases when duplicating speed and then increases when increasing speed again, but it can be considered constant with the speed taking the uncertainty in these measurements into account. Slight dependence of wear rate with sliding speed could be due to the hardness
