VOLUME 4 NUMBER 4/5

THE CONSERVATION OF SEVILLE CATHEDRAL.

By Alfonso Jiménez, Maestro Mayor, Cathedral of Seville, Sevilla, Spain.

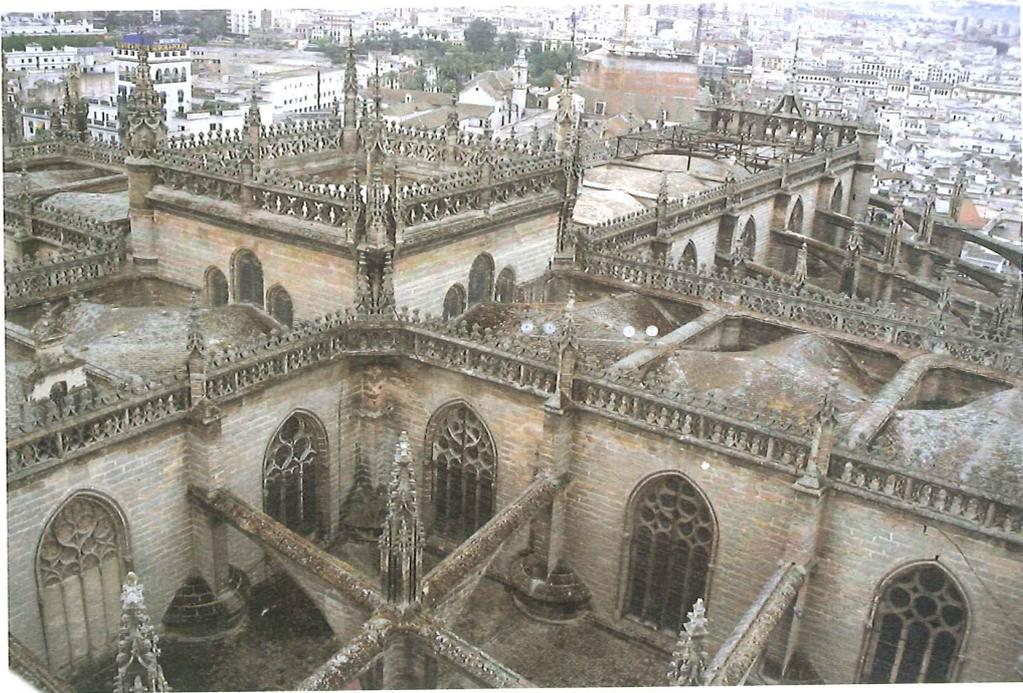
Figure 1 The extensive and flat roof of the Seville Cathedral, the main source of the problems.

The key structural problem of the *Magna Hispalense* is penetration of rainwater during the intensive winter

rains. Massive stone fragments have shed from several tracts, difficult to identify from 32m below. Subsequently, the Gothic vaults were inspected from the platform of a mobile crane, and at present the disintegration caused by the leaks has been mapped. It appears that fissures emerged mainly at the sites of older restorations, where attempts were made to "reinforce" cracks with iron elements. These cracks are either due to earthquakes of which there are no precise records, or simply structural defects in the foundations or the pillars. The corrosion of the iron clamps split the blocks, thus trans-

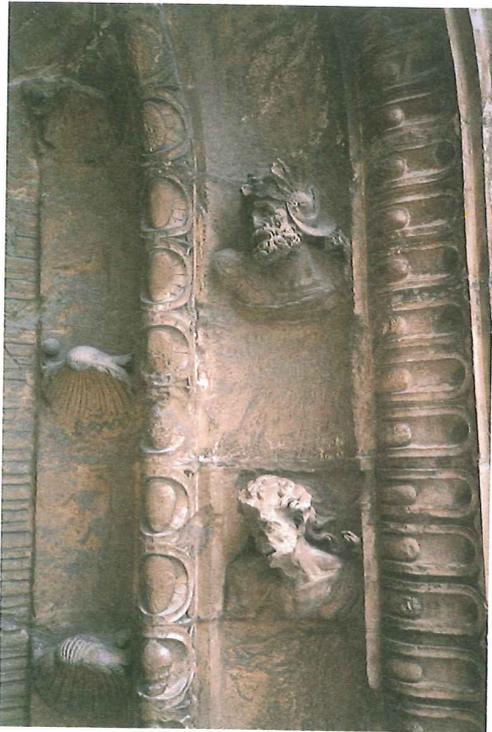
Figure 2 The effects of pollution: typical black-and-white sulphatation phenomena.

rounded off. Thin pinnacles and crests have also become weakened. Air pollution, mainly caused by the exceptionally congested traffic (becoming worse each day), has added black crusts and sulphatation highly apparent in the bright sunlight of Seville. Nevertheless, air pollution, although bestowing a general impression of dirtiness, is currently considered as being a mere accessory when compared to the structural and natural pathologies.
