A procedure to track vibration modes under changing external factors: application to a pedestrian bridge

Soria, José M.¹; Díaz, Iván M.²; García-Palacios, Jaime H.³; Ibán, Norberto⁴; Lorenzana, Antolín⁵

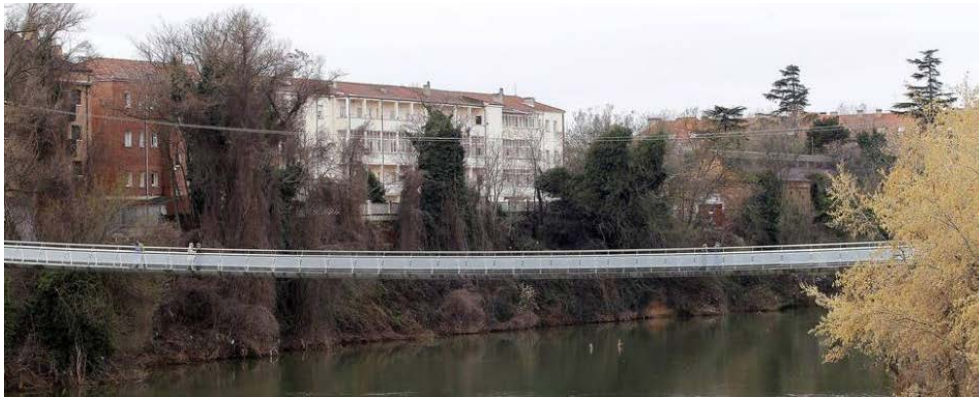
Figure 1. Pedro Gómez Bosque footbridge. Landscape view.

PGB footbridge, sited in Valladolid (Spain), is a slender and lightweight structure that creates a pedestrian link over the Pisuerga River between a sport complex and the city centre (see Figure 1). This bridge, built in 2011, is a singular stress-ribbon footbridge born by a pretensioned catenary-shape steel band with a single span of 85 m that provides minimal impact on the surroundings. The structure mainly consists of a Corten steel band of 94 m long, 3.6 m wide and only 30 mm thick which is pre-tensioned and anchored to the two abutments. The complete steel band is fabricated by welding 8-meter long sheets and a number of 110 precast concrete slabs lay on the steel band [17]. These slabs do not have bearing capacity in such a way that the only structural element is the band. The structure is completed by rubber flooring and a stainless steel glass handrail.

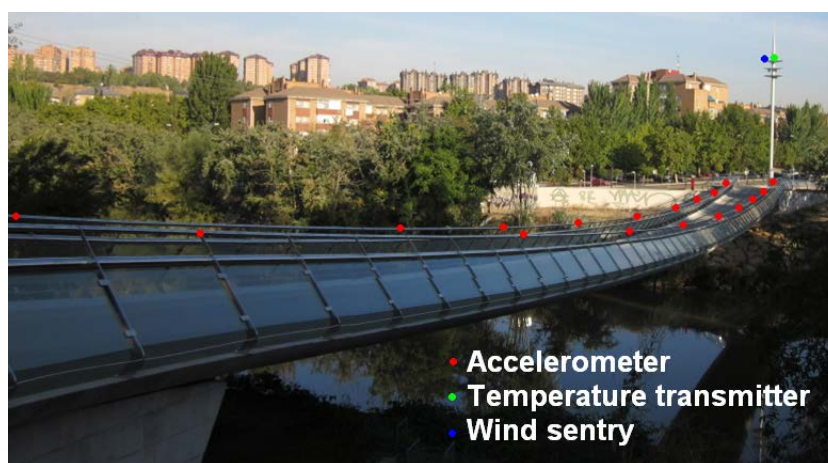
Figure 2. Monitoring system. Distribution of sensors.

capacitors, one to each channel, were placed to fix the frequency bandwidth to 100 Hz. Second, since the accelerometer has to be supplied by 3.6 V to get its maximum nominal sensitivity of 500 mV/g, the power supply unit of 12 V and a voltage regulator to 3.6 V were integrated into each circuit board in order to avoid power losses by the long distance wires. Thirdly, an operational amplifier was used to reduce significantly the output impedance, achieving thus a good signal-to-noise ratio for acceleration parameter (constant sensitivity and low noise). The achieved signal-to-noise ratio was $25 \mu\text{g}/\sqrt{\text{Hz}}$, which was considered to be enough for monitoring the structural vibrations. Finally, each circuit board with all its components was covered with a plastic coating to protect it from environmental conditions. Then, the accelerometers were ready to be installed inside the tube of the handrail. The sensing system was completed by a temperature sensor (model T0110 transmitter of Comet) and a wind sentry (model 03002L of R.M. Young Company) to measure the speed and direction of the wind. The temperature sensor and wind sentry were installed on the public light tower sited closed to the structure (see Figure 2).

The monitoring system then comprises 57 voltage channels that are processed continuously. The data logger CompactRIO 9076 (National Instruments) with two NI 9205 with 32 analog input channels is used for real-time data acquisition. The frequency sampling for each channel was chosen to be 200 Hz, enough to identify the modal parameters of the structure and to avoid aliasing problems during the post-processing. The actual orientation of the accelerometers installed inside the handrail is unknown. However, the Euler angles between the accelerometer coordinate system and the structure coordinate system can be derived taking into account the following: (i) the longitudinal axis of each accelerometer matches with the longitudinal axis of the footbridge, and (ii) the accelerometers are able to measure acceleration due to gravity. Therefore, the transformation matrix between both coordinate systems is obtained, and then, the acceleration in the global axes can be finally calculated [18]. Before its final installation, a laboratory validation was carried out and after the installation, an in-situ validation was performed by comparing against conventional piezoelectric accelerometers.

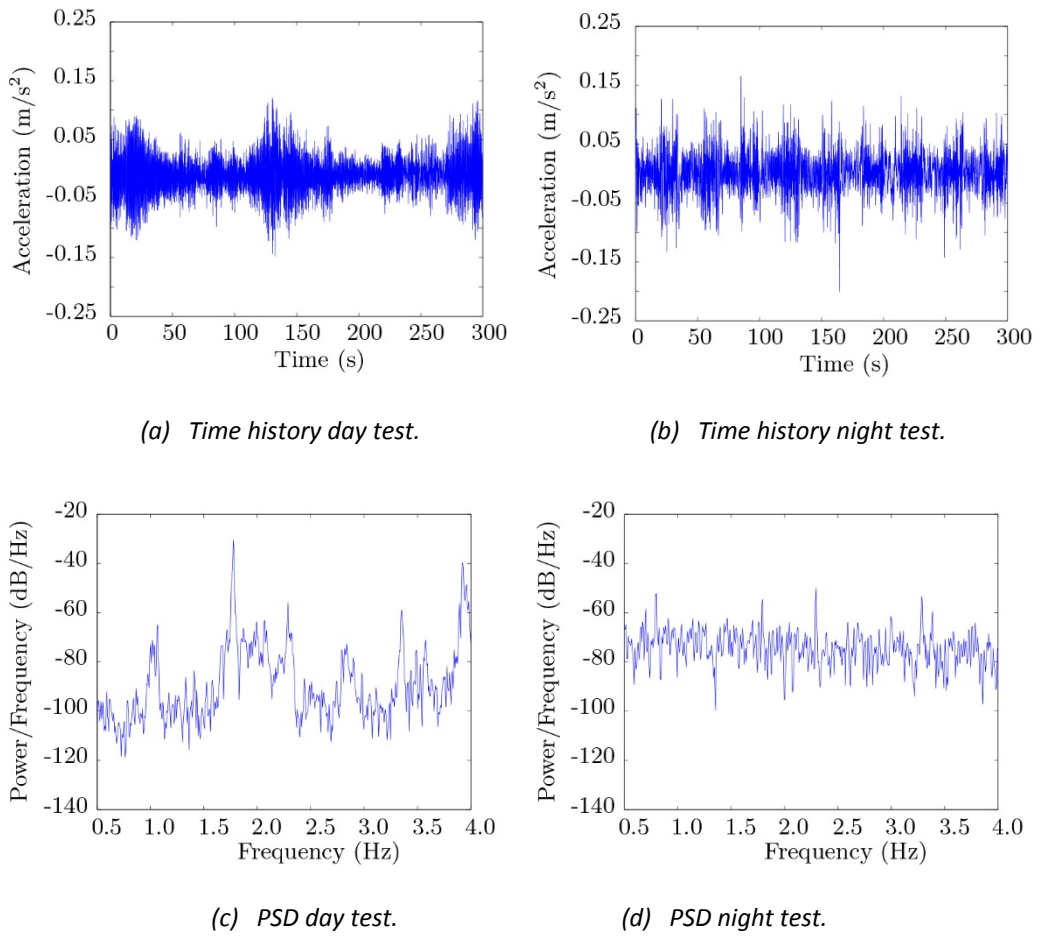
Figure 8. Results at day and night test.

It can be seen that the repeatability of modes is quite lower than total number of tests. Figure 8 shows the time history and PSD results of two tests at day and night time corresponding with 15:00 and 3:00 hours respectively. Although, vibration levels are similar, the frequency contents show significant differences between both tests. We should comment that the signal to noise ratio and the sensitivity of the conditioned sensors is not high, anyway, when the structure is in use, structural vibrations arise and the monitoring system has success in the estimation. Remind that the monitoring system is much cheaper than a conventional one.
