# PROPOSED METHODOLOGY FOR MEASUREMENT, SURVEY AND ASSESSMENT OF VERTICAL DEFORMATION OF STRUCTURES

Jonathan Ruiz-Jaramillo , Emilio Mascort-Albea , Antonio Jaramillo-Morilla , (2016) "Proposed methodology for measurement, survey and assessment of vertical deformation of structures", Structural Survey, Vol. 34 Iss: 3, pp.276 - 296

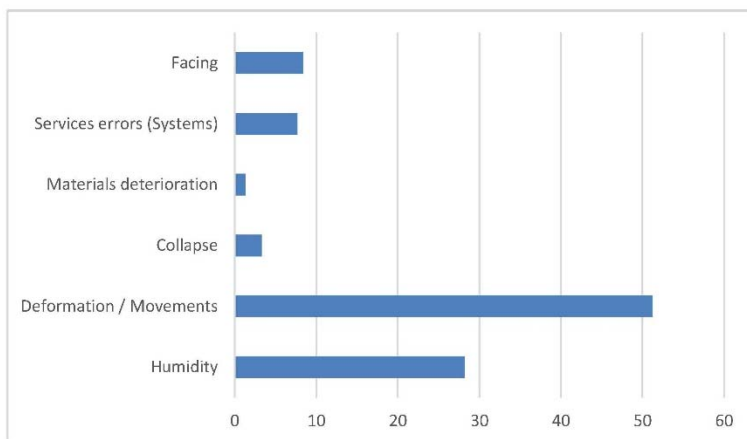
Figure 1. Main causes of building pathology in Spain since 1983 (%).

Several studies of building pathology in different European countries have shown that most damage is due to deformation or movement of the structural system (Harris 2011). Figure 1 (Avilés 2011) presents in detail the statistics of building pathology in Spain over the last 30 years. This dataset, developed by ASEMAS (an insurance company created in 1983 to cover the professional liability of architects in Spain), includes all buildings and structures built in 1983 or thereafter. The analysis reveals that more than 50% of damages claimed on buildings were caused by deformation of the structures or movement of the foundations. These problems are illustrated by the presence of fractures and cracks in structural and construction elements (Watt 2008).

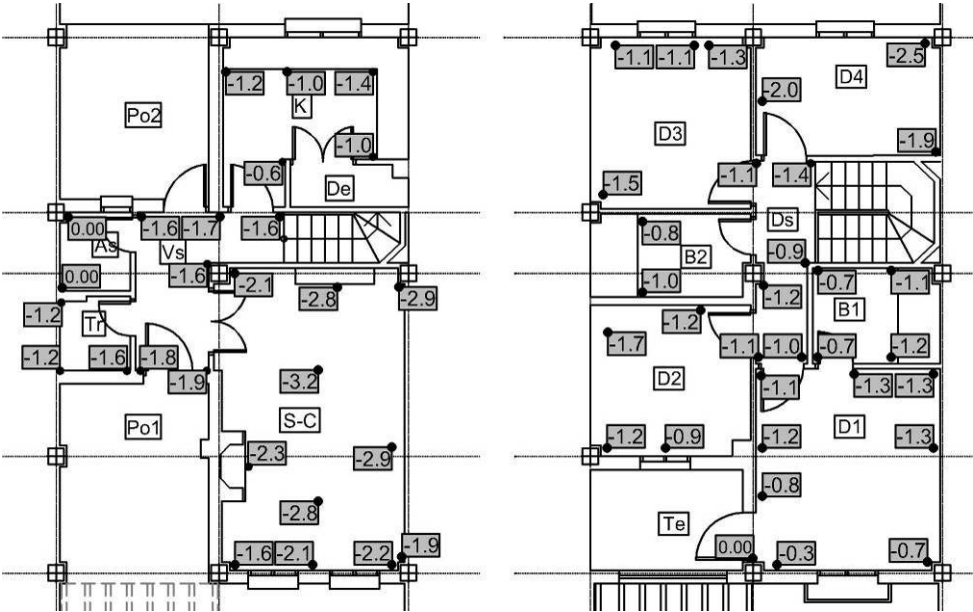
Figure 3. Levelling points and the associated Z-coordinates located on the ground and first floors of a building.

Following this procedure, a  $Z$  coordinate (level) is obtained at each point and this information is shown on the building floor plans (Figure 3). Displaying the information in this way allows a preliminary analysis to be performed and a diagnosis to be made regarding the vertical deformations and angular distortions of the building structure.

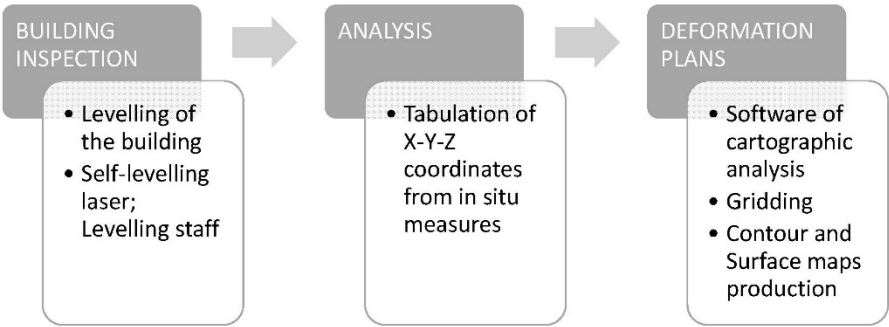
Figure 4. Proposed methodology to obtain vertical deformation plans.

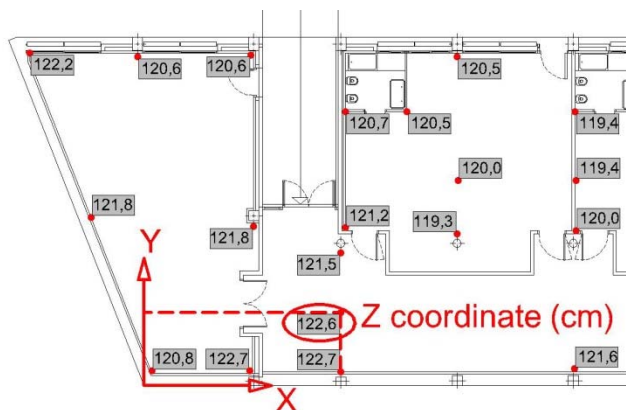
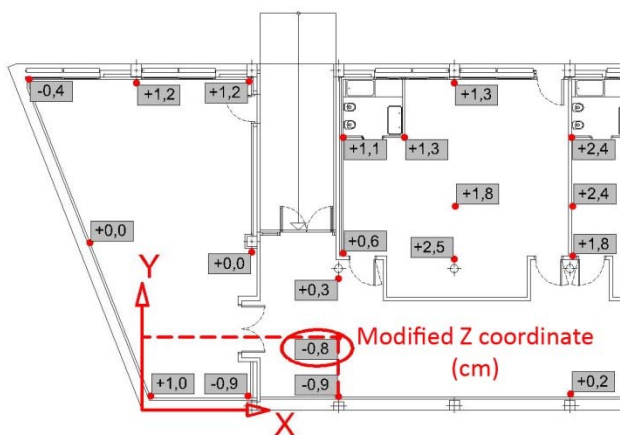
X (m)	Y (m)	Z (m)	Median (Z; m)	Dif. Z (m)
0,2834	0,5067	120,8	121,8	1,0
3,6487	0,5067	122,7		-0,9
6,7837	0,4767	122,7		-0,9
6,7828	4,5691	121,5		0,3
3,7832	5,4832	121,8		0,0
-1,8192	5,7967	121,8		0,0
-3,9218	11,4550	122,2		-0,4

Figure 5.  $X$ - $Y$ - $Z$  data array prepared before application of the cartographic analysis software.

Organizing the data in this way involves the generation of a discontinuous 3D grid in which the points are located at irregular intervals. This means that there is no regular pattern extending over the entire measured floor. In addition, it is not possible to level an infinite number of points, so there will always be areas devoid of data. The software can use this information to create a regular grid linking each  $Z$  value to any coordinate of the new grid using an interpolation method with respect to the original array (Bourges et al. 2012).

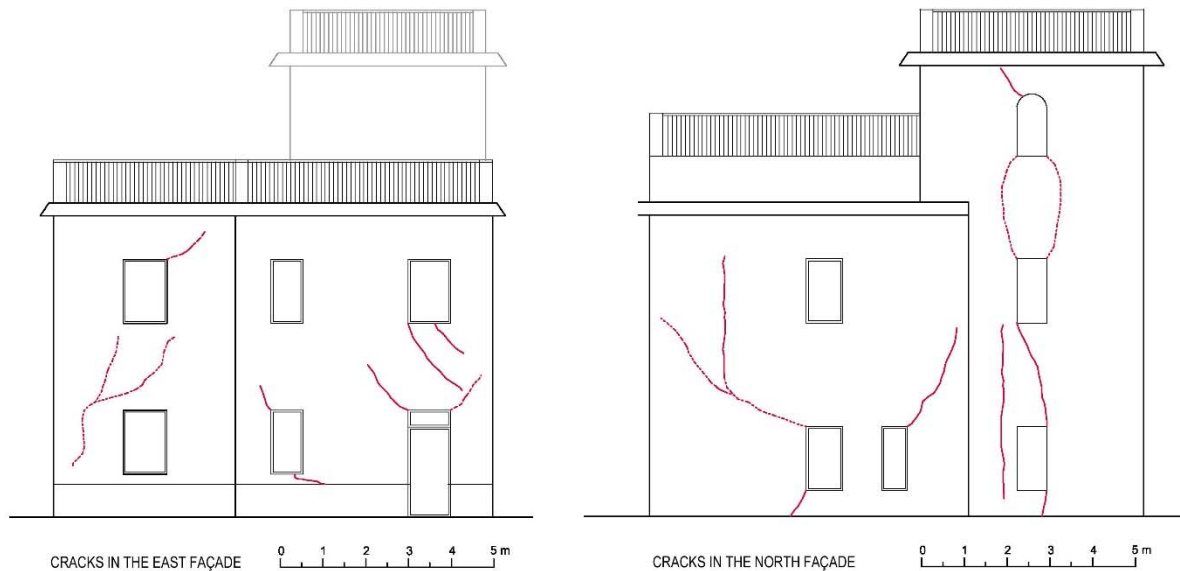
Figure 6. Maps of cracks in the east and north façades of the building.

The damage suffered by the single-family house in this study was mainly revealed by cracks in both exterior and interior walls (Figure 6) (Jaramillo-Morilla & Pérez-Murillo 2011).

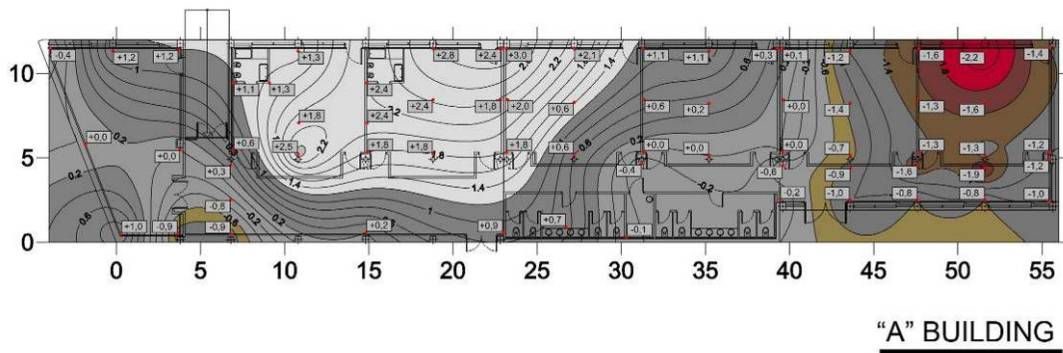
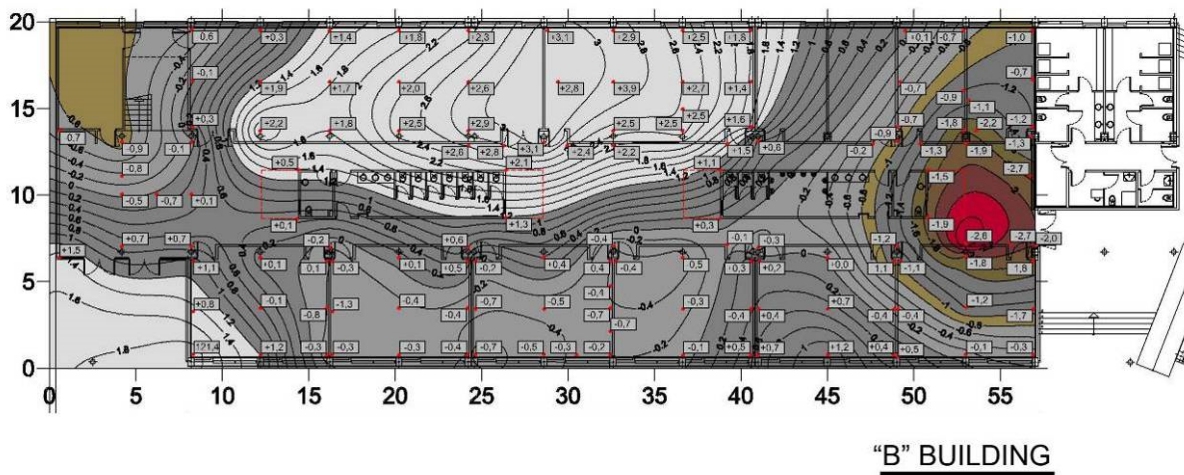
Figure 8. Ground-floor vertical deformation maps (contour maps) of the buildings forming the school complex. The areas with greatest movement are shown in red.

These maps clearly show those areas that suffered the greatest vertical movements (red) and, in contrast, those where this displacement was less than 1.0 mm (white). From these maps, 3D deformation sketches were generated (Figure 9).

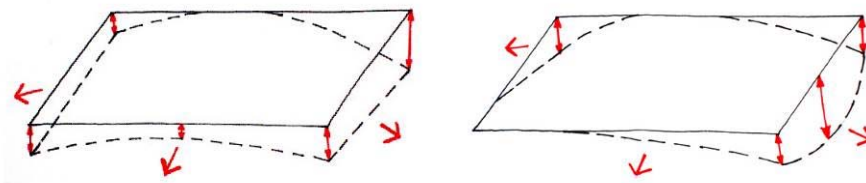
Figure 9. Sketches of deformation of the ground-floor slabs in buildings A and B produced from vertical deformation maps.

The results show that building A had subsided on its opposite sides, with differences of 3.9 cm in the southwest façade and 5.2 cm in the northeast façade with respect to the geometric centre of the floor.

Building B had also settled on its opposite sides, with the differences in this case being 4.0 cm

(southeast façade) and 6.6 cm (northwest façade). From this analysis, it was concluded that the building pathology was the result of differential settlement of the foundations. To determine the causes of this settlement, an analysis of the topographic plot levels was carried out, comparing the initial and final contour maps. The analysis revealed that the main reason for the settlement was insufficient compaction of the infill soil. This analysis also made it possible to dismiss other hypotheses that had initially been considered, such as expansion of clay in the soil (Potts & Higgins 2004).

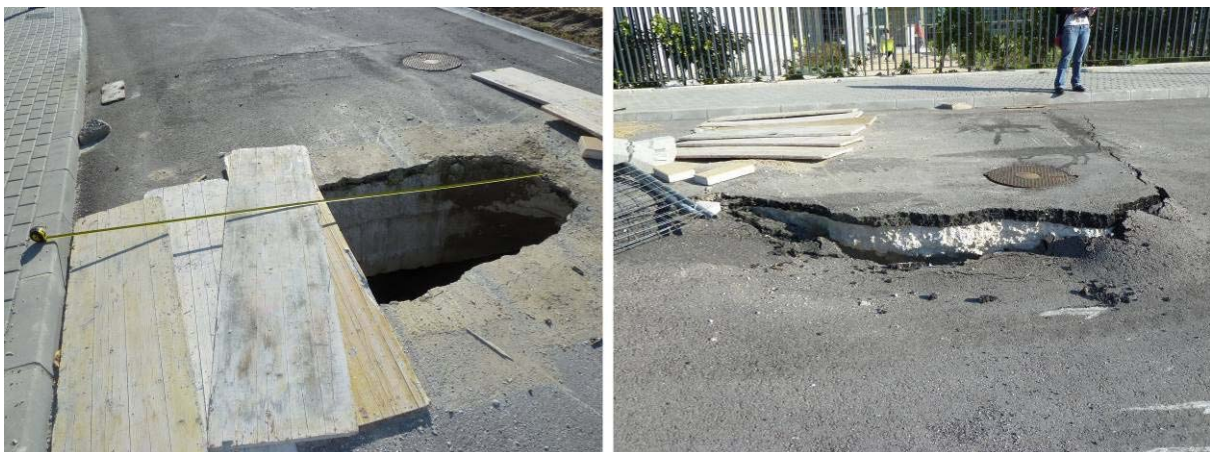
Figure 10. Damage arising from soil subsidence in the exterior area around the building and on the perimeter access roads.
