Repair of the Church of La Purisima Concepcion of Huelva (Spain) with Jet-Grouting, for Damages Caused by the Construction of Diaphragm Walls in its Proximity

REPAIR OF THE CHURCH OF LA PURISIMA CONCEPCION OF HUELVA (SPAIN) WITH JET-GROUTING, FOR DAMAGES CAUSED BY THE CONSTRUCTION OF DIAPHRAGM WALLS IN ITS PROXIMITY

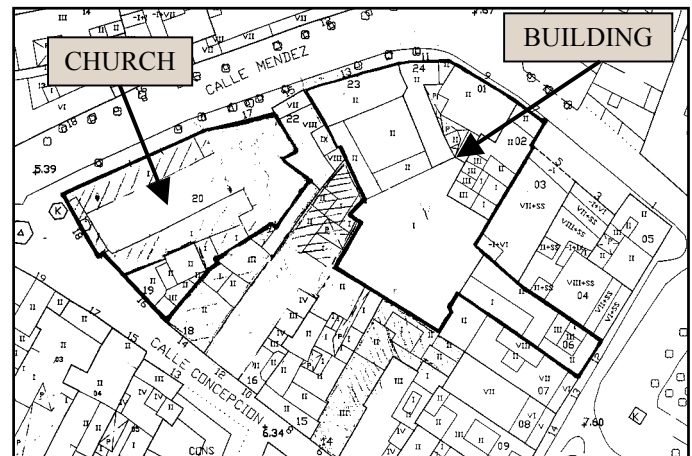
Fig.4. Situation

Because of the movements of the walls there had been differential settlements in the supports of the church, and the parochial buildings, and many cracks appeared in the walls.

The damages caused by the movements of the walls by failures of the provisional struts have been increased by the modifications of the water table, and the changes in the soil parameters.
