# Structural Analysis of La Giralda's 16<sup>th</sup>-century Sculpture/Weather Vane

## **Abstract**

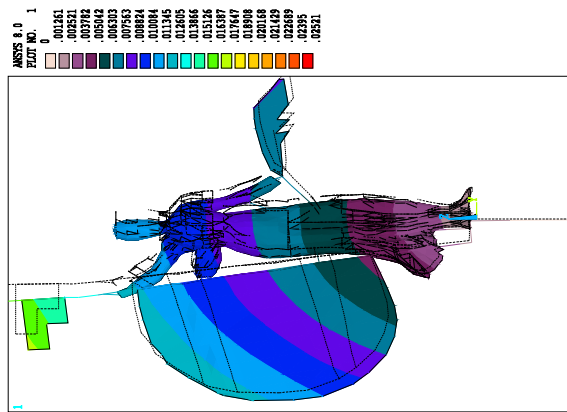
Fig. 15 Representation of the total displacement (in metres) from the effects of its own weight (the image after deformation is superimposed on the contour image of the figure before it was deformed). The imbalance towards the standard (right side) can be clearly observed.

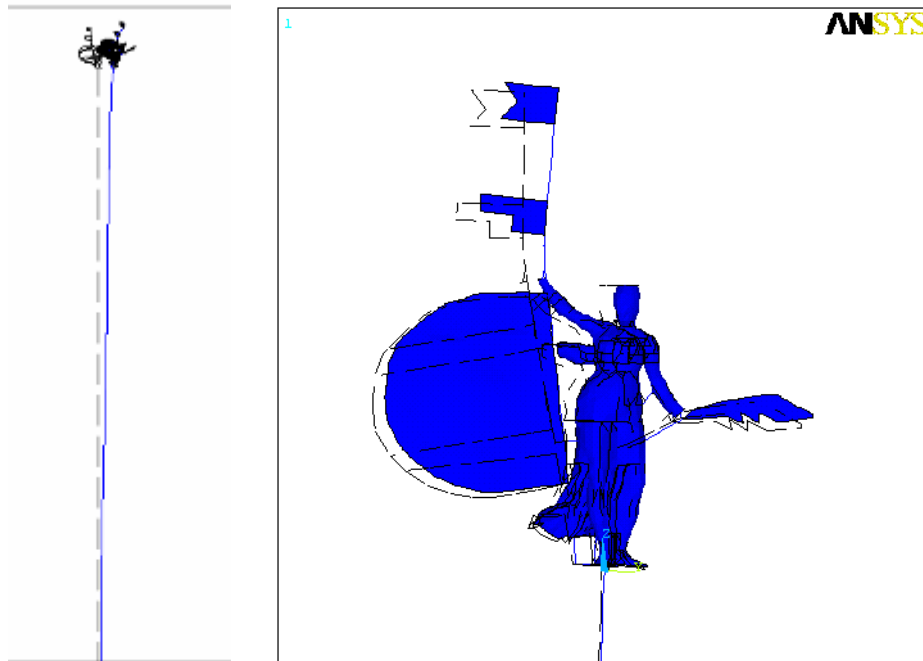
It was also determined that a high-speed wind (45 m/s) hitting the Giraldillo laterally causes lower mechanical stress than a lighter wind (11 m/s) striking it frontally (Fig. 18). Therefore, beyond the issue of preserving the Giraldillo's function as a weather vane, the conservation effort also proves to be important to minimise wind-generated stress. The bending and torsion moments predicted in the axis with the numerical model (579 Nm and 2,581 Nm respectively) matched the experimental results (600 Nm and 2,747 Nm, respectively) obtained before the restoration process began with strain gages attached to the axis and wind-speed readings taken simultaneously [10].

Fig. 18 Von Mises equivalent stress map (0-50 MPa) observed under the conditions of an 11m/s headwind.

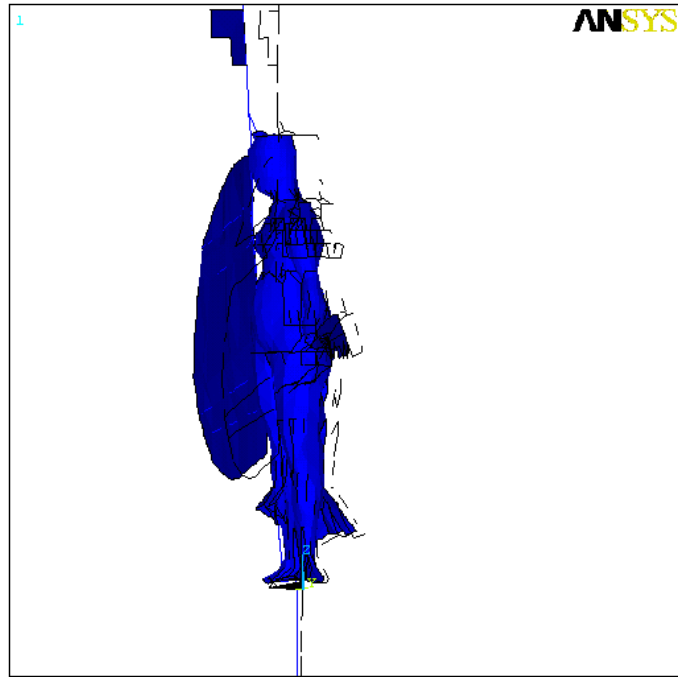
The deformed shape of the Giraldillo under lateral and frontal seismic excitation are shown in Fig. 19 and Fig. 20, respectively. These deformed shapes are almost identical to the first two vibration modes of the Giraldillo alone from a qualitative point of view. The contribution of higher modes to the seismic spectral response analysis is almost negligible.

Fig. 19 . Deformed shape under lateral seismic action
