# Exterior Brick Walls: Learning Nonquality through Failures and Climate-Pathological Distribution

**Abstract:** The object of this research was to identify the list of climatological variables involved in the appearance of construction failures in the external walls of dwellings through the analysis of over one thousand cases. The data source used consisted of the judicial records of the Justice Administration, a source to which few researchers have access, given the dispersion of the data and the permissions required to access it. Once obtained, all situations pertaining to dwellings were read and annotated, until 100% of the cases were accounted for, and percentages of recurrence were calculated for each of the nine different types of failures that were described. A study was carried out by so-called *strips of climatic location* according to four climatological variables (situation, latitude, climate, and annual rainfall) that were sorted from largest to smallest to obtain the *ranks of pathology concentration* according to the resulting preponderance. Using these results, technicians will be able to identify the most problematic climate-geographical areas by determining the r

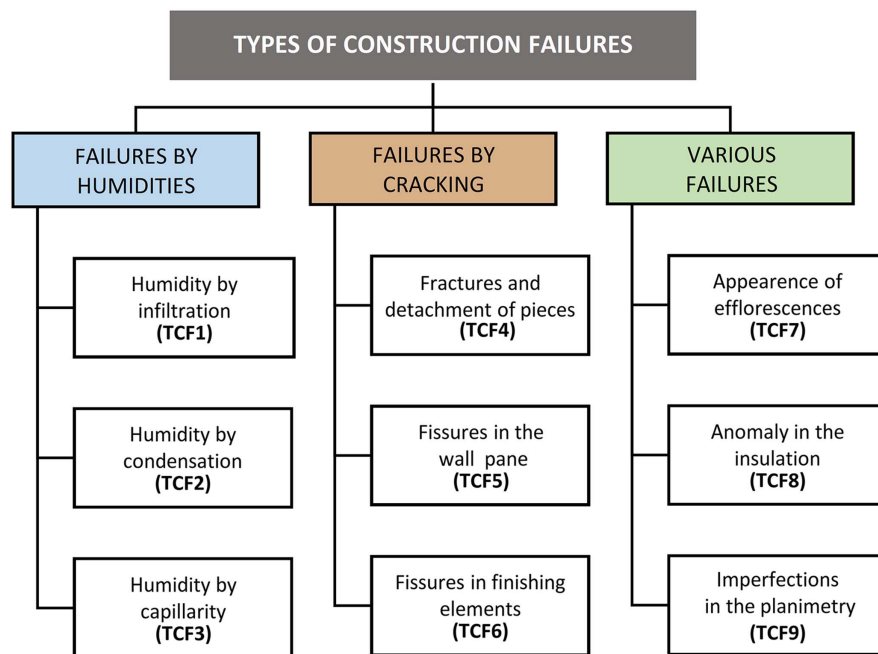
**Fig. 1.** Types of construction failures found.

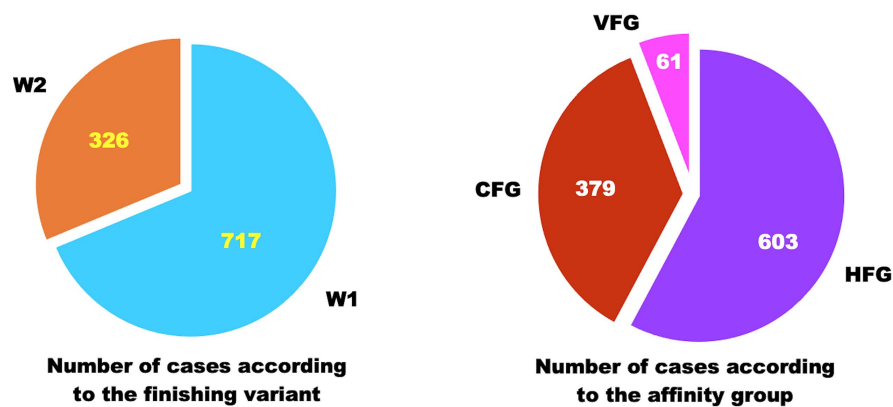
**Fig. 2.** Distribution of cases according to finishing variant and affinity group.

for over two thirds of the total (W1 = 68.74%; 717 cases), while facing walls do not reach one third of cases (W2 = 32.16%).

Note that on the right side of Fig. 2, the affinity group with the highest reoccurrence is HFG with 58% of the total (603 cases), followed by CFG with 36% (379 cases).

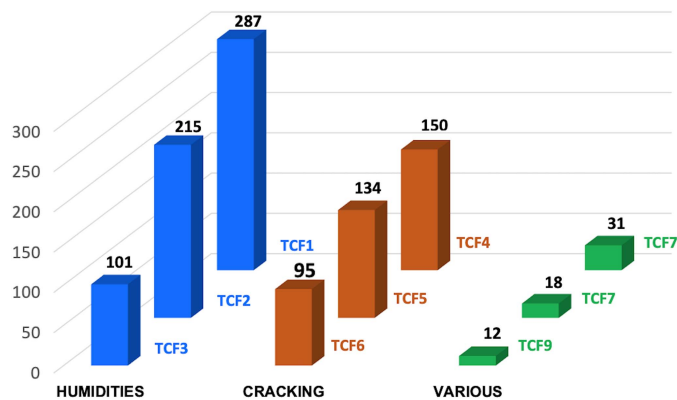
Fig. 3 shows the number of cases found for each of the nine types of construction failure. The type of failure with the most cases was humidity by infiltration (TCF1 = 287), which represents 27% of the total. This was followed by humidity by condensation (TCF2 = 215) and fractures and detachment of pieces (TCF4 = 150).

Fig. 3. Number of cases by type of construction failure.

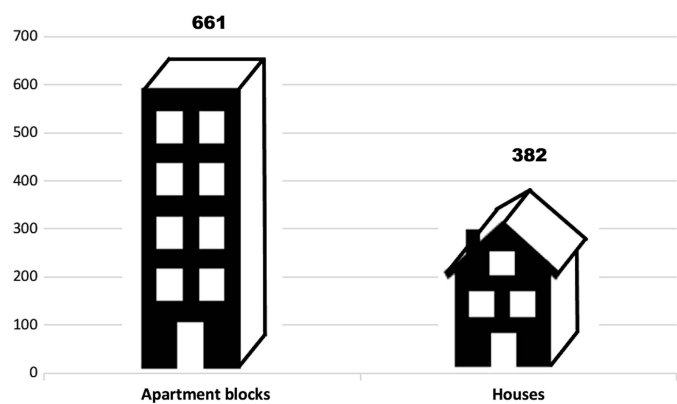
The cases were broken down according to the dwelling typology in which they occurred (Fig. 4). Most (nearly two thirds) of the time, failures were concentrated in apartment blocks (689 cases). Just over a third occurred in houses, whether detached or attached

to other houses. It should be noted that these general values are in accordance with the dwelling typology built in Spain, where there is a clear preponderance of apartment blocks.

Fig. 4. Number of cases according to dwelling typology.
