Integration of disciplines in the structural analysis of historical constructions. The Monastery of San Jerónimo de Buenavista (Seville-Spain)

Abstract

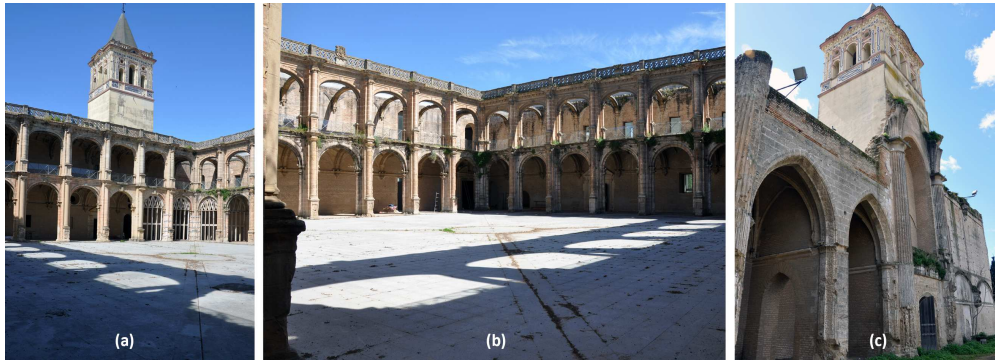
Figure 1: Views of the current state of the Monastery of San Jerónimo de Buenavista, Seville, Spain: (a) North and East wings and tower; (b) South and East wings; and (c) remains of the cloister church and the tower.

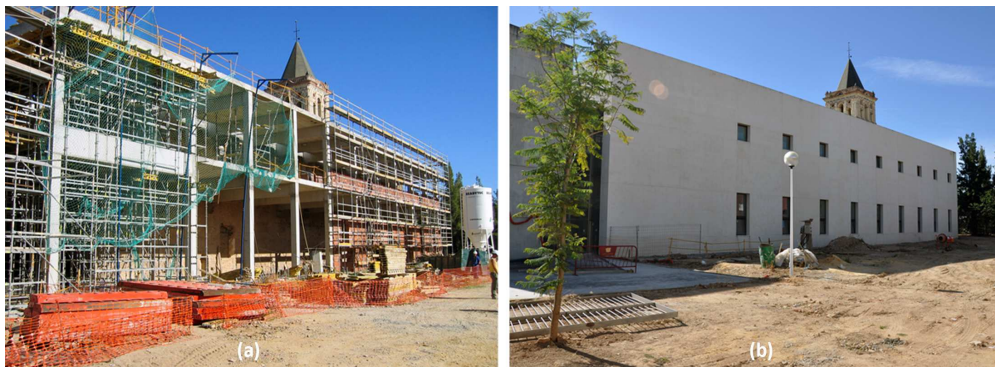
Figure 2: Views of the civic center (a) under construction (2012) and (b) in service (2013).

67 After the construction of the new building, the existing damage in the cloister increased and it
68 became urgent to assess the state of the entire complex. The Monastery is a building of significant
69 size and it has a complex nature due to the numerous alterations it has suffered over the course of
70 history, all of which have visibly affected its structure. However, this also enables the possibility of
71 detecting localized deficiencies, making the Monastery a relevant case study to apply and validate
72 the new approach of increasing the accuracy of a structural model by integrating information
73 obtained from NDTs and MDTs.

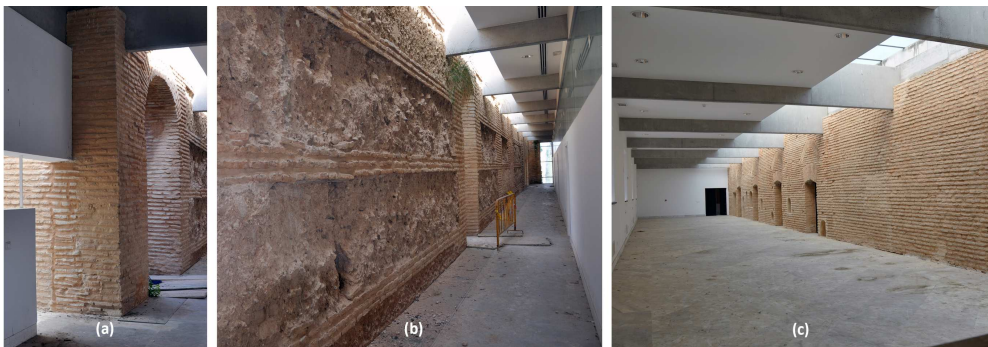
Figure 5: New building structure: (a) resting on the ancient one; (b) east wing; and (c) south wing.

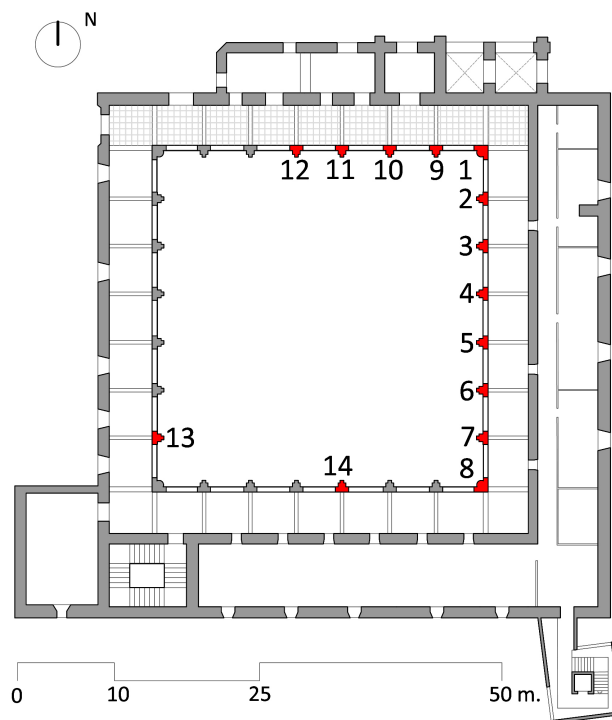
Figure 9: Location of inspected columns.

212 On the other hand, 10 columns (1-4 and 9-14) were inspected by means of high-resolution
 213 seismic tomography with the aim of detecting excessive material degradation. Two horizontal
 214 planes of each of these columns were studied, at heights +0.70m and +2.00m. The velocity models
 215 obtained present values typical of the calcarenite stone that they are made of, that is, between
 216 1000 and 2000m/s [15]. However, the tomograms show velocities that are generally lower at inferior
 217 levels (Fig. 11). Likewise, at the same heights, velocities that are considerably lower (in the order
 218 of 30%) in the columns of the northern wing in comparison with the values recorded for those on
 219 the southern wing [15]. These results show that there is more material degradation and, therefore,
 220 a reduction of capabilities in the areas with a lower associated propagation velocity. There is one

The calcarenite stone used for the columns of the cloister was extracted from a nearby quarry (the quarry of San Cristóbal, in El Puerto de Santa María, Cádiz). This type of stone has a very high porosity, typically about 32-39% [22, 23]. Likewise, this stone is characterized by a significant degradation of mechanical properties under increasing water content [16]. This is why the moisture content of the cores of a total of 8 columns at two different heights was obtained: +0.70/0.90 m and +2.00 m. By analyzing the results obtained from these *in situ* tests, it is possible to state that the moisture content at the lower part of the columns is higher in every case, with an average value of 30%, reaching up to 70% in columns 1 (northern wing) and column 14 (southern wing).

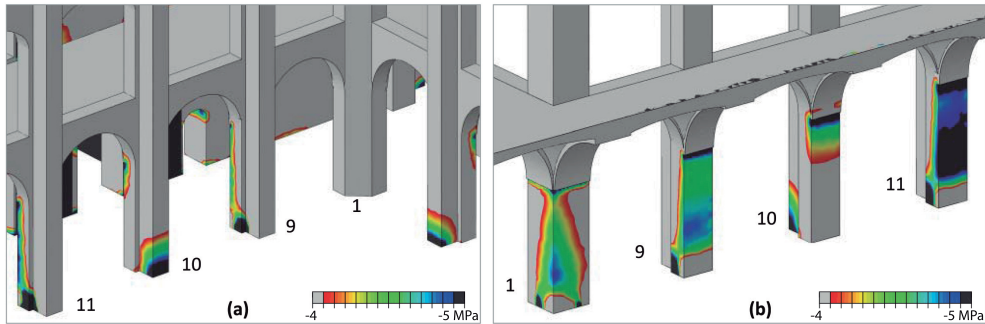
365 With respect to the boundary conditions, initially the movement of the nodes situated at
366 the base of the supports was considered fixed. However, given the differential settlements detected
367 during the surveys (section 3.2.3 and Fig. 13), a preliminary linear analysis of the model was carried
368 out in order to assess the influence that considering these settlements would have on the results.
369 This study revealed that taking into consideration these settlements in part of the supporting
370 surface area of the columns was relevant to the analysis, since it entailed significant changes in
371 their structural behavior. Figure 15 shows the results from this preliminary study from a qualitative
372 point of view. In this study, only columns 1,9 and 11 were subjected to the mentioned settlement
373 by an imposed downward displacement of 2cm, while the base of column 10 was completely fixed.

374 As it can be observed, the consideration of the settlement along half the base of the column implies
375 changes in the position of the more compressed areas on the column. Thus, in column 10, the
376 highest compressive stresses are found in the lower areas of the outer face and in the upper areas
377 of the inner face, while the highest compressive stresses of the rest of the columns are located
378 along the inner face. In correspondence with results from archaeological inspections (section 3.2.3)
379 and taking into consideration the results from the preliminary linear analysis mentioned above,
380 differential settlements as those described were considered in the model at the base of columns of
381 the northern wing. Thus, nodes at the half-base of each column that were next to the gallery were
382 considered fixed, while those of the other half counted on imposed downward displacements. The

Figure 15: Exterior (a) and interior (b) views from preliminary model with differential settlements only on columns bases 1, 9 and 11. A different structural behaviour of column 10 (without settlement) with respect to the other columns can be observed regarding compressive stresses.

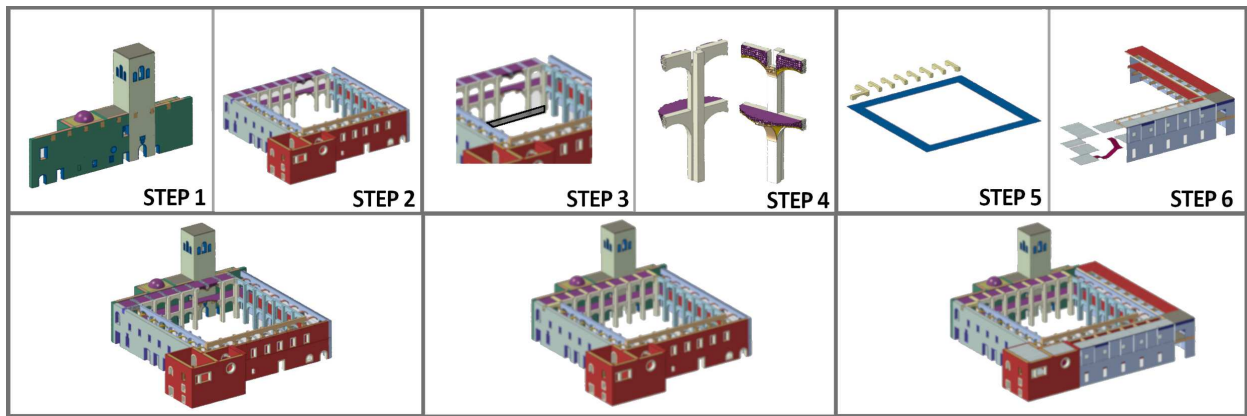
471 In addition, as mentioned, the monastery was built over the course of a drawn-out period and
 472 has been subjected, throughout its history, to unique milestones, such as the loss and reconstruction
 473 of one of its columns. Therefore, the results extracted from a model defined by construction phases
 474 with staggered increases of stiffness are of greater value. These phases have been defined according
 475 to the information provided by the archaeological studies of the monastery [28]. Figure 18 defines
 476 the 6 steps that have been taken into consideration as phased analysis.

Figure 18: Construction phases taken into consideration in the analysis: STEP1, tower, staircase and chapels; STEP2, preserved elements of the cloister without the column lost during the earthquake; STEP3, differential settlements in the columns of the northern wing; STEP4, inclusion of the reconstructed column; STEP5, concrete beams and slabs introduced in consolidation works; STEP6, inclusion of the new building.
