Research Article

Operational Modal Analysis: A Tool for Assessing Changes on Structural Health State of Historical Constructions after Consolidation and Reinforcement Works—Jura Chapel (Jerez de la Frontera, Spain)

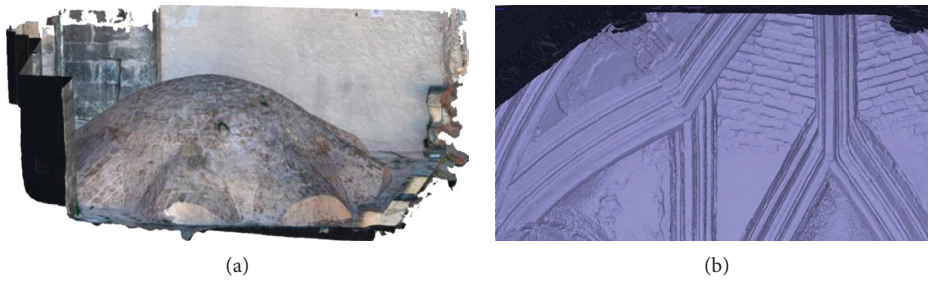
FIGURE 8: Geometric model using the photogrammetric technique.

- (1) Before intervention, the chapel vault counted on a specific deformation state, so a geometrical model built from coordinates based on a theoretical geometry would not be accurate. In order to improve the identification of the dynamic properties, a photogrammetric model [18] was developed to precisely determine the XYZ coordinates of the accelerometers' position (Figure 8). From this model, it could be confirmed that the difference between theoretical and original coordinates reaches up to 6 cm.

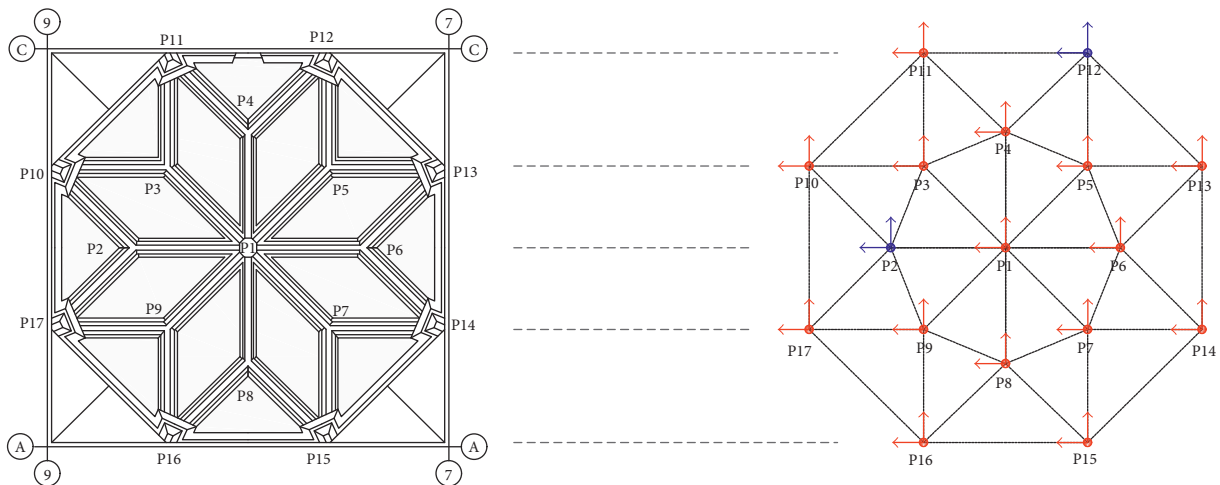
FIGURE 10: Accelerometer locations and directions on the intrados.

Regarding the sensor layout, it can be seen in Figure 10 that the total number of measuring points in each

experimental campaign is 17. All of these points were set in the three principal directions in order to also capture the global vibration modes of the vault in the longitudinal, lateral, and vertical direction. As the total number of accelerometers was six and considering that two of them were held stationary for reference measurements, a series of nine setups in each stage were necessary to cover all measuring points. In each one of these setups, the accelerations were recorded with a sampling rate of 100 Hz and a sampling time of 12 min. The measuring points that correspond to the ambient vibration tests from the extrados are analogous to those in Figure 10. Their coordinates are the result of the normal projection of these last points on the extrados surface.

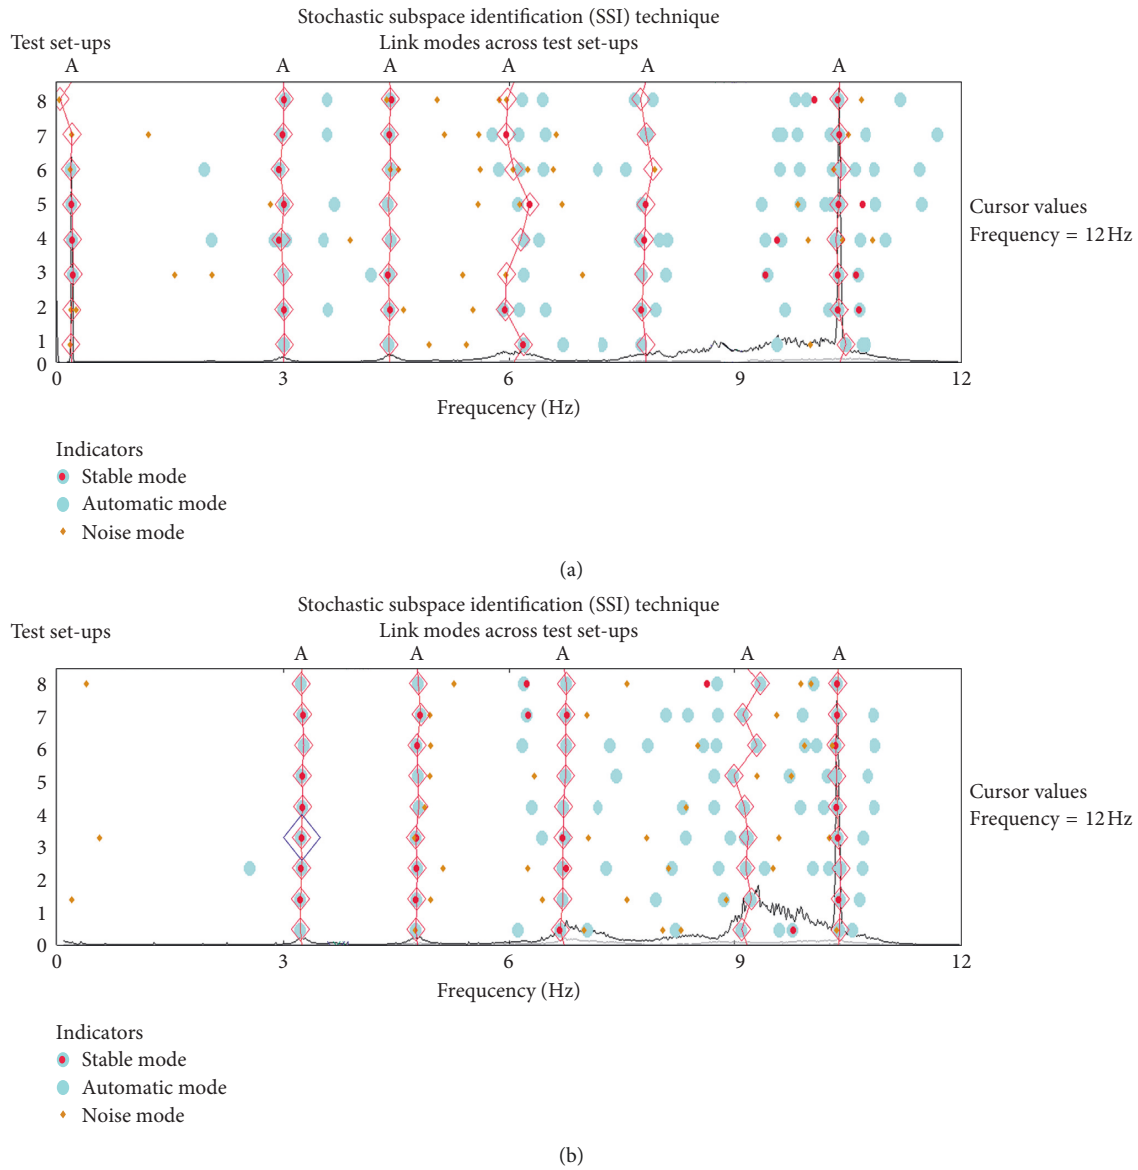
FIGURE 13: Ambient tests before and after works: intrados of the vault (SSI).

Results have been analysed and compared by following two different approaches. The first one is in line with the main purpose of this study, that is, the assessing of changes on the structural health of the chapel caused by the consolidation

process, so focuses on the results that were obtained from the experimental campaigns that were performed from the vault intrados before and after the intervention. On the other hand, the second approach will compare results extracted from the four experimental campaigns in order to satisfy the secondary objective of this work, that is, to demonstrate the
