Sustainable restoration of traditional building systems in the historical centre of Sevilla (Spain)

This study applies eco-efficiency and sustainability criteria to the restoration of a building, as an alternative to strict compliance with planning rules in this field.

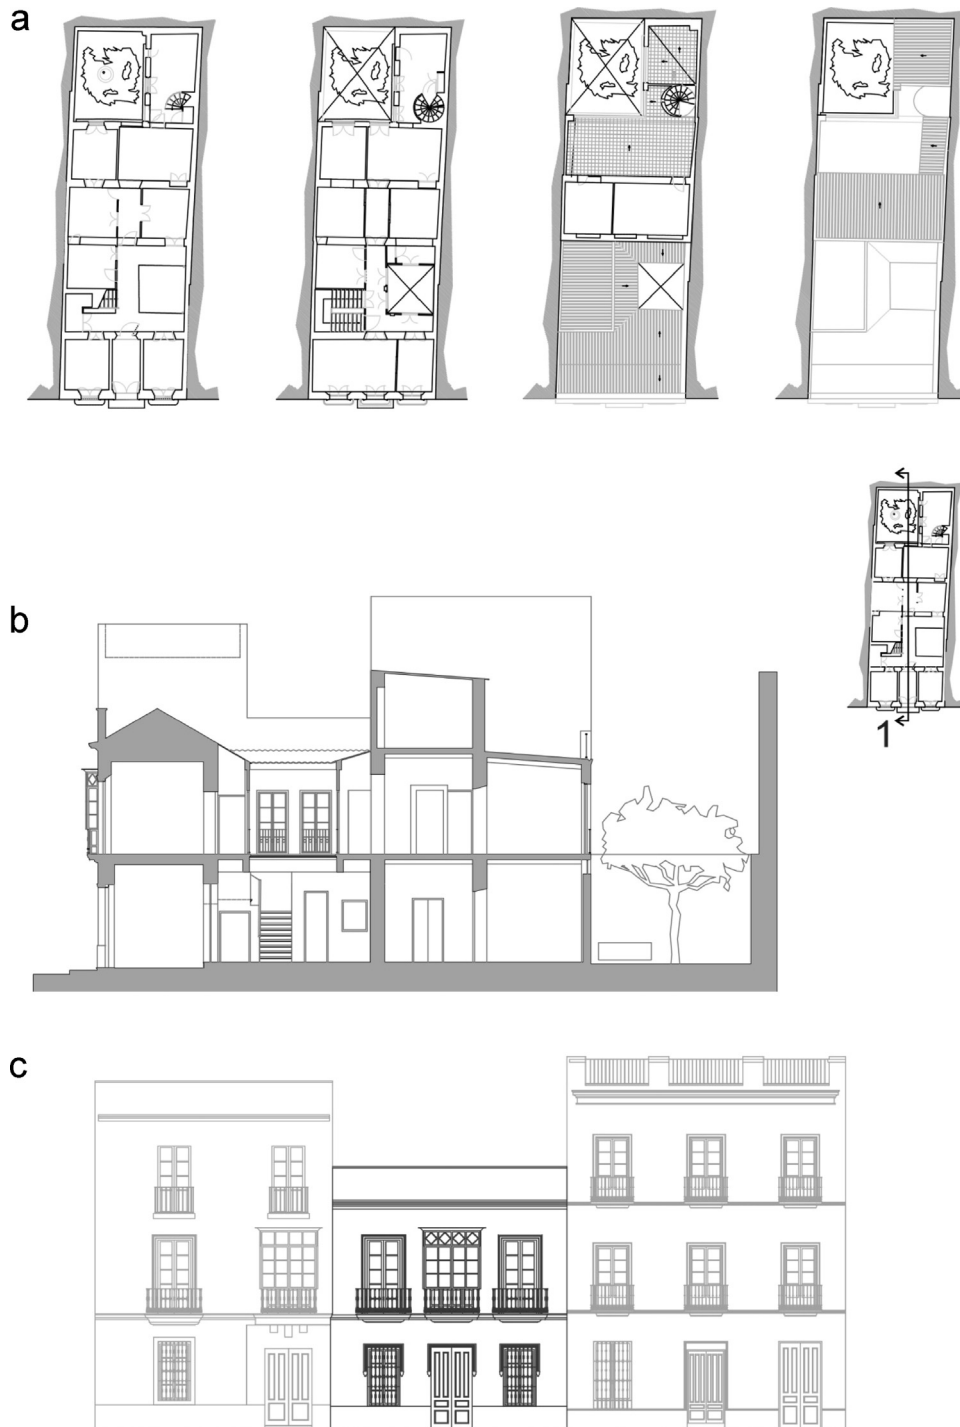
Fig. 1. Model A. (a) Plans, (b) Section 1 and (c) elevation.

It was originally a two-storey house, with five supporting walls and two patios (Fig. 1a and b), both traditional features of residential architecture in Sevilla in the 18th and 19th centuries, with

the house built around a main patio, with load-bearing walls made of brick and limestone mortar. The narrow facade adjoins two restored buildings each with three floors (Fig. 1c).

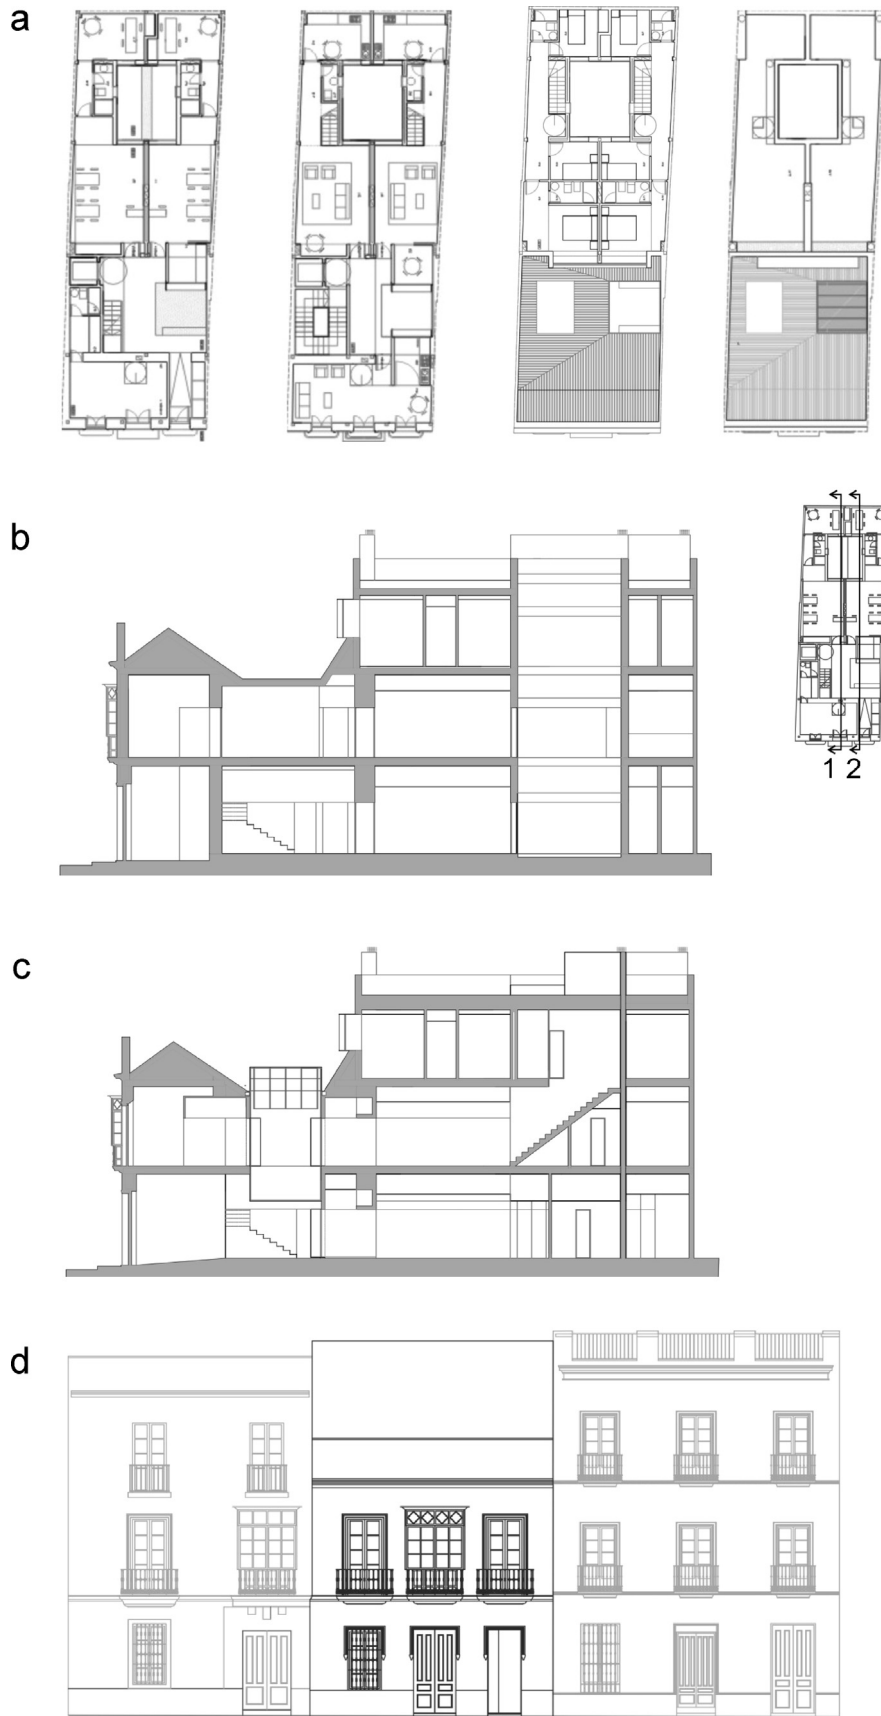
Fig. 3. Model B. (a) Plans, (b) Section 1, (c) Section 2 and (d) elevation.

The restoration plan adhered to the developer's requirements of three apartments each containing three bedrooms, and two offices (Fig. 3a–d). As a result, an extra floor was added, with the supporting wall maintained, as required by the regulations.

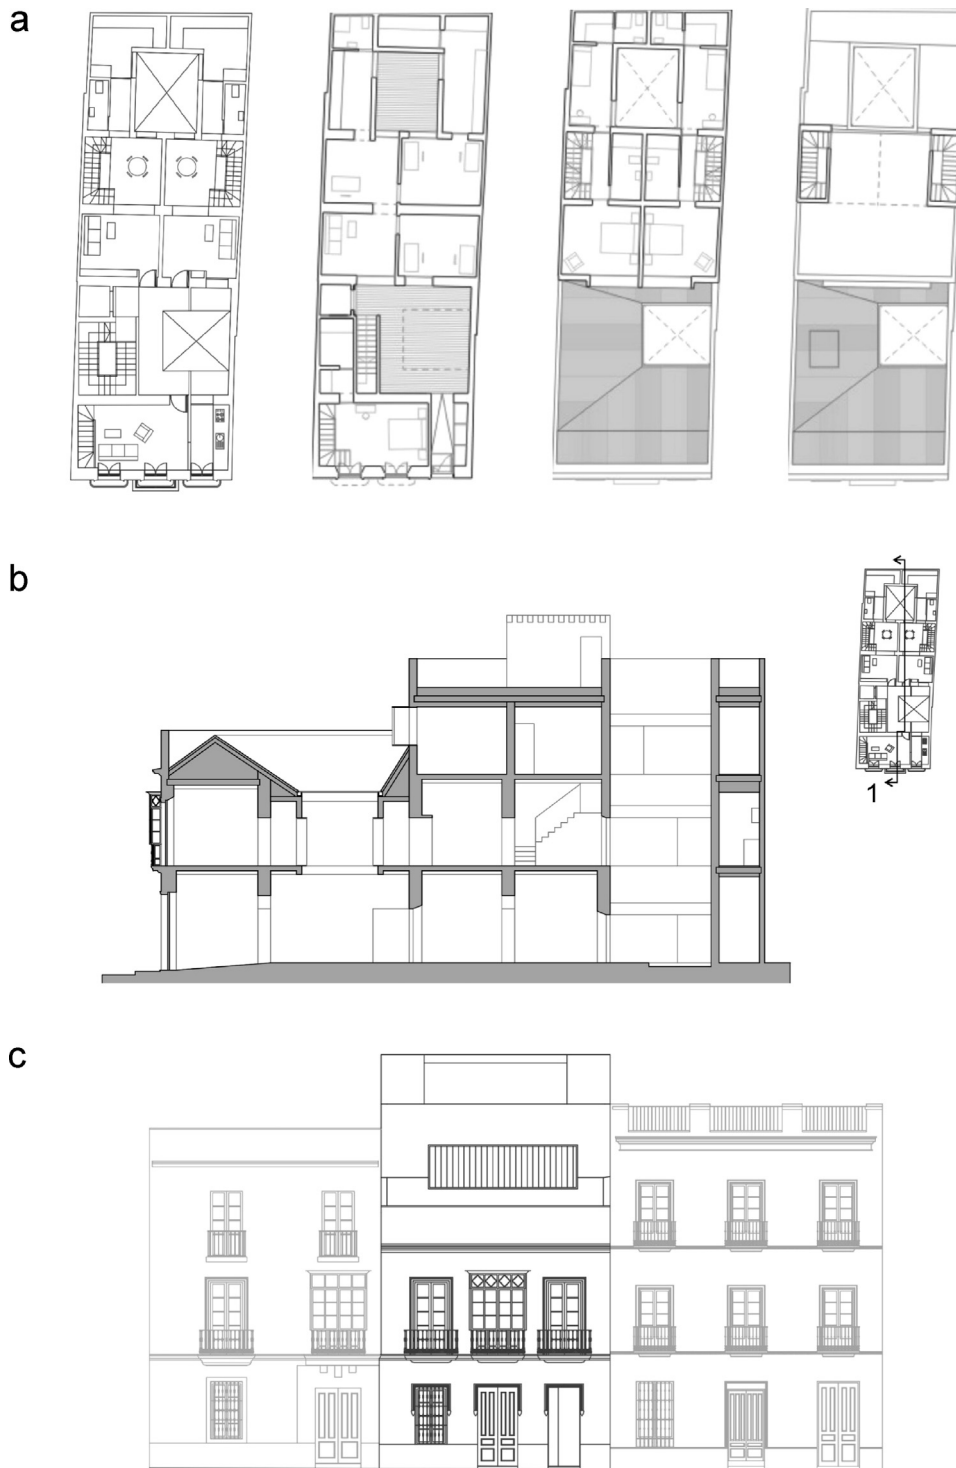
Fig. 5. Model C. (a) Plans, (b) Section 1 and (c) elevation.

The Model C design includes the developer's three individual properties and two offices to dimensions very similar to those actually built (Fig. 5a–c).

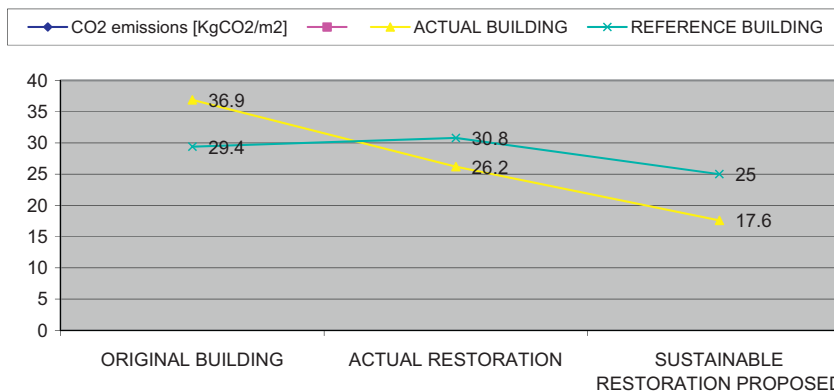
Table 17
Comparison of CO₂ emission evolution in the reference building and each case analysed.
