The Influence of Pathological Situations on Churches' Functionality: An Approach Based on Historical Records

A. J. Prieto, A. Silva, J. de Brito, J. M. Macías-Bernal & F. J. Alejandro

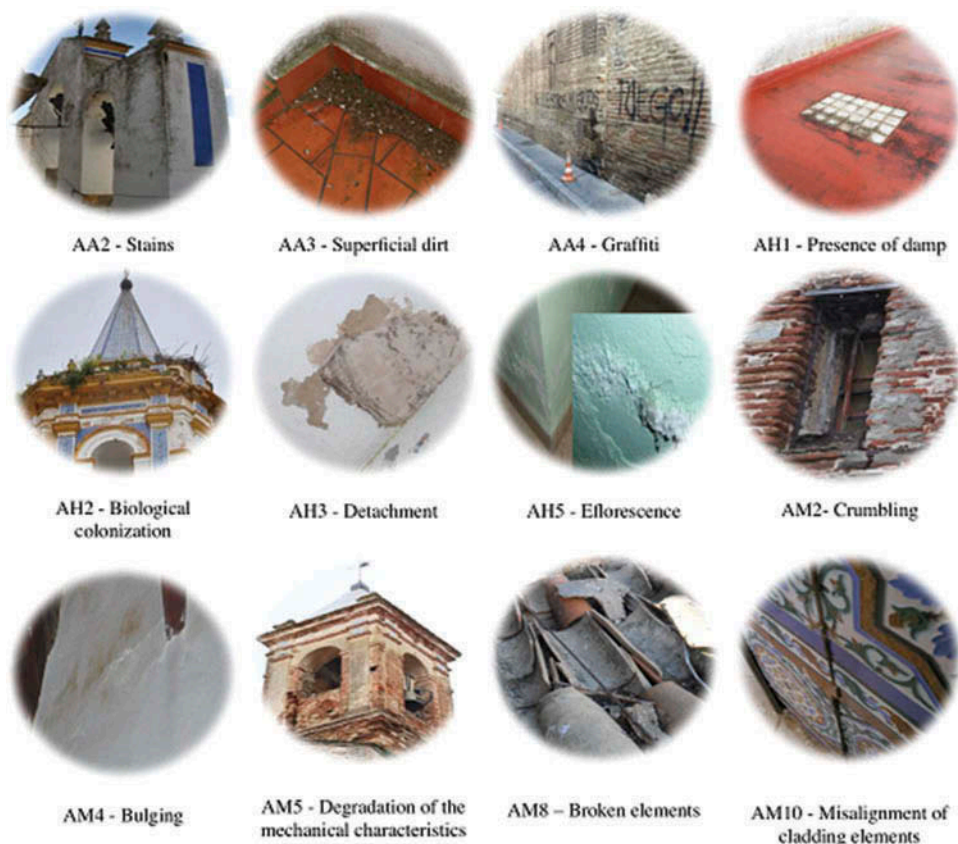
**Figure 1.** Examples of anomalies observed in the built heritage and its classification.

As shown in Table 1, the main anomalies are organized in three groups: aesthetic (AA), which do not jeopardize the integrity of the building but strongly influence its visual appearance; associated with the presence of moisture (AH); and mechanical (AM), which are associated with the concentration of stresses (loads or displacements) that lead to the building's degradation through their physical destruction (Sá et al. 2014). Figure 1 presents some examples of the anomalies observed on the cultural heritage analyzed.

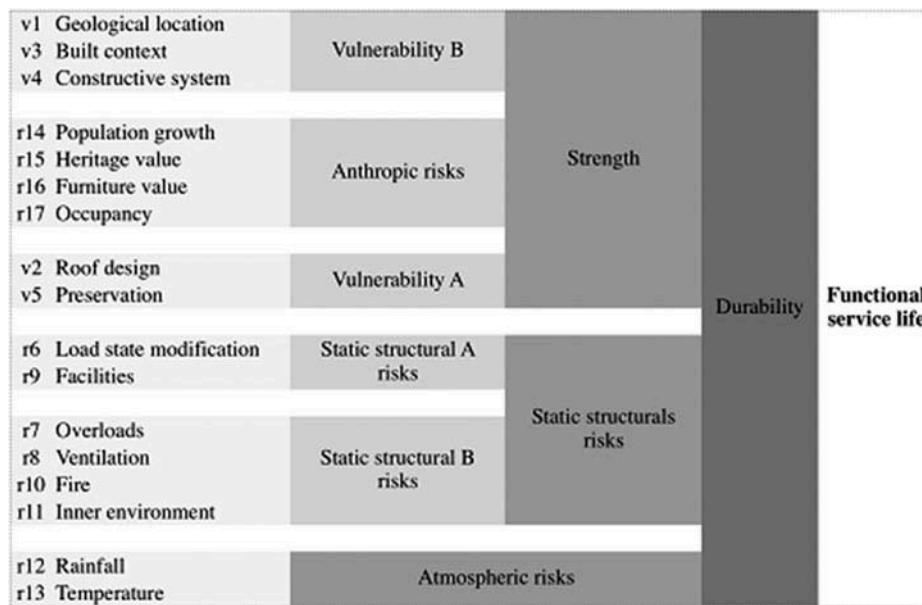
Figure 4. Hierarchical structure of the fuzzy expert system (data sourced from Macías-Bernal, Calama, and Chávez 2014).

model is shown in Figure 4, where it is possible to see the interrelation between the variables developed in the different levels of the fuzzy model. To establish these rules in the model, the following documents were analyzed: Spanish Technical Building Code (2007); National Cathedral Plan (1990); Law on Construction

All the fuzzy rules are extracted from engineering and architect knowledge, expert’s judgments and experience (Prieto et al. 2016a). The full hierarchical structure of the fuzzy model is shown in Figure 4, where it is possible to clearly see the interrelation of the variables developed in the different levels of the fuzzy model.

As seen in Figure 4, the first level of intermediate fuzzy variables on the hierarchical structure is the next one. For Vulnerability A (V_a), Vulnerability B, Static-

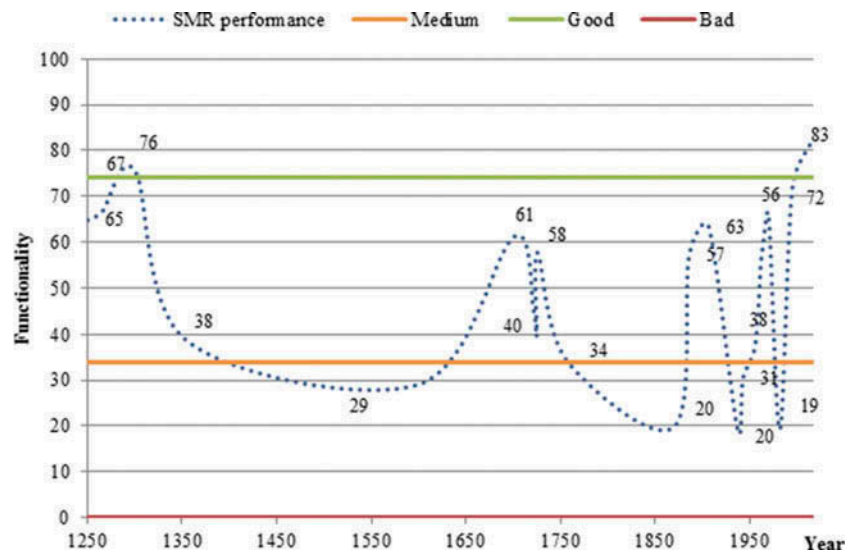
Figure 5. Functional performance over time of Santa Marina's church.

until 2016. In the analysis of Santa Marina's church, (ID code: SE-SMR) a total of 23 historical records were recovered (López 2015). Figure 5 shows the evolution of the Santa Marina church's functionality. Four cataclysm events with disastrous consequences in the building performance were examined: (i) the first one occurred in the 14th century, due to the 1356's earthquake, located around San Vicente's cape, leading to "bad" functional condition of the church; (ii) the second one, occurred in 18th century (1755—Lisbon's earthquake); (iii) the third one occurred in 1936 (first half of 20th century), during the Spanish Civil War, in which the church was burned; and (iv) finally, the fourth event occurred in 1981 (second half of 20th century), corresponding to the complete destruction of the church due to a fire. The building was also involved in another fire during the period of time considered.

Regarding the evaluation of the parish church performance (Table 10 and Figure 5), the data gathered from historical records of Santa Marina's church were considered. The historical records mentioned the following (Vigil-Escalera Pacheco 1991): The building was burned in 1936, during the 60th decade various restoration campaigns (reinforcement of vaults and arches, roofs and masonry reconstruction) were carried out. In 1973, the church was again ready to be opened to the public. However, it remained closed without maintenance actions for almost ten years, even suffering plundering of many of the goods that were stored inside. In 1981, the church suffered another fire. The building did not have any detection or fire protective system and the roof was completely destroyed. Between

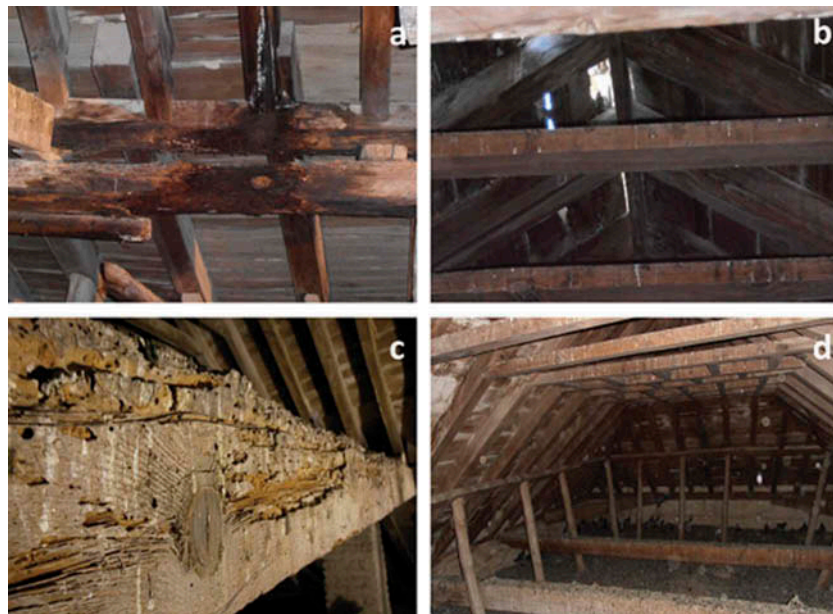
Figure 7. (a) A fungus infection of the timber roof could be due to permanent damp, dirt collection and natural causes; (b) external atmospheric actions (strong wind and rainwater); (c) active attack of xylophages' insects; and (d) Biological actions inside the roof.

Anomalies in the timber elements are also very common in the churches analyzed. Who (2009) refers that the growth of microorganism (such as fungi or bacteria) (Figure 7), are usually caused by prolonged presence of moisture on the building elements, associated with lack of ventilation, with adverse effects on the salubrity of the interior spaces.
