Journal of Building Engineering (2021): 20/06/2024

INTERRELATIONS BETWEEN THE TYPES OF DAMAGES AND THEIR ORIGINAL CAUSES IN THE ENVELOPE OF BUILDINGS

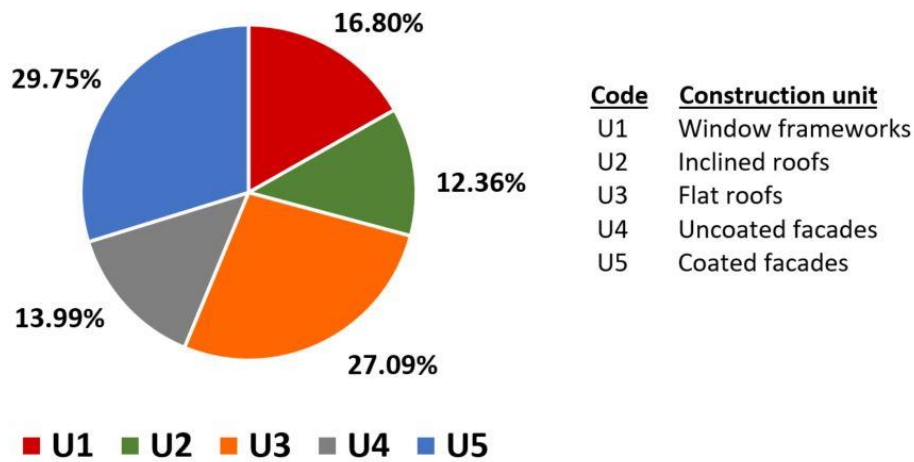
151 Descriptor 1 analysed the existing construction units. According to Figure 1, the coated facades
152 was where the number of cases was greater (U5=29.75%), followed by flat roofs (U3=27.09%) and
153 window frameworks (U1=16.80%).

154 *Fig. 1 –
155 Percentage of cases
156 obtained per
157 construction unit*

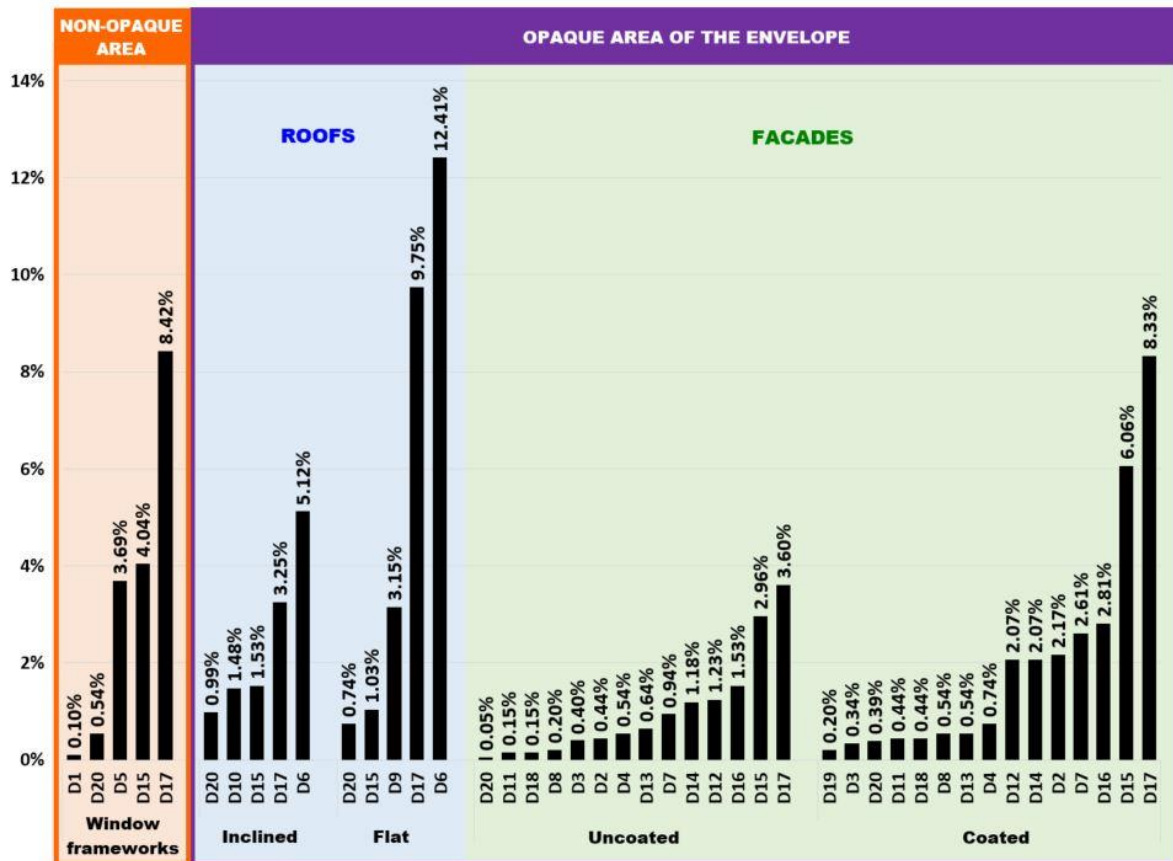
187 Figure 4 shows the relationship between the type of damage (descriptor 2 from Table 1) and
188 the construction unit in which they occurred (descriptor 1 from Table 1) to precisely know which
189 damages are involved in each place and to have detailed information to be used later in the
190 prevention during the project stage.

191 Following a combined nomenclature based on Table 1, the damages with a greater percentage
192 in comparison with the total of the set were $D6_{U3}=12.41\%$, $D17_{U3}=9.75\%$, $D17_{U1}=8.42\%$,
193 $D17_{U5}=8.33\%$, and $D15_{U1}=6.06\%$. Thus, the 'infiltration humidity' (D17) was on the top in 3 out of
194 these 6 times.

195 Furthermore, the types of damage D6, D15, D17, and D20 were present in the two types of
196 roof (U2 and U3). As for the two variants of facades (U4 and U5), the same types of damage were
197 repeated, except D19 (breakage of pieces or elements) which only occurred in the uncoated facades.
198 Finally, the types of damage which were common in the 5 construction units were 'condensation
199 humidity' (D15) and 'infiltration humidity' (D17), and again the key role of humidity in the set was
200 notable.
201

Fig. 4 – Distribution of the damages in each construction unit

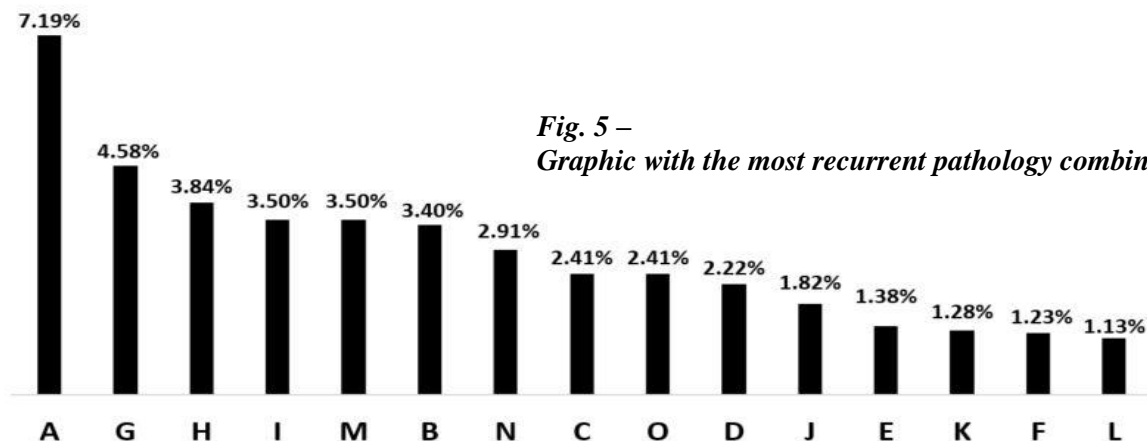
239 To be seen more easily, 3 different pathology combinations were chosen from the 44 groups
240 of pathology combinations described in the two previous tables. These 3 pathology combinations
241 had a larger number of cases by each construction unit (and therefore, the most important pathology
242 combinations: 15 in total). These 15 pathology combinations were called ‘recurrent’ (see Table 4 and
243 the terminology section at the end of the paper), and each was designated with a letter from A to O,
244 as Figure 5 shows.

253 **Fig. 5 –**
 254 **Graphic with the most recurrent pathology combinations**
