Seismic behavior of Mudejar structures

ABSTRACT: Intensive seismic events show the particular impact of these actions in the destruction of the built heritage. The Mudejar architecture has been analysed from the standpoint of the structural behaviour under seismic actions, trying to verify the response of these buildings if today they needed to face an earthquake. Dynamic analysis in situ of the structural rigidity is proposed for the seismic design, protection and rehabilitation of existing structures. This method makes possible the knowledge of the building, contributing to the restoration works through the proposal of specific constructive solutions according to the particularities of each building.

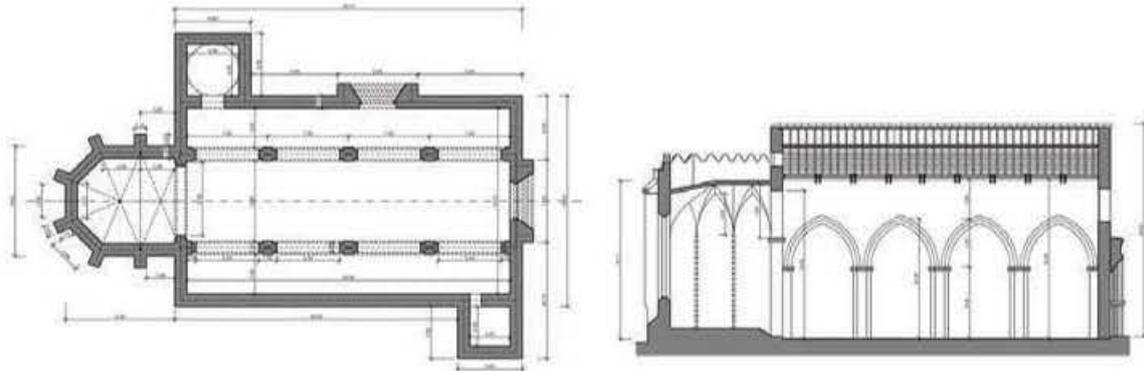
The type of study consists of a structure with four bearing walls of brick that configures three naves covered by a wooden couple-close roof with decorative tracery of different designs. The lateral naves are covered by a single wooden pitch roof. The end of the three naves in the chancel is solved by incorporating a polygonal head (also built with brick, like the lateral bearing walls) with the presence of Gothic buttresses on the outside and ribbed vaulted roof inside. The

wall separating the nave from the aisles is materialized by pointed arches on pillars, which are also built in brick (Cómez, 1974).

Figure 1. Plan and section for the type. Source: author.

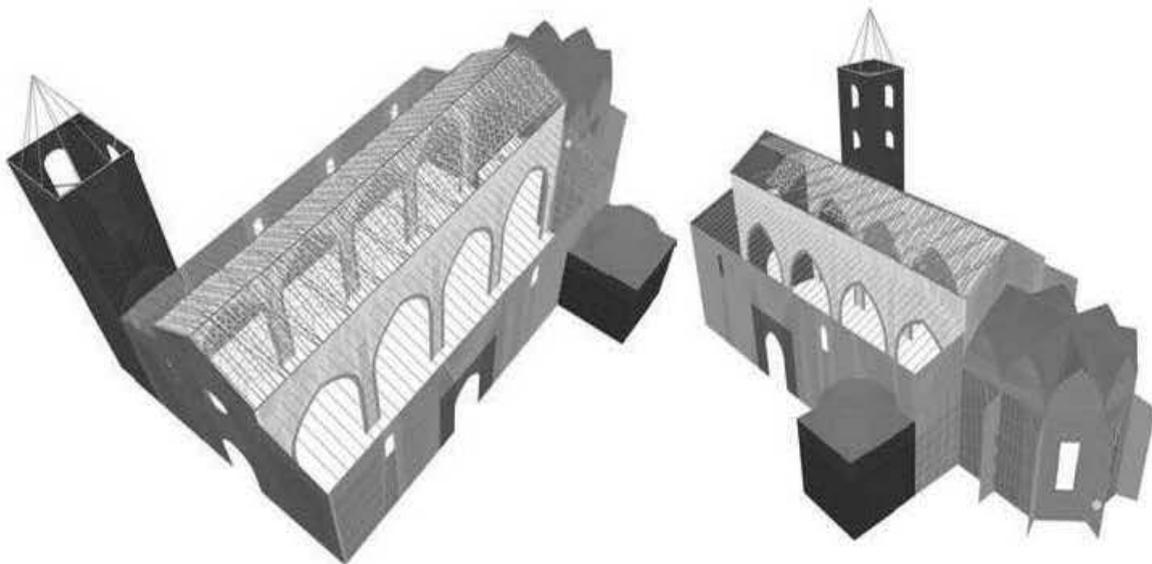
Other features that configures the type are the front stone factory, located ending the central nave in the gable wall and on the side of the Epistle nave, and the side chapel with its vaulted brick and the tower usually located joining to the wall of the feet.

Figure 2. 3D model of the type. Source: author.

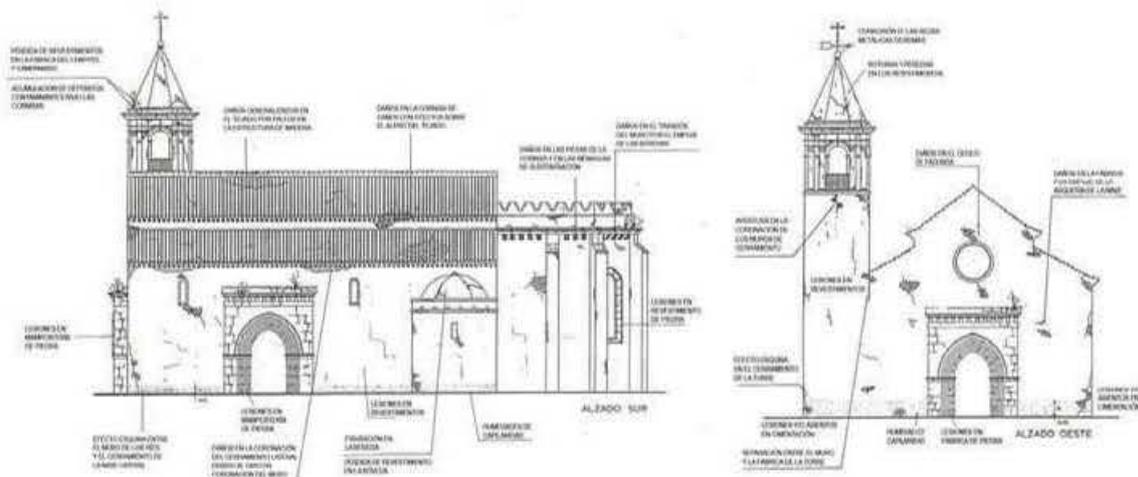
Once defined the type and components that define it, we must have an impact on the most common damages that presents because they will have an impact on the structural behaviour. The professor Vigil-Escalera already made in 1991 a catalogue of typical damages of this constructive type (Vigil-Escalera, 1991). The most of them have appeared again after the restoration that has been carried out in many of them in the latest years of twentieth century.

Figure 3. Typical damages of the model. Source: Vigil-Escalera, 1991.

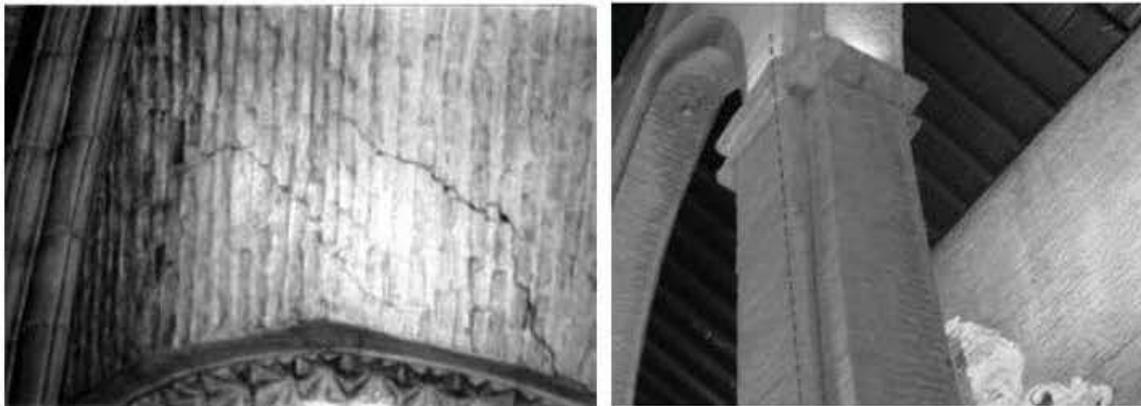
Figure 4. Cracks on the brick vaulted of the head and inclination of the pillars of the central nave. Source: author.

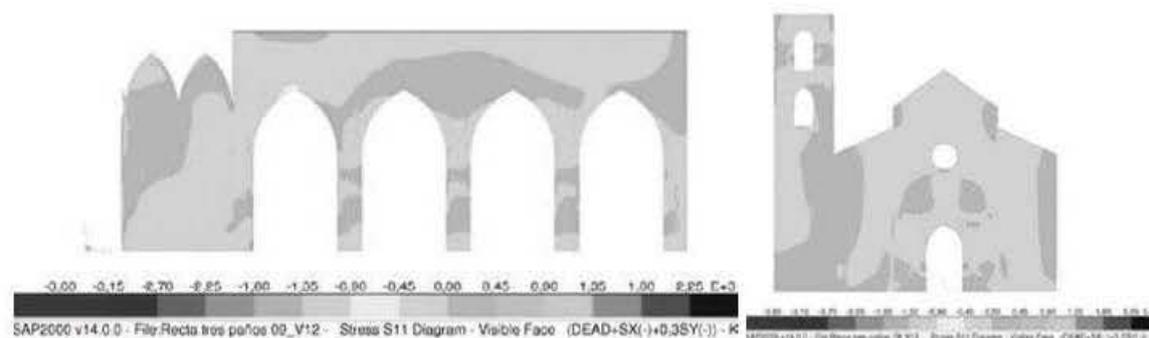
Figure 5. Main stress diagram on the bearing wall of the central nave and on the gable wall. Source: author.

It is significant that in any case the values of admissible stresses in compression are supported by the brick walls. However the tensile stress are overcome this admissible tension on some areas that are unable to resist the stress generated. These points are located in the centres of the side walls, the headwalls, the gable walls, the central arches, pillars and at the joints between side walls and headwalls or gable walls.

With these data, once the calculation has been developed both principal stress in each of the resistant elements (walls and roofs) and main deformations and displacements are obtained.

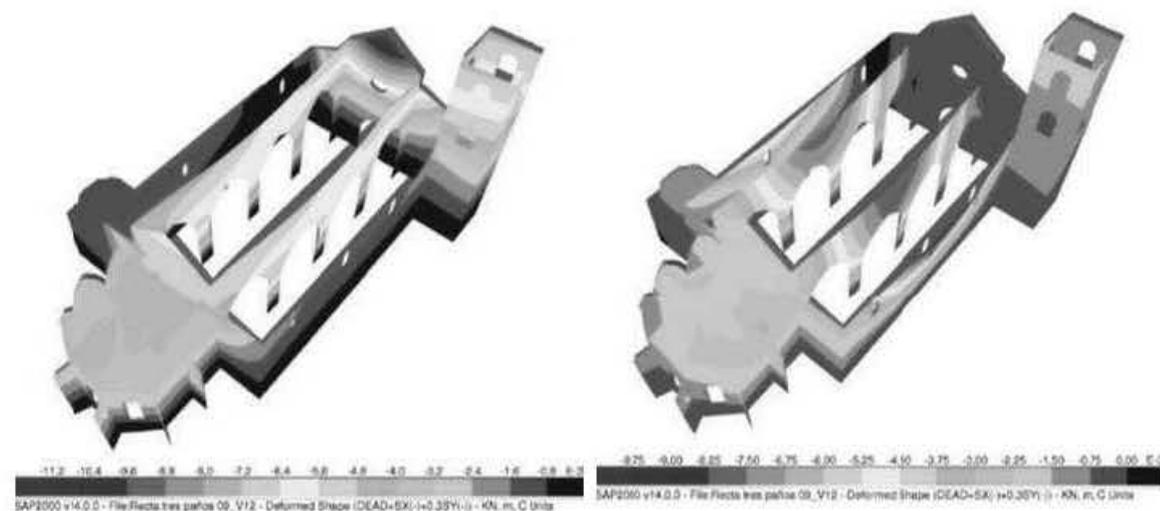
Furthermore the stress state, it is particularly interesting to study the maximum displacements. These occur at the top of the gable wall, at the top of the central arches and the top of the tower.

Figure 6. Main horizontal displacements on the 3D model (longitudinal and transversal direction). Source: author.

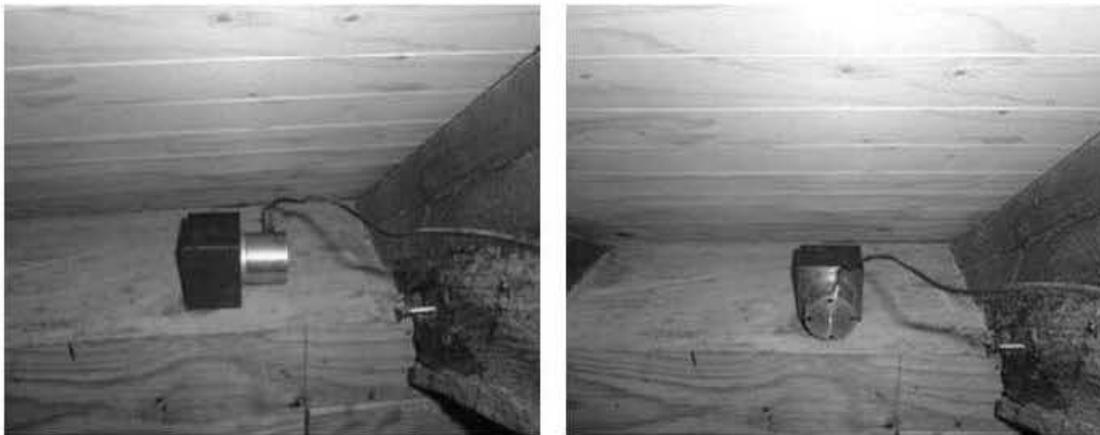
Ambient vibration tests have been developed in a similar model to those studied in Seville but located in the town of Utrera (Seville). These tests were carried out during the restoration works and after the end of the works in order to obtain the natural period of the structure of the model. Due to the similarities between the buildings, these values were compared with those obtained using the finite element computer program and the results of analytical estimations based on the

Figure 7. Environmental vibration tests (longitudinal and transversal direction) developed on the church of the convent of the Carmelites (Utrera, Seville). Source: author.

According to the calculation model, the frequency ranges varying from 2 to 5 Hz. According to Spanish law, should be between 6 and 20 Hz for this type of buildings. These values would be between 4 and 10 Hz according to the average values obtained from the analysis of other regulations (Dominican Republic, Cuba and Peru). Therefore, the logic values would be between 2 and 20 Hz. This range, although it is broad, it locates us around the result we should expect from the in situ test which is especially important to exclude unusual results.

The in situ tests have shown that we are in the range noted above. To settle on respect to other values as possible options, we have compared on the table below this results with the values obtained from the Finite Elements Method Calculation and those coming from the application of the codes.
