Action protocols for seismic evaluation of structures and damage restoration of residential buildings in Andalusia (Spain): "IT-Sismo" APP

Abstract: The seismotectonic conditions of the Iberian Peninsula trigger the occurrence of earthquakes with an occasional periodicity, but with intensities greater than VI on the European macroseismic scale (EMS). For this reason, local action protocols are required in order to efficiently organise the technical inspections that must be carried out on a massive scale after events such as the earthquakes experienced in the Spanish cities of Lorca (2011) and Melilla (2016). This paper proposes the development of a set of documents for the evaluation and diagnosis of the state of existing buildings and infrastructure regarding seismic activity in Andalusia. With special attention paid to residential typology, approximations have been carried out to the normative context, to general comparatives, to particular analyses of a case studies selection, and to complementary approaches. The results have led to the establishment of two specific protocols. Firstly, the short-term guideline enables the classification of damage and risk levels, and the determ

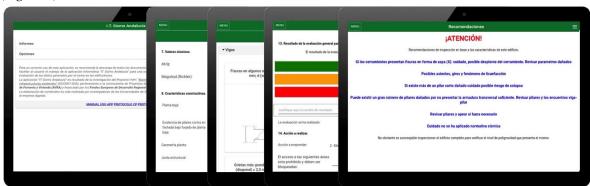
Figure 7. Several screenshots of the ICT tool developed for the assessment of existing buildings and infrastructures (IT-Sismo). Source: Prepared by the authors.

The first contact of the user with the application occurs via the presentation screen, which provides an introduction regarding the characteristics of the project, as well as a set of recommendations aimed at facilitating its use. To this end, the contents of the protocols explained above are provided, as well as a manual for the tool itself. Once the users have become familiarised with the aforementioned contents, they will be able to use the interactive protocol to good advantage (Figure 7).
