Acoustical Behavior Of Churches: Mudejar-Gothic Churches

Abstract: Christian churches have traditionally been considered to have very good acoustical behavior. This unfounded belief has led to important errors in church rehabilitation works, especially when the church is to be used subsequently as an auditorium or theater; this is the case of many churches in Spain. Our research group has worked in acoustical analysis for more than ten years. We have participated in many cases of church rehabilitation and have had the opportunity to achieve surprisingly good acoustical behavior in several. We deal with a very common type in southern Spain: Gothic-Mudejar churches, which have a small volume, a triple-nave layout, and wooden ceilings.

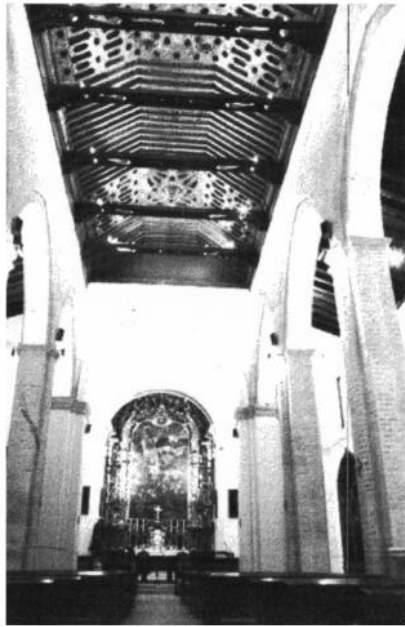
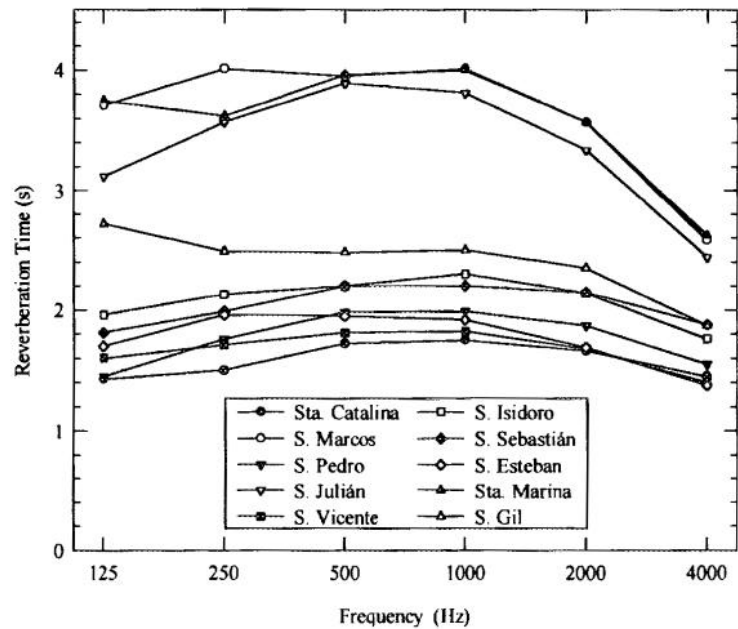
FIGURE 1. Inside of the Mudejar-Gothic St. Isidore Church and reverberation times measured in the ten churches

When Christians recovered southern Spain from the Arabs in the thirteenth century, they built churches over the mosques for symbolic reasons: they wanted to represent the new power. To do so, they brought masters from the north who knew the rules of Gothic architecture. However, a large number of churches had to be built in a short time, and the available workers were mainly Mudejars (subjugated Moors), who were familiar with other constructive techniques, such as wooden roofs and brick walls. This gave rise to the Mudejar-Gothic style, with churches whose most representative points (presbytery and portals) are built of stone, following the Gothic style, while the body of the church has brick walls and three naves with a coffered ceiling (figure 1).

The sound distribution study allowed us to deduce a model similar to Barron's model (3) to describe the reverberated field, which we published recently, (4). From the analysis of the reverberation times at different frequencies in the ten churches (figure 1), we can conclude that their acoustical conditions are reasonably good, even when there is no audience. These conditions are close to optimum for music at medium and high frequencies, although the values are rather low for bass because of the presence of a large amount of bass-absorbing material (wood). When the church is full, reverberation times are near optimum for speech.
