A masonry catalogue for the Groningen region

Conference Paper · June 2018

A MASONRY CATALOGUE FOR THE GRONINGEN REGION

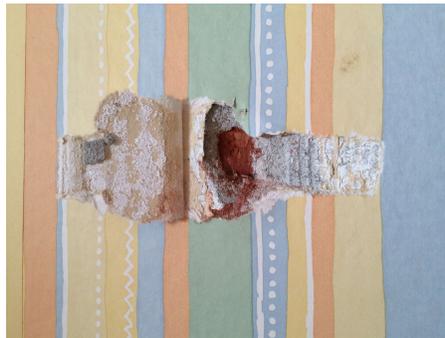
Figure 1. Inspection of wall for material determination

- f. Information about the selected buildings is gathered. The addresses and availability is provided by Nederlandse Aardolie Maatschappij BV (NAM), and Arup performs the required inspection of the buildings (see Figure 1);

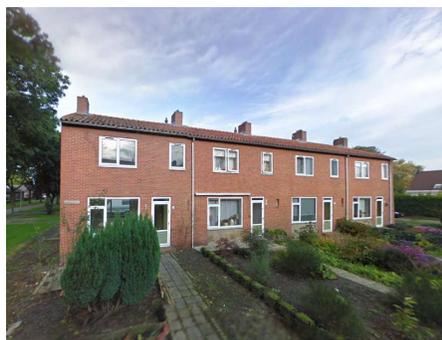
Figure 2. One of the tested buildings, typical terraced house of the Groningen region

In order to obtain meaningful results, it was decided that a minimum of four buildings per masonry category should be tested. Following the philosophy of maximizing the usefulness of the performed tests, the new test buildings were chosen among those which will be used in more than one sector of the project (see Figure 2). In particular buildings which will be upgraded and buildings to be demolished.

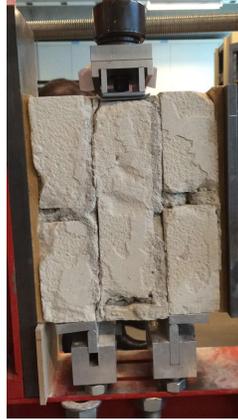
Figure 3. Laboratory shear test on calcium silicate masonry

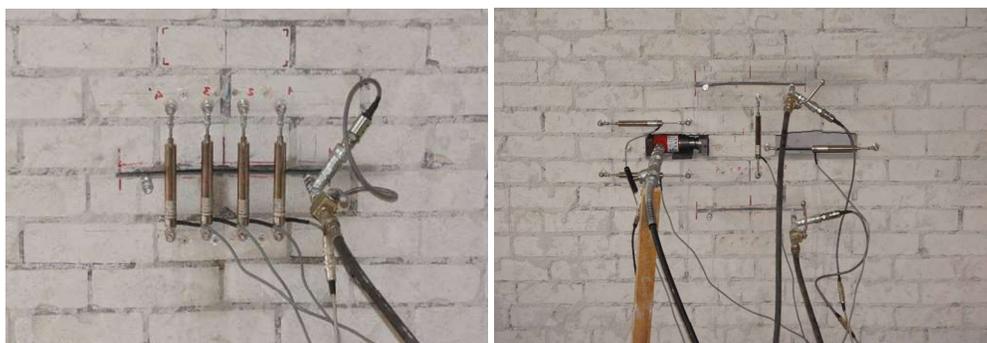
Figure 4. Single flat jack test (left), shove test (right)

The in-situ campaign is divided in semi-destructive test, i.e. single and double flat jack and shove test, and non-destructive tests, including rebound hammer test, penetrometric test on mortar and sonic test. A complete list can be seen in Table 4 below, together with the main property obtained and the possible correlations with other properties.

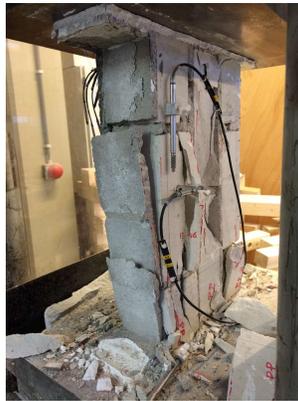
Figure 5. Horizontal compressive test on masonry

Compressive properties of masonry in orthogonal directions: by performing the compressive strength tests with the direction of loading parallel to the bed joints (see Figure 5), the relation between strength and stiffness values for orthotropic directions was investigated. A trend was observed, indicating the influence of the direction of loading on the values of compressive strength and Young's modulus. This effect can be explained by the type of failure observed: brittle splitting in the vertical direction, versus delamination at bed joints, at a lower load but less brittle, in the horizontal direction. Again, given the sample size, only trends and qualitative conclusions, and not a quantitative ratio could be identified at this stage.
