A proposal to improve the acoustics in Fernandina churches. The example of Magdalena Church in Córdoba (Spain)

R. Suárez, J.J. Sendra & J. Navarro

Instituto Universitario de Ciencias de la Construcción (I.U.C.C.). E.T.S. Arquitectura. Universidad de Sevilla. Spain

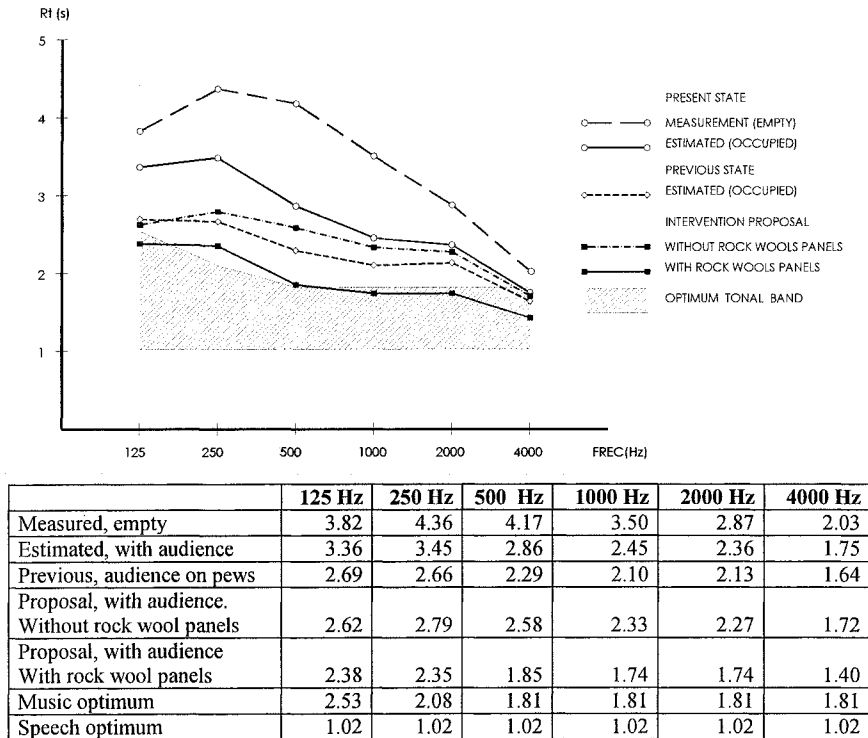
Figure 6. Reverberation times. Audience sitting in chairs.

The conjunction of all the correction measures would provide adequate reverberation times for all the frequencies needed for musical use. In order to reinforce high pitched sounds, part of the absorbing rock wool panels could be eliminated, taking into account that the kind of musical composition may recommend this option.

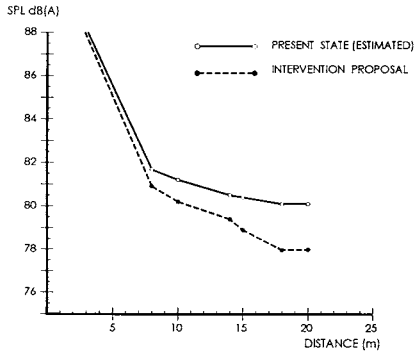
Figure 7. Sound pressure level in relation to distance.

Sound distribution is similar to the present state, although the increase of sound absorption in the proposal supposes a reduction of the sound pressure level (fig. 7). For the proposal, the estimated global sound pressure levels in relation to the distance to the source have been represented, and they have been compared with the values foreseen by the classical model and Barron's model (fig. 8). In proximity to the source, the estimated sound levels are close to those foreseen by the classical model, due to an effect of sound concentration caused by the increase of reflections from the entrance door and the closing of the side chapel.

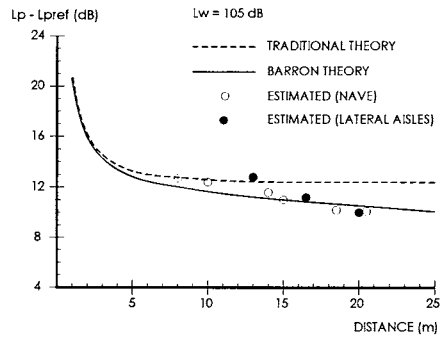
Figure 8. Performance of the acoustic field in relation to distance.

In the remaining spots, the estimated sound levels adjust to those foreseen for Barron's model showing an adequate diffusion of sound.
