The stone as constant presence: vernacular structure of the cultural heritage of Porcuna (Andalusia, Spain)

Topic: T1.3. Studies of traditional techniques and materials

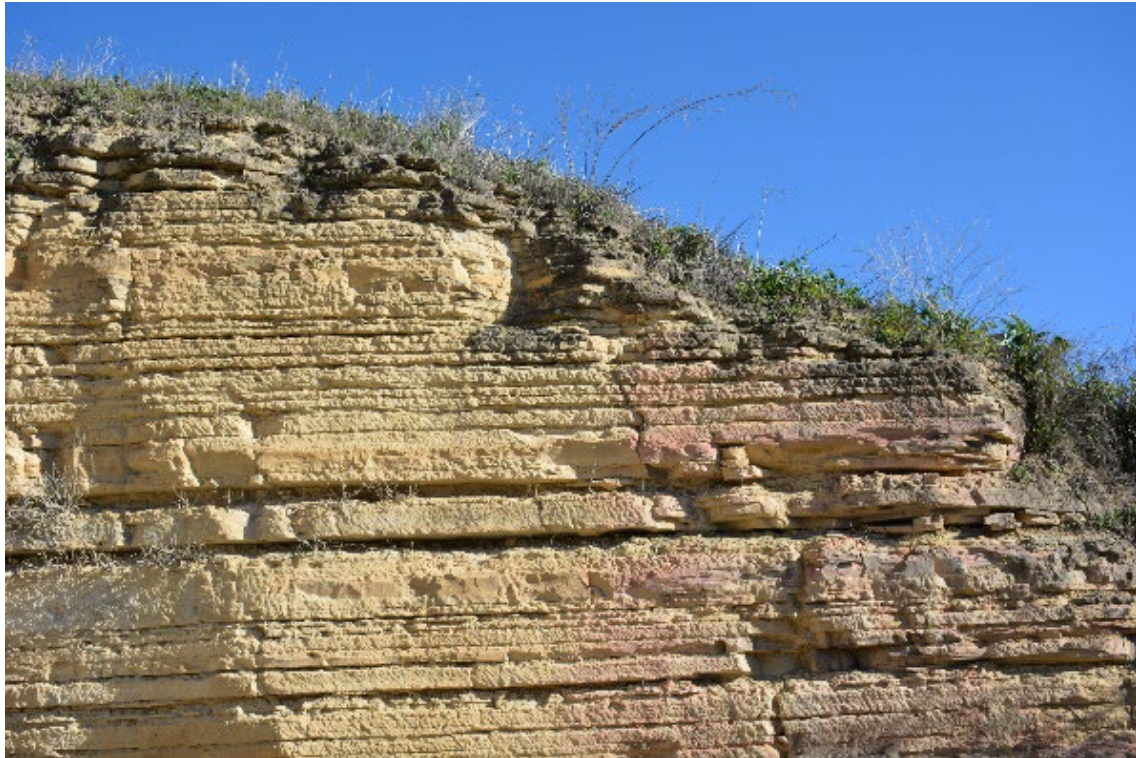
Fig. 1. Subsoil section of Porcuna, in which it is possible to observe the different stone strata alternated by soft betas. (Source: Belmondo, Millán, 2022).

In the Porcuna area, the deposits are dated back to the Messinian age, and the stratification is composed by an initial interval of about 20 m thickness of a sandy, massive, partially cemented part, with abundant content in bioclasts, followed by a part of about 14 m composed by an alternation of cemented bioclastic sandstones between which

centimetric levels of grey-bluish loams are interspersed. This initial interval is followed by a part of about 6 m of rhythmic alternation of sandstones, blue-grey marls, grey-blue and white marls (Cárdenas *et al.*, 2008).

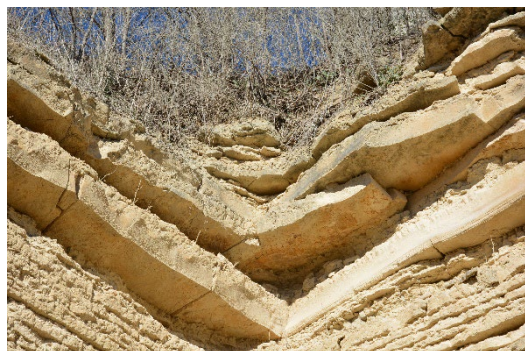
Fig. 2. Detail of the quarry with the alternance of soft and hard layers. (Source: Belmondo, Millán, 2022).

The process of extraction of the stone is determined by the banks or deposits of stone from which the extraction is proceeding. As described above, there is an alternation of layers of different hardnesses. This is what defines the process by which the stone is obtained from the quarries of Porcuna. Though previously there were more places of extraction, due to the decrease of demand, today only three fronts of extraction remain.

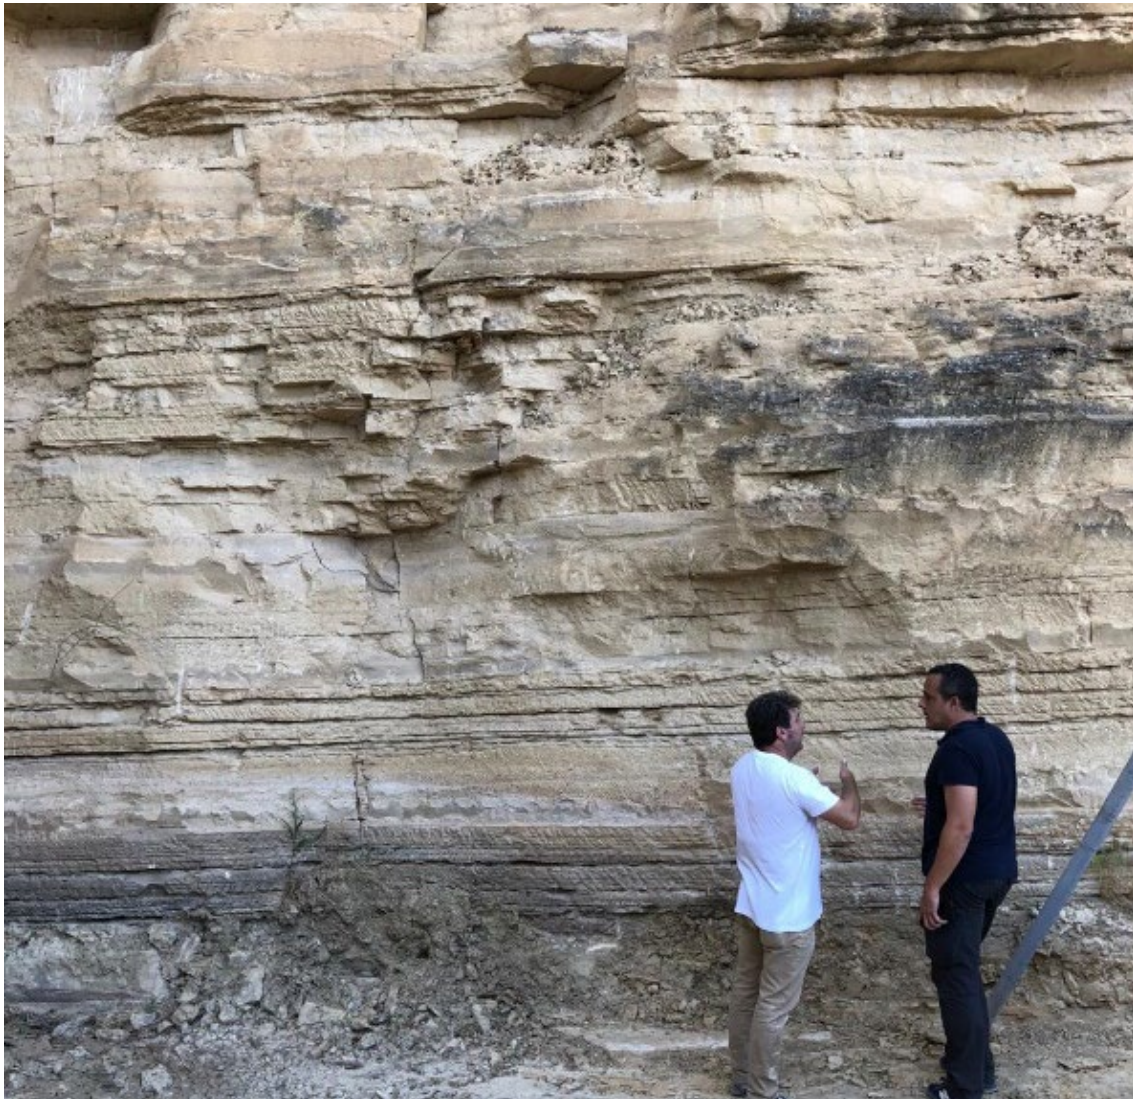
Fig. 3. Image of one of the historical quarries operating until recently. (Source: Belmondo, Millán, 2022).

The process by which the stone is extracted is still the traditional one dated back to centuries ago, by levers in the first place and then by mechanical processes when the stone block has been extracted. The first moment is the selection of the terrace on which the stone will be removed. Once selected and after delimiting the size, various steel wedges are nailed to the head of the piece and are gradually introduced into the soul of the stone. These wedges are

usually located on the soft board, so that quickly, once they are beaten, they break the hard-stone reef and the stone slab comes out. This system allows to extract large pieces but with minimum thicknesses as mentioned before. This extraction process generates numerous small pieces or wedges of stones that are used to settle the large slabs in the construction.

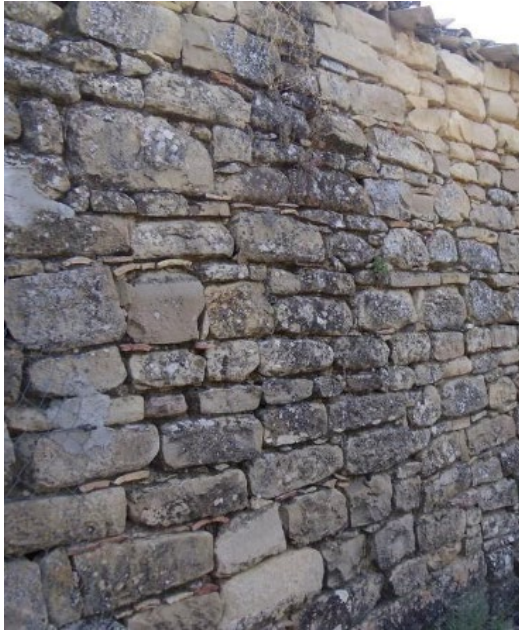
Fig. 4. Detail of a wall in Porcuna without mortar (*a hueso* construction). (Source: Belmondo, Millán, 2022).

hand, would be a natural hardener. However, the recommended and most used system in Porcuna, is the so-called *emparejados* system, that is, a system by which stone is used without mortars and is minted with small slabs of the same stone. This is the system known as a *hueso*.

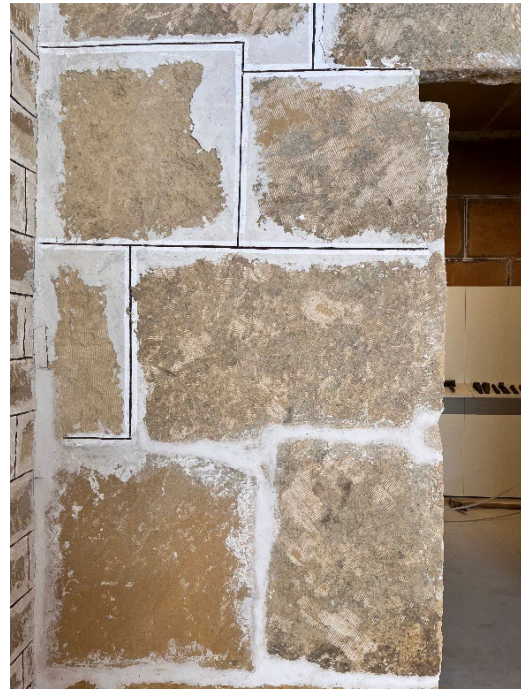
Fig. 5. Detail of a partition wall of *losetas* (blocks on “sailor” courses). (Source: Belmondo, Millán, 2022).

Due to the internal structure of each of these hard-stone strata, it is easy to extract pieces of large flat dimensions, with large slabs. These, throughout history, have been used as separations of rooms, as partitions of solid stone, arranged in the so-called position *de canto* (“sailor” courses), known in the municipality as partitions *de losetas*. Although the boundaries were not usually regular, master stonemasons used wooden wedge systems to adjust them. After this, with a

minimum amount of plaster, they managed to adjust them in a stable and safe way.

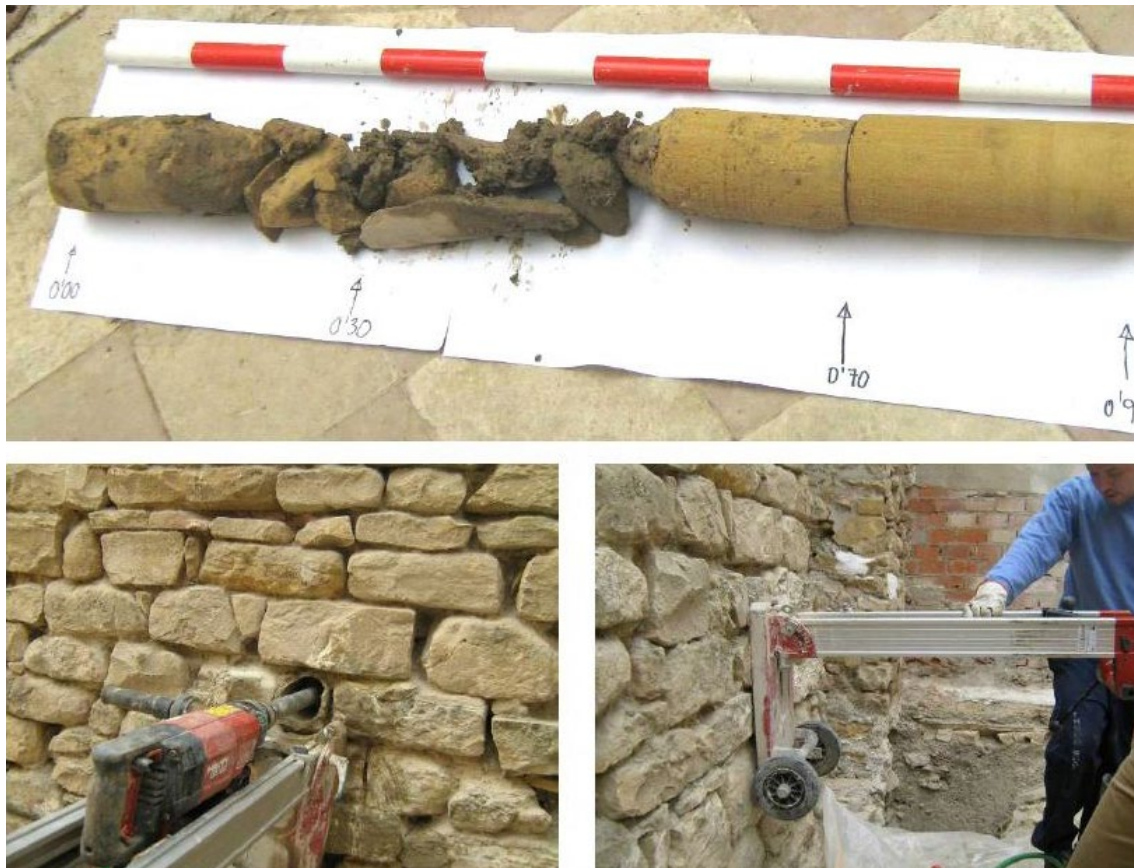
Fig. 6. Test about the internal composition of the façade of the Royal Butchers (16th century) in Porcuna, during the restoration process. It is possible to observe that the façade is characterized by an orderly configuration, instead the “soul” of the wall is composed of filling material without any consistency. (Source: Millán, 2014).

Considering the small dimensions of thickness of each stone strata, the load-bearing walls used to be made of small volumes of stone but of great thickness. These load-bearing walls, although to the outside they showed an orderly configuration, the interior (known as the “soul” of the wall) was configured by small fragments and a minimum mortar that gave consistency to the wall.

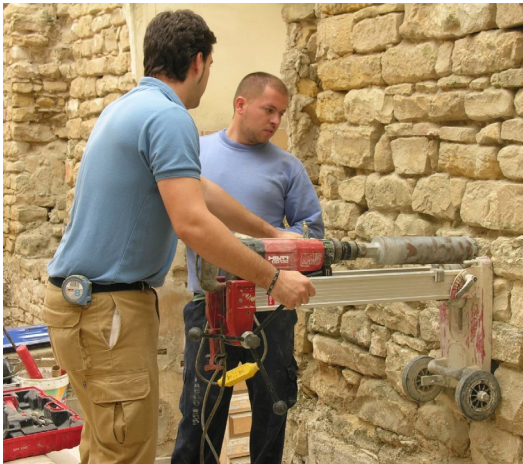
Fig. 7. Detail of the process of extracting the stone from a load-bearing wall to analyse its internal composition. It is possible to observe that the wall is without mortar but just a mud poor in lime. (Source: Millán, 2014).

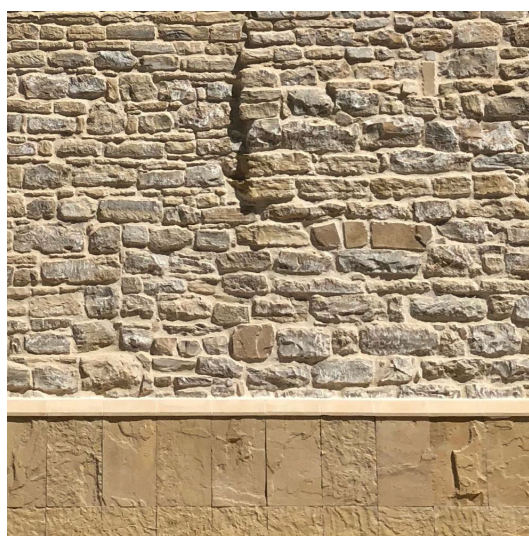
Fig. 8. Detail of a stone cladding in the lower part of the façade. (Source: Belmondo, Millán, 2022).

The structure of the stone allows to develop large flat pieces. These have been used to cover large facades. With this system, vernacular typologies of facades have been built, limited by the thickness of the stone. It is interesting to analyse how today they are still built in the same way as they were centuries ago. Being stone cladding, its layout and design have been preserved perfectly throughout history. For this type of surface typologies, various finishes have been configured, with different ways of working the stone.

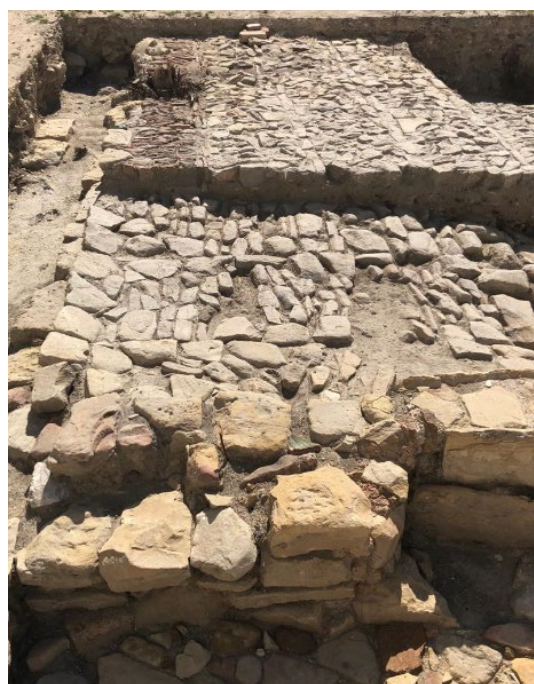
Fig. 9. Detail of the archaeological excavation in Porcuna in which the same types of pavements can be observed at different times. (Source: Millán, 2020).

The Porcuna stone has generated numerous possibilities for the construction of other elements, such as pavements. Throughout history, there has been the use of large pieces for pavements in slabs as well as pavements in small pieces. All these have been executed with the stone called *viva*, since the so-called *arena* could not be suitable for this use.

In various archaeological campaigns, it has been possible to verify how the floorings have remained unchanged and the same technique is still used.
