# Improved damage detection in Pelton turbines using optimized condition indicators and data-driven techniques

Structural Health Monitoring

2021, Vol. 20(6) 3239–3251

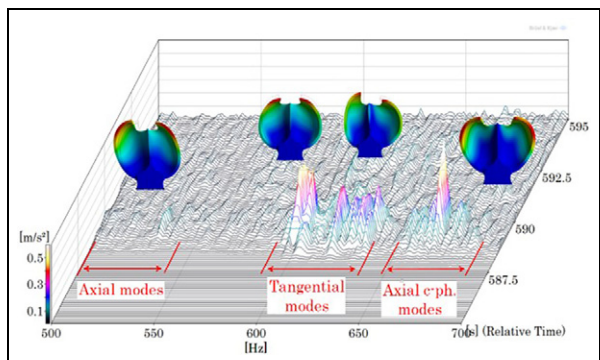
Figure 4. Excitation of the first runner natural frequencies during start-up of a Pelton turbine.

A more detailed dynamic analysis of Pelton runners<sup>31</sup> indicates that the runner response is quite complicated, with many natural frequencies and mode-shapes (tangential, axial, and radial). They are close to each other with high modal density and covering a high-frequency range well above the rotor natural frequencies. In Figure 4, the first natural frequencies of a Pelton runner and associated mode-shapes detected during the start-up transient are indicated.

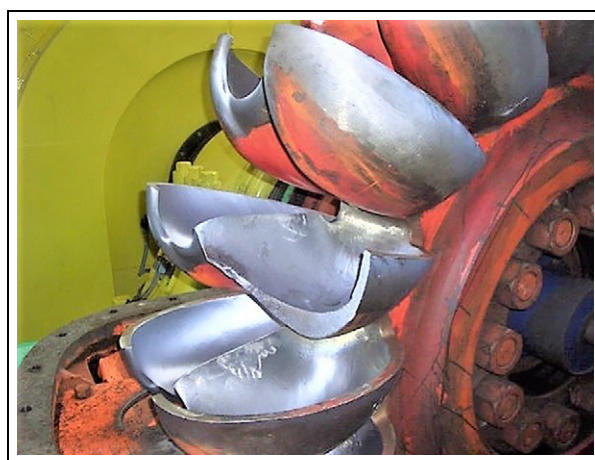
**Figure 8.** Damage in a bucket.

For the analysis, a history case has been selected. On 29 August 2011, the system detected an abnormal root mean square (RMS) vibration value surpassing the alarm threshold and the machine was stopped. The following inspection revealed the cause of the increased vibration: a piece of one bucket broke off while in operation and, in addition, cracks were present in the same area of several buckets (Figure 8). The inspection of the runner indicated that the incident took place due to the fatigue of the material, for which it was assumed that the machine had not been operating properly for some time. Machine vibrations in all the monitoring

locations were available with the machine in good condition, with incipient damage and with severe damage.<sup>36,37</sup> After that, the machine was repaired and put again into service.

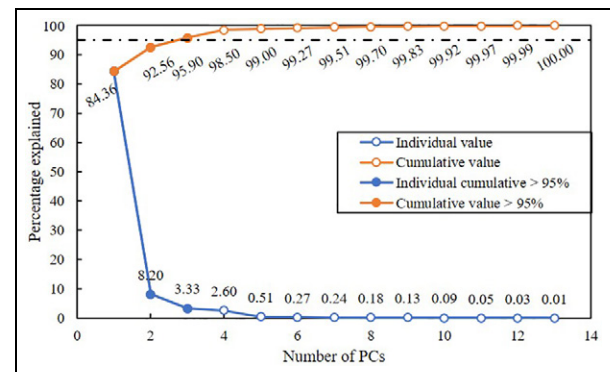
Figure 10. Scree plot of the PCA result of point A34-10.

most relevant indicators. FA is preferred over PCA for dimension reduction as the physical meaning of the indicators is retained. The measurement point A34-10 is taken as an example to describe the process.

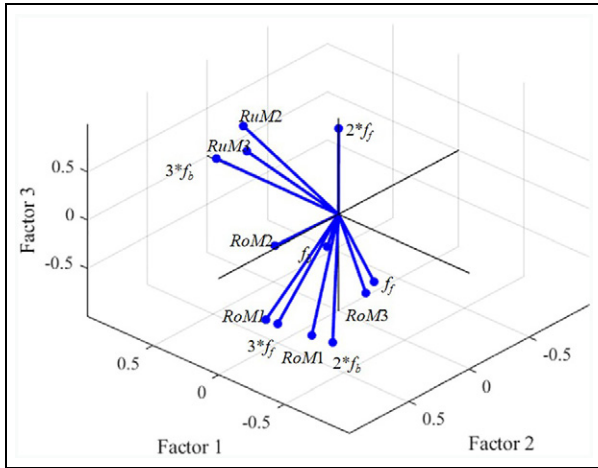
**Figure 11.** Loading factors of each new indicator on the three common factors.

three-dimensional (3D) plot, which is helpful for visualizing and comparing the loadings of the indicators. The loading vectors are shown in Figure 11. Thus, the direction and length (module) of each vector indicate its relevancy with the common factors. For example, there are four indicators with negative loadings on the first common factor and seven with positive loadings. The indicator  $3*f_b$  has the smallest angle with the axis and the largest loading value, which indicates  $3*f_b$  has the greatest dependency with the first common factor. On the contrary, the length of vector  $f_b$  is 0.2606, which is too small to represent any common factor.

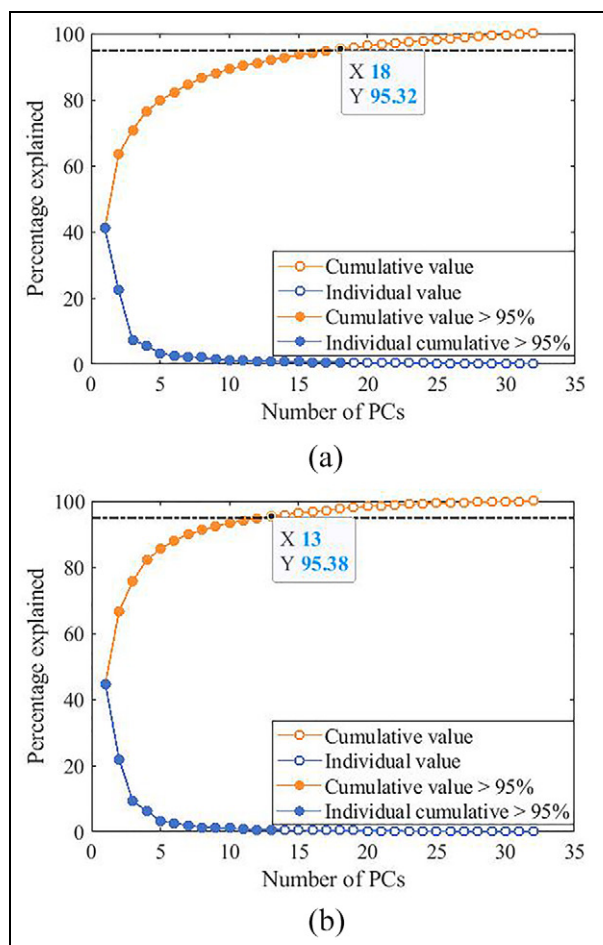
**Figure 13.** PCA scree plot of the “spectrum level” (a) and “harmonic level” (b) indicators’ sets on point A31-04.

The first condition indicator is the spectrum level of the turbine. The whole vibration spectrum (magnitude of the spectrum after applying the fast Fourier transform) is considered in order to build this set of indicators. According to the configuration of our monitoring system, the frequency range is 3–800 Hz with a resolution of 0.5 Hz, so there are 1595 lines in each spectrum. For each measuring point, the input pattern contains 1595 columns.

The second set encompasses the harmonics levels of the spectrum. The spectral bands of the rotating speed and its harmonics are excited by unbalance or misalignment of the rotor. Different types of damage can be reflected by changes in the harmonics of  $f_f$ .<sup>15,30,39</sup> The energy of a spectral band with a width of 2 Hz and containing each harmonic is calculated according to equation (2). Since the range of the spectrum is 3~800 Hz, 78 indicators are extracted from the raw

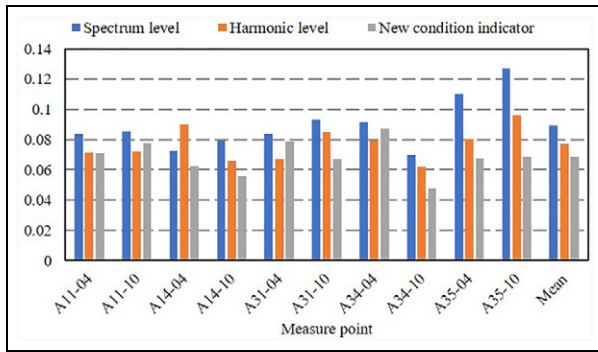
Figure 15. Prediction performance of the three indicators' set for each measurement point and averaged performance.

where  $\text{ADI}_p$  is the predicted damage index in each round of LOOCV and  $n$  is equal to the total number of observations, which is 33 in our case. For each point, 50 trials have been carried out on the three groups of indicators, respectively. Their RMSE values have been calculated and are shown in Figure 15.

It can be observed from the chart that the prediction result of the “spectrum level” set has the largest error in every point and the proposed set of indicators has the lowest error in most of the measurement points. The mean RMSE in the rightmost item in the chart indicates that the proposed condition indicators have the lowest error among the three data sets. Compared to the “spectrum level” and “harmonic level” indicators, the prediction error of new condition indicators has been decreased by 23.62% and 10.88%, respectively. The most accurate point for the damage detection is the vertical position when the machine is working at 100% load (A34-10) and when the data set containing the new condition indicators is used. It can be concluded that the new condition indicators have a better correlation with the ADI for almost all the sensors analyzed (minimum RMSE). The reason lies in the characteristics of the especially selected spectral bands in the proposed set of indicators, which are more correlated to both the dynamic response of the structure and excitation forces. Thus, these indicators are more sensitive to detect the onset of an incipient damage.

Sensor A31 is located on the same bearing as A34, measuring vibrations in the horizontal direction. However, the prediction error is much higher than A34. This can be explained by the dynamic response of the structure: the weight of the runner makes the oil film thinner in the journal bearing, which makes the coherence between the bearing and the shaft higher on the vertical direction than in the horizontal direction. Another reason lies in the direction of the horizontal water jet, which causes too much noise on the measurement.

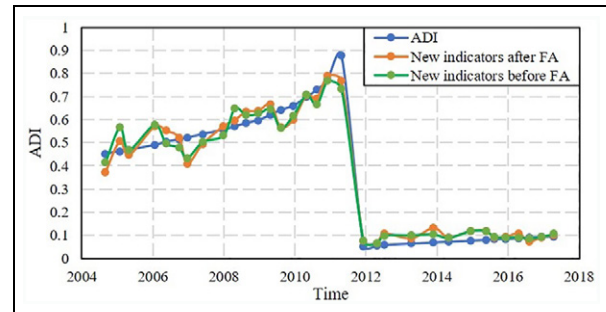
Figure 16. Predicted ADI by indicators before and after FA in point A34-10.
