SfM Photogrammetric Techniques Applied in the Building Archaeology Works of the Old Cloister of the Monastery of San Francisco from the 16th Century (Cazalla de la Sierra, Seville)

Abstract: The cloister from the old monastery of San Francisco (Cazalla de la Sierra, Seville) has been suffering a series of remodeling transformations from its original construction in the 16th century to the current day. Thus, a study of building archaeology needed to be accomplished by using photogrammetric techniques by SfM (Structure from Motion) and laser scanning or TLS (Terrestrial Laser Scanning), which ensure the geometric exactitude and high resolution of the facings surveying. For that, over 500 images were taken for the 4 existing facings (about 78 lineal meters) from which a photogrammetric model was obtained of over 50 million polygons, as well as a cloud of over 40 million points from the laser scanning. It can be concluded that by using the techniques of SfM, the task of documenting, analyzing and studying the facings of the historical building in order to establish its evolutional process gains not only precision and exactitude but also opens the possibility to go further by obtaining

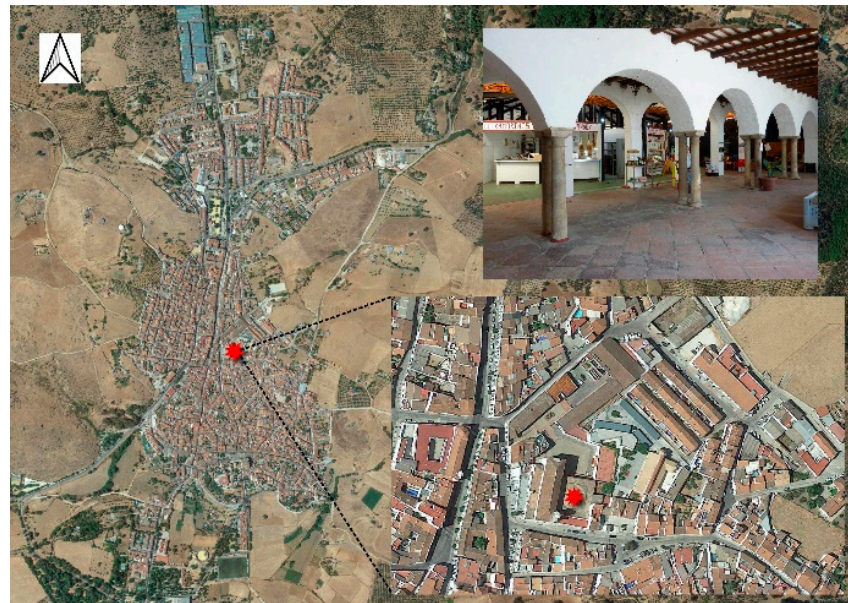
Figure 1. Location of the Municipal Food Market of Cazalla de la Sierra and indoor sight, where the cloister of the monastery of San Francisco is located.

The current Municipal Food Market of Cazalla de la Sierra (Seville) (Figure 1) is located in a building whose history began at least as early as 1588, when the order of San Francisco, settled in Cazalla from 1493 in the old Monastery of San Jerónimo (current Hermitage of Carmen), decided to be relocated inside the walls of the city and build their new monastery in the block in which the monastery was located [1–3]. Although neither the exact date is clear nor the rhythm of edification of the new monastery, it would not be ludicrous to think that at least the main buildings would have already been built, especially the dependencies where the daily life would be developed and the cloister in which the aforesaid activity will revolve around.

The exact space that the Municipal Food Market reuses from this monastery of San Francisco is its cloister (Figure 1), in which, during the 10th century, modifications and reforms of the original building were realized, so as to adapt it to its new use. However, this cloister displays the footprint of other reforms and adaptations that it had had for previous uses that have taken place throughout its almost 450 years of history.

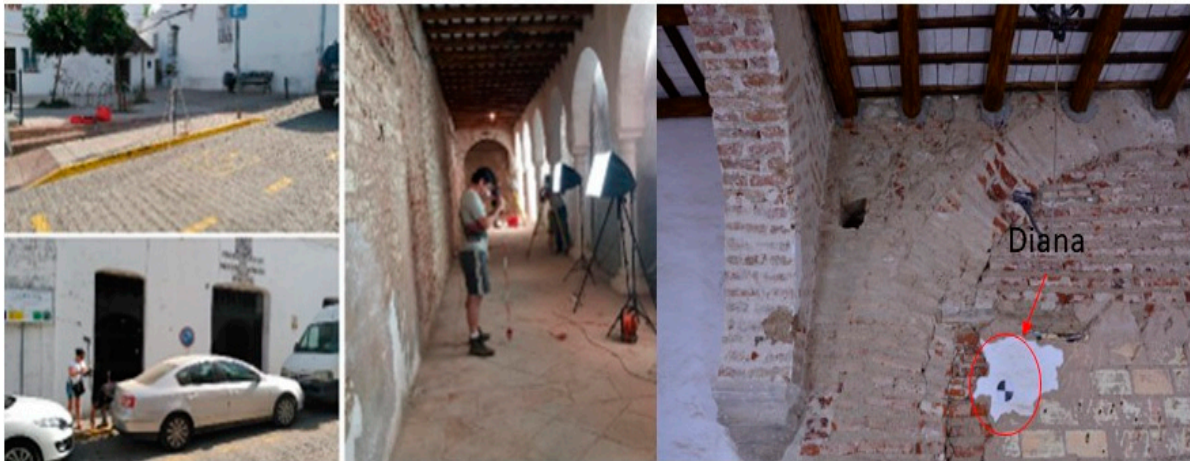
Figure 2. GNSS stationing, placing and measurement of permanent points inside and outside the cloister.

Using a Leica's total station TCR705 [10], a free stationing was carried out, taking as reference the previously measured points with the GNSS, in particular those two which were visible from the inside of the site, located at the pavement from which the entrance to the market square is accessible (Figure 2). These points and the rest of the measured points in the work were taken by employing a mini prism (Leica's GMP111-0), except those points that were located on the surface of the walls to be measured that, because of being on top of a vertical plane, were signposted by adhesive paper targets; in this case, the TCR705 was used in "red laser" measurement mode, modifying the measurement parameters in the equipment (Figure 2).

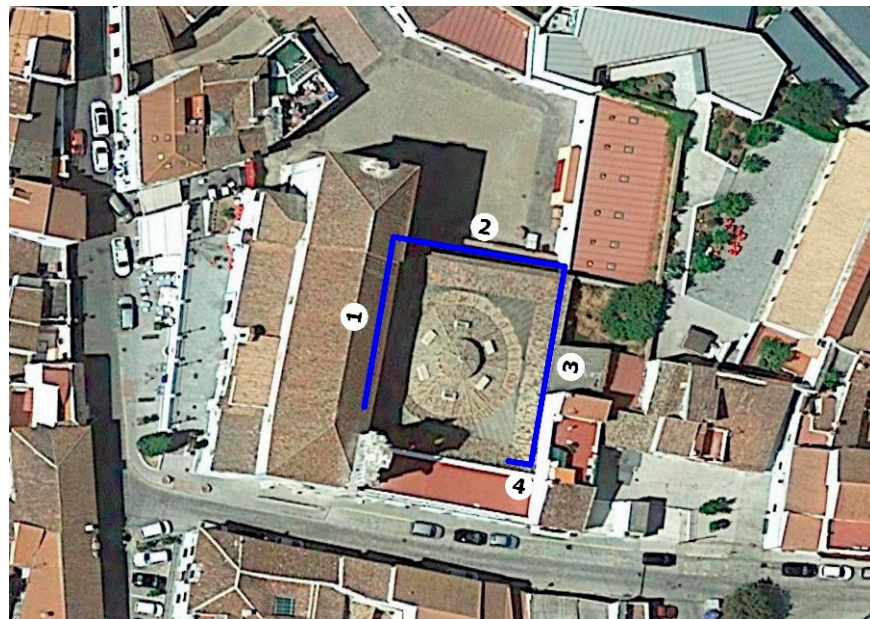
Figure 6. Localization and numeration of the studied walls panels: 1 west wall, 2 north wall, 3 east wall, 4 south wall.

The analyzed facings (Figure 6) were numbered for their correct identification, moving clockwise, starting from the most W point.

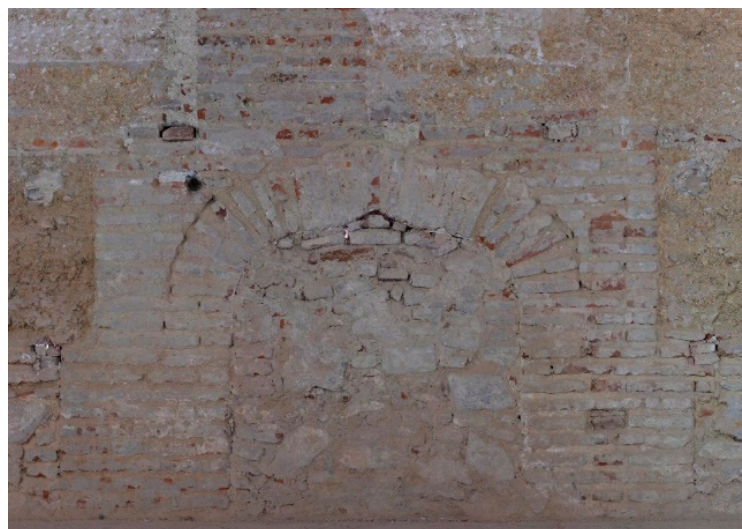
Figure 12. Main door of the original cloister with an ogee arch on the top.

This austerity was broken in Facing 2, located at the N of the cloister. In it, just a door is documented, located in the exact center of the wall, and it has an ogee arch on the top. Despite this stylistic license, the door presents a similar size to the rest of the documented doors (Figure 12). The fact of locating just a door in this facing, centered concerning it and with a slight stylistic and formal difference concerning the others, leads us to believe that it would have been the point of access to the noblest area of the monastery at that time, perhaps a chapel or some other room of rank and importance in the life of the monastery.

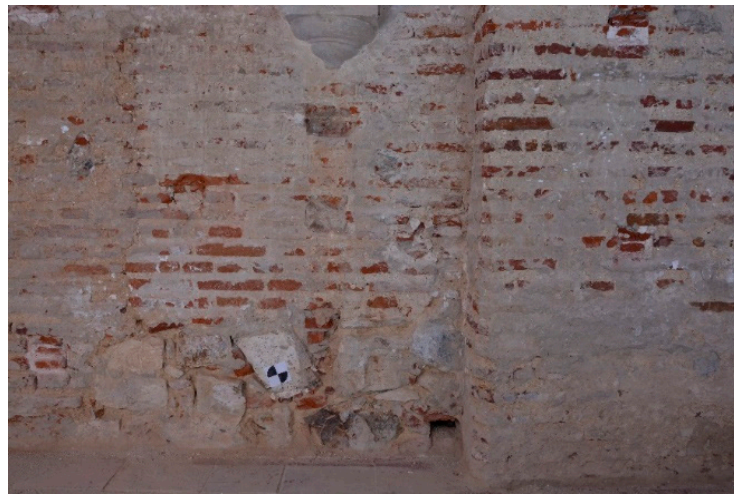
Figure 13. Detailed image of the facing of the church, the original wall and the reforms of the cloister.

Between 1623 and 1716, the edification of San Diego’s Church took place, which is completely attached to the W flank of the cloister, causing the almost total transformation of this. We say “almost total” because only a small residual sample of the original masonry can be seen at the N end of Facing 1, which we already mentioned in the previous section (Figure 13).

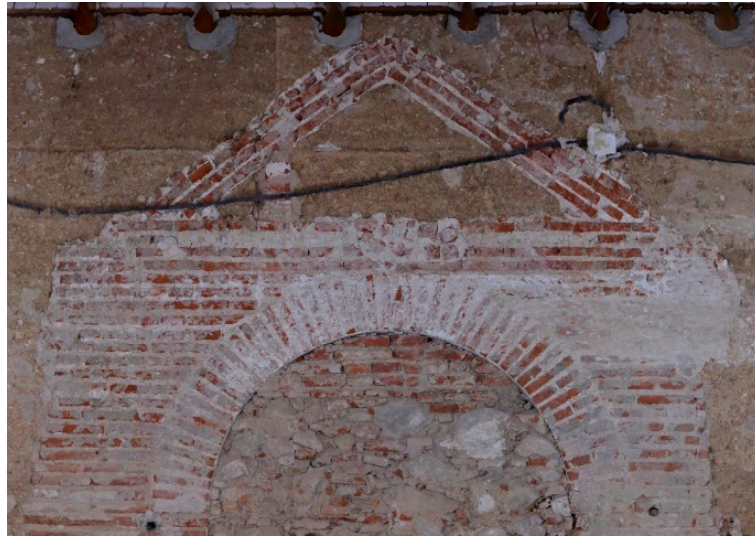
Figure 14. Detail of the front and the semicircular arch of the new open portal on Facing 2.

The most noticeable change was the one produced on Facing 2, where another new door was opened immediately beside the one existing in the previous phase. This new door was bigger than the previous one, presenting a triangular front at the top, of which only the traces of its fitting into the original masonry of the cloister wall remain (Figure 14).

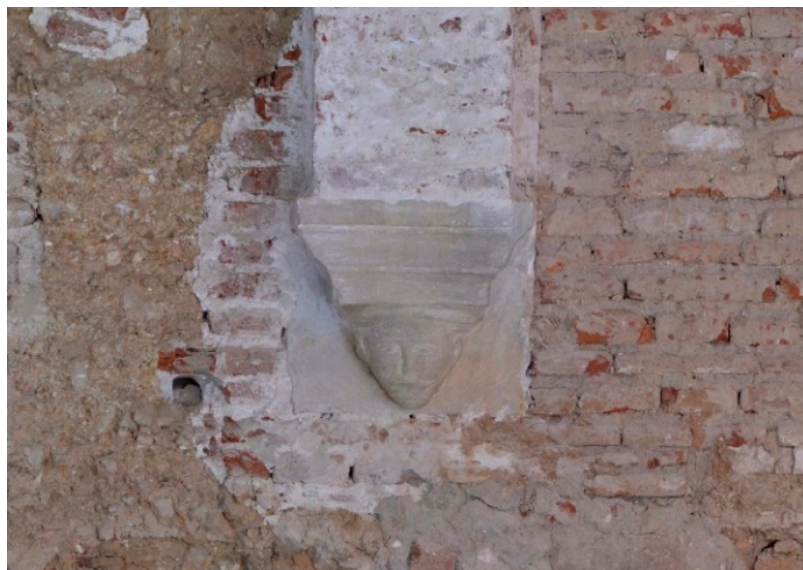
Figure 15. Corbel in the shape of a human head from an arch in the porticoed gallery on Facing 2.

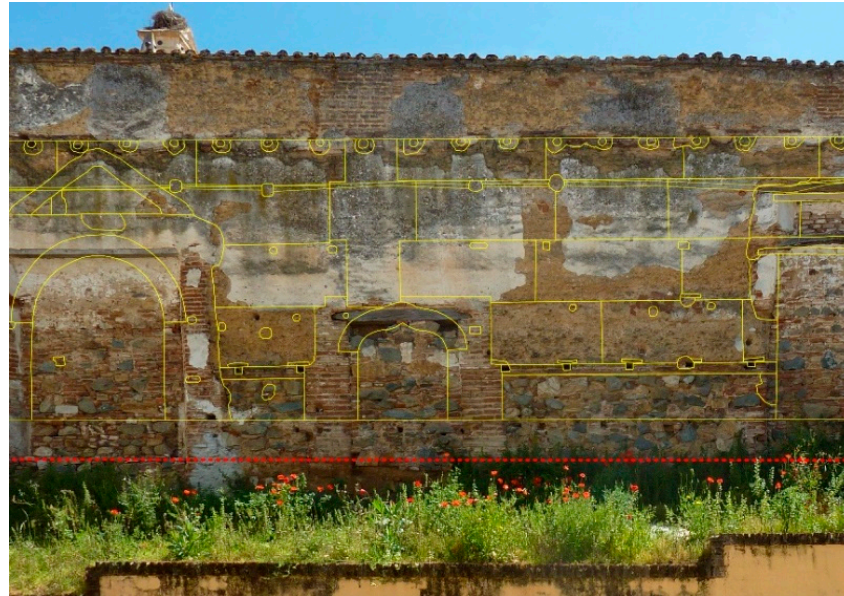
Figure 16. North Facing 2, with the elements of the south face, georeferenced and indicating the original floor level of the cloister.

Another significant aspect of his facing is the elevation of the pavement coordinate of the cloister, elevating it up to reach the usage level that is observed in the current days. Thanks to georeferenced photographs of Facing 2 and superimposing on it the mapping of the main components of the wall obtained from the orthophoto generated by photogrammetric methods for this work, it can be established that the original pavement is approximately 0.60 m below the current one (Figure 16).

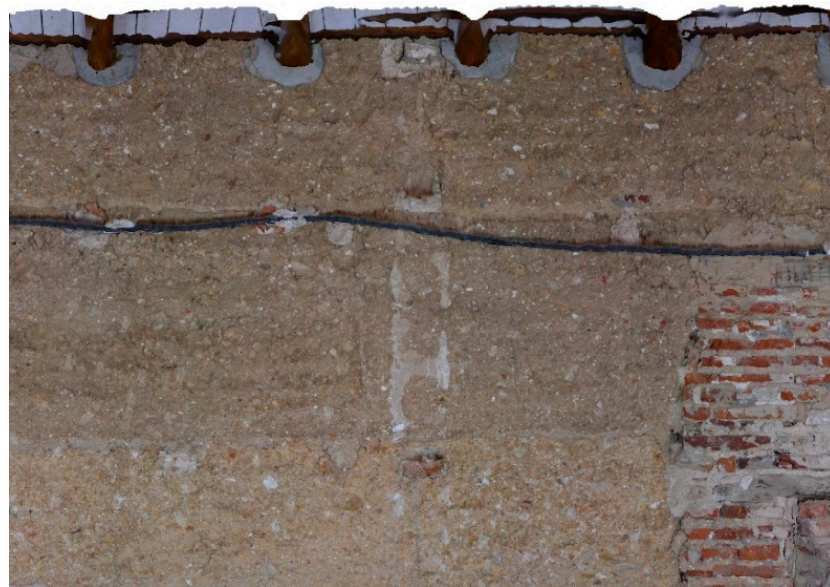
Figure 17. Imprint of the market walls, drawn on the wall of the cloister.

What is more, a series of brick quoins, loosely embedded in the original walls, are placed along the whole length of the cloister gallery, so that they share the cloister (Figure 17), defining different quadrangular spaces used as stalls for the sale of goods traded in the market.

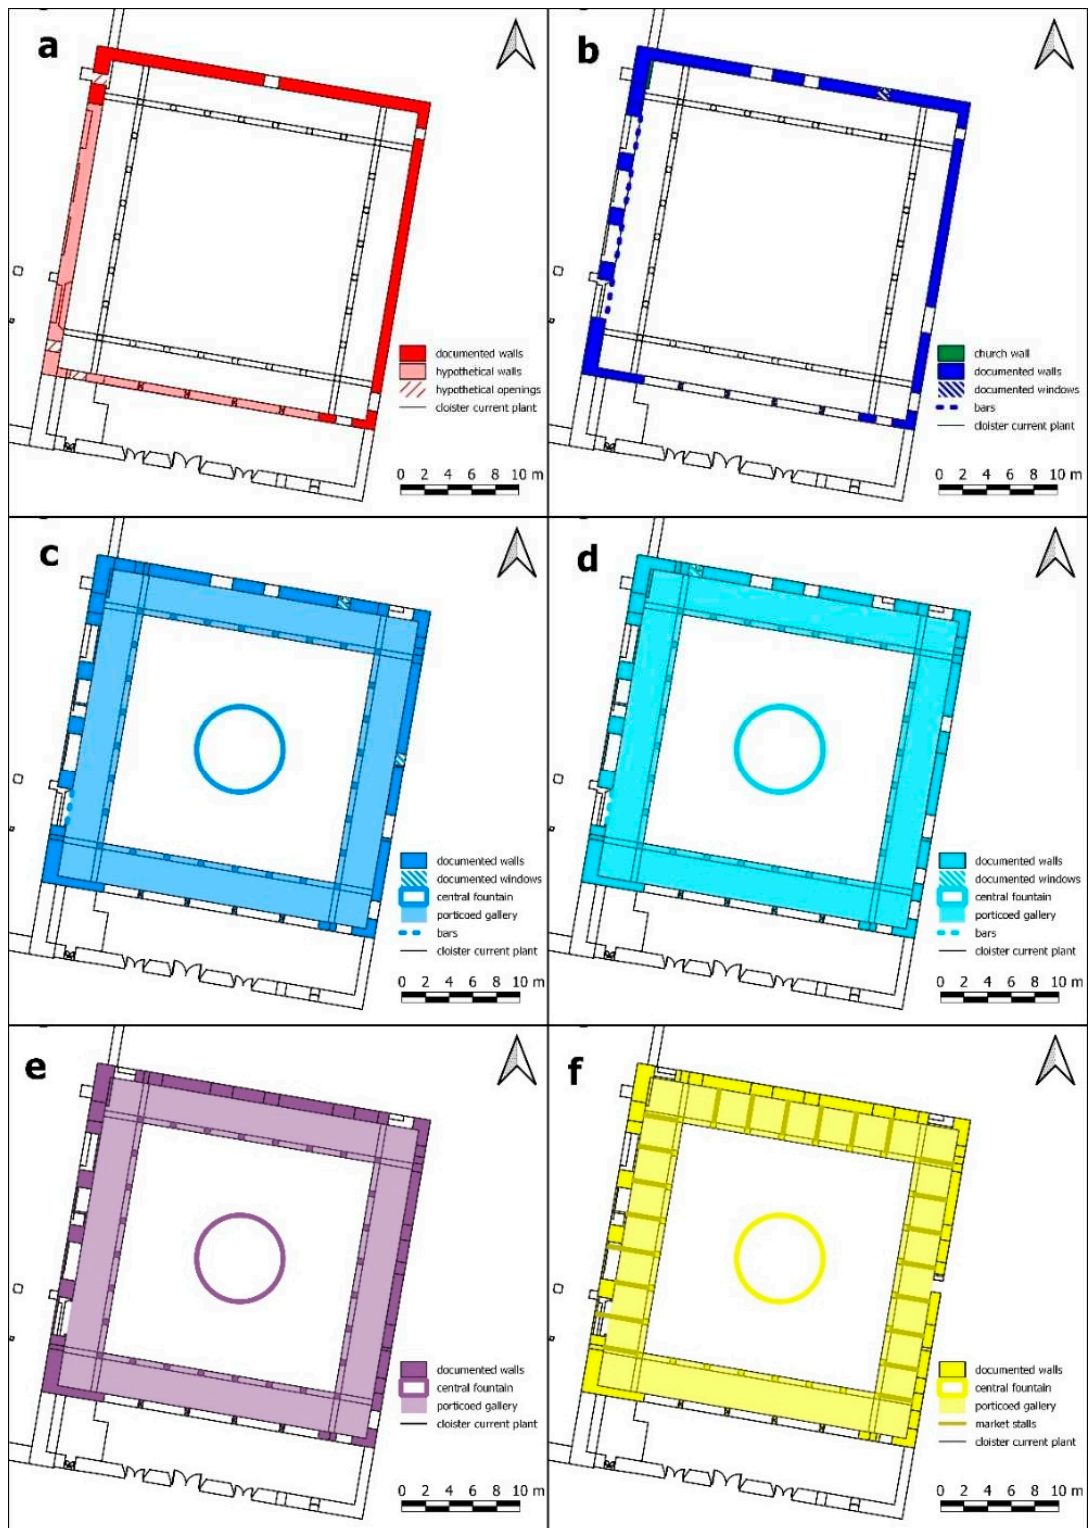
Figure 19. Evolution of the cloister: (a) original building, circa 1588; (b) first reform of the cloister encouraged by the construction of San Diego's Church attached to its flank W, from 1623 to 1716 (ending year); (c) remodeling because of the addition of a porticoed gallery with arcades, during 17th century; (d) light reforms from the 18th century; (e) remodeling due to the fact of the Spanish confiscations and the implementation of a schnapps factory in its environment, from 1835 and during the rest of the 19th century; and (f) transformation for the market's adequacy, circa 1940.

The last great reform of the cloister was produced so as to make it adequate to serve as the Municipal Food Market circa 1940 (Figure 19f).

All the remaining hollows were closed completely and just one new hollow was opened in the middle of the E facing, so as to give access to the dependencies of the new market located on the other side. As commented above, the stands are arranged under the porticoed gallery, building brick quoins from each column of the gallery to the corresponding wall of the cloister at its perpendicular. This way, 23 stands are available.
