Review: Best Practices In Educating  
Sustainability and Heritage

# Casa Diáñez (Diáñez House)

## Rehabilitation of Casa Diáñez. Alcalá de los Gazules

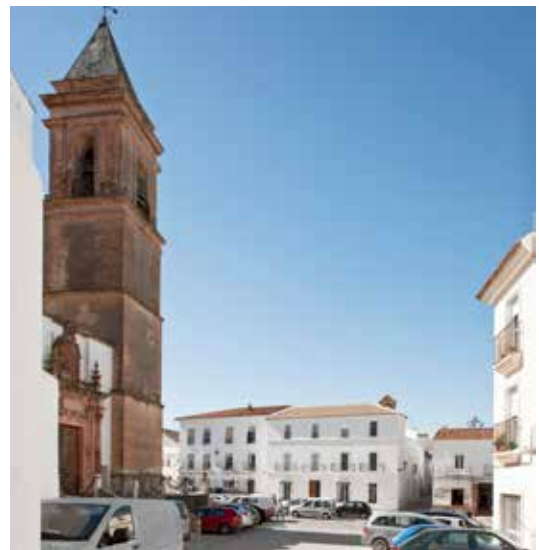
Figure 2. Casa Diáñez (Diáñez House), Plaza San Jorge

The building was in a poor state of general repair and underwent shoring and structural consolidation work in 2005. The most significant damages affected roofs and floor slabs, mainly due to the poor condition of the wooden load-bearing elements - both beams and boards - which led to the fall of entire sections in some areas of the building, the appearance of deformations and the loss of tile pieces in the gables with the consequent general lack of water tightness of the roofing system. However, the load-bearing structure of the masonry walls remained solid and showed no significant damage, except for occasional pathologies due to the absence of cladding material.

Recovery of the typology through the consolidation of the structure and the potential character of the courtyard.  
Elimination of the stairs to relocate them next to the rear party wall.  
Suppression of internal partitions in certain bays.  
Replacement of the contemporary sloping roofs with terraces.

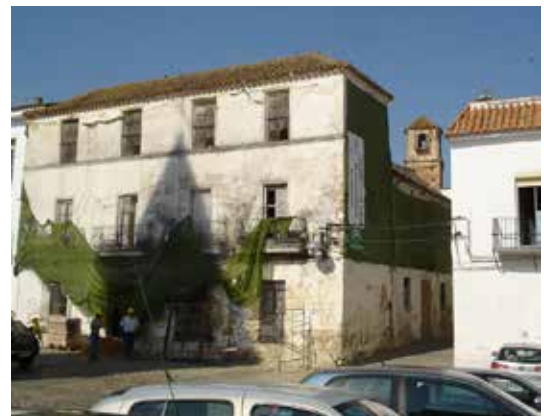
Figure 3. Exterior view before the intervention. Source: Document provided for the restricted proposal competition by Consejería de Obras Públicas y Transportes, Junta de Andalucía, 2005.

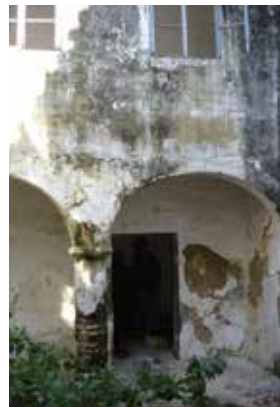
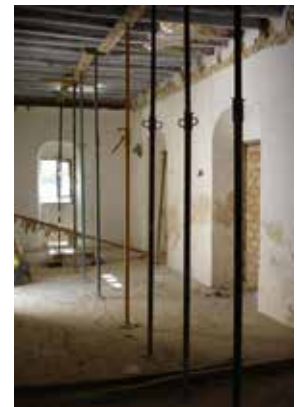
Figure 4. View of the arcades before the intervention and Figure 5. Interior view before the intervention. Source: Document provided for the restricted proposal competition by Consejería de Obras Públicas y Transportes, Junta de Andalucía, 2005.

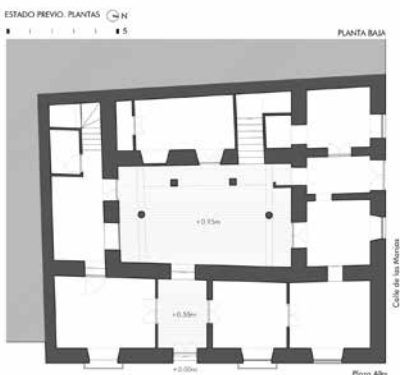
Figure 6. Ground floor before restoration  
Author: Francisco Reina Fernández-Trujillo.

The house stands on a plot with a geometry similar to a rectangle of 15x12 m, structured around a central courtyard of 5.5 x 4.5 m with four perimeter bays. The clear interior spans are approximately 3 m in the outer bays and 2.50 m in the inner bays. On the two smaller fronts of the courtyard, arcades are built to support galleries at the first-floor level. The arcades are made up of a double carpanel arch with a brick masonry column as an intermediate support. Functionally, the manor house was structured by levels; ground floor for service activities, offices, storerooms, or stables; first floor for housing and second floor for storing foodstuffs or household goods.

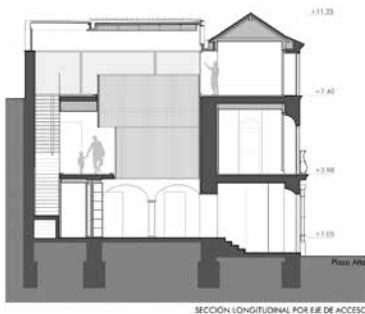
Figure 7. Longitudinal section

The adaptation of the new spaces is entrusted to light and unitary structure that is introduced into the building, transforming its section and intertwining naturally with the pre-existing. The courtyard, the new axis of routes and circulations, becomes the backbone of the house. Its treatment with wooden lattices combined with glass elements nuances the relationship between the void, the rooms, and the circulation spaces, diluting its limits to make the house lighter as we ascend. Transparencies, glazing, permeability, brightness and reflections give the building a public and institutional character, compatible with the more domestic image of the original house.

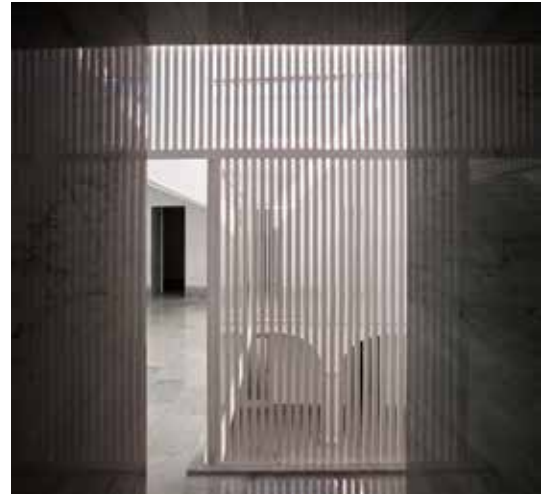
Figure 8. View through wooden lattices after the intervention.

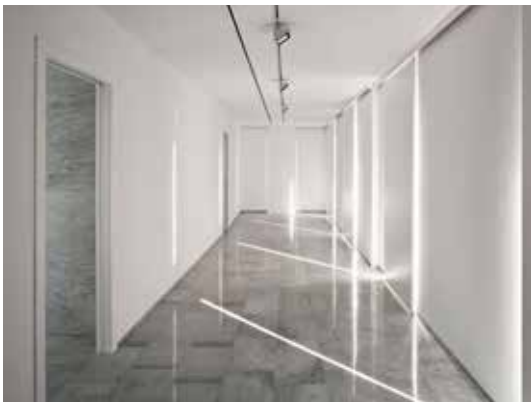
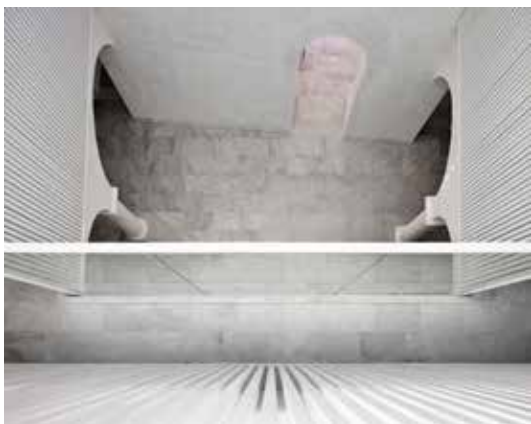
Figure 9. a) View of the interpretation room and b) View of the courtyard from second floor.

On the technical side, energy efficiency interventions are proposed through passive actions (such as the treatment of light through the courtyard or the control of orientations). A decentralised air-conditioning system was incorporated to make each floor independent. Finally, photovoltaic solar energy panels were not installed due to the use of the building. From a functional point of view, it is proposed to flexibly adapt the uses demanded, allowing for other future occupancy alternatives.

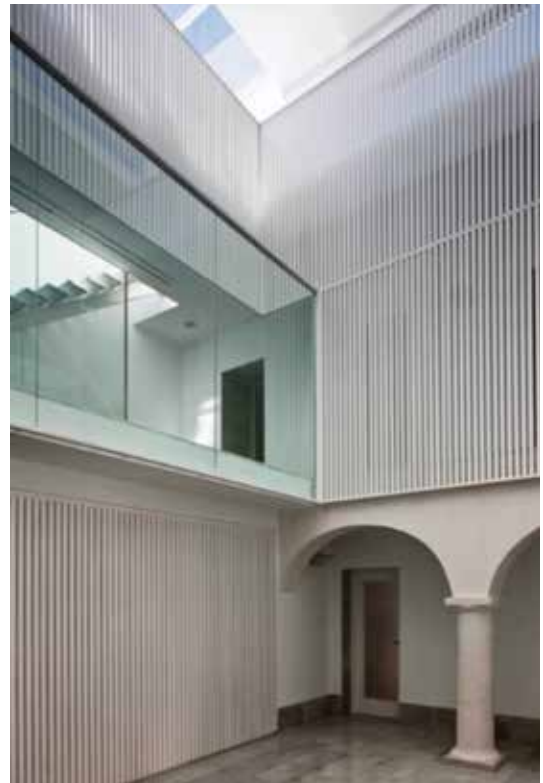
Figure 10. View of the courtyard after the intervention.

The proposal transcends the conservation of the building that is the object of the intervention to “recover the urban and natural (cultural) landscape” in which it is inserted. In this way, the intervention in the courtyard, in addition to “capturing the light”, seeks to establish visual relations with other heritage elements in the surroundings, such as the tower of the church of San Jorge (to the east), the tower of the convent of Santa Clara (to the west) and the castle tower of tribute from the north terrace.
