# Analysis of the influence of the block in the dynamic properties of domestic buildings with masonry structure.

## ABSTRACT

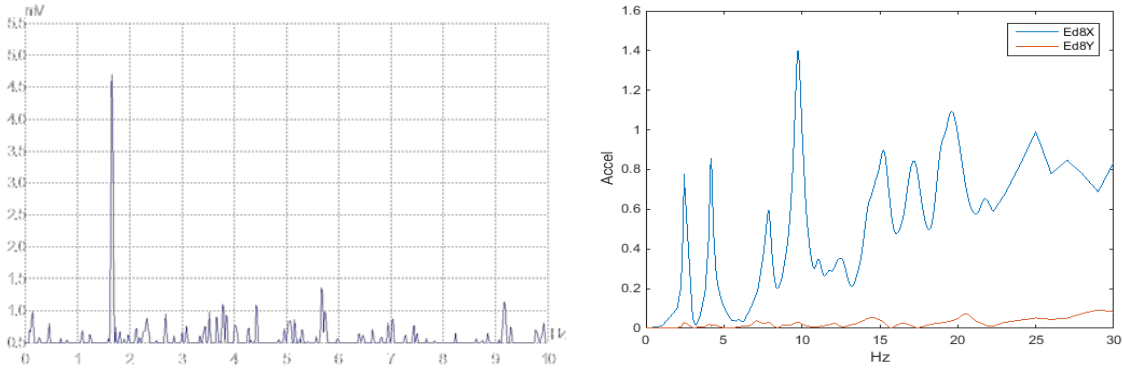
**Figure 1.** Response diagrams obtained by accelerometer (left) and FEM (right).

using finite element method (FEM). Later, in a second phase, the results of these models will be compared with those obtained on real buildings using an accelerometer test (Fig. 1).

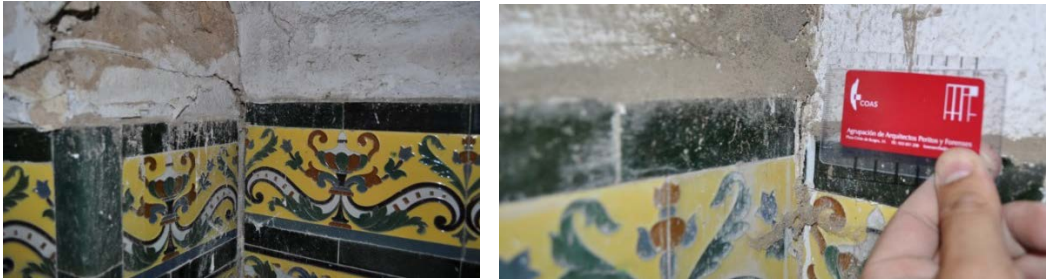
**Figures 2 y 3.** Offset between tiled baseboards.

The seats on the walls, can be seen in the tiled plinth (fig. 2, 3 and 4). We suppose that this coating was not constructed with the gap we can see today.

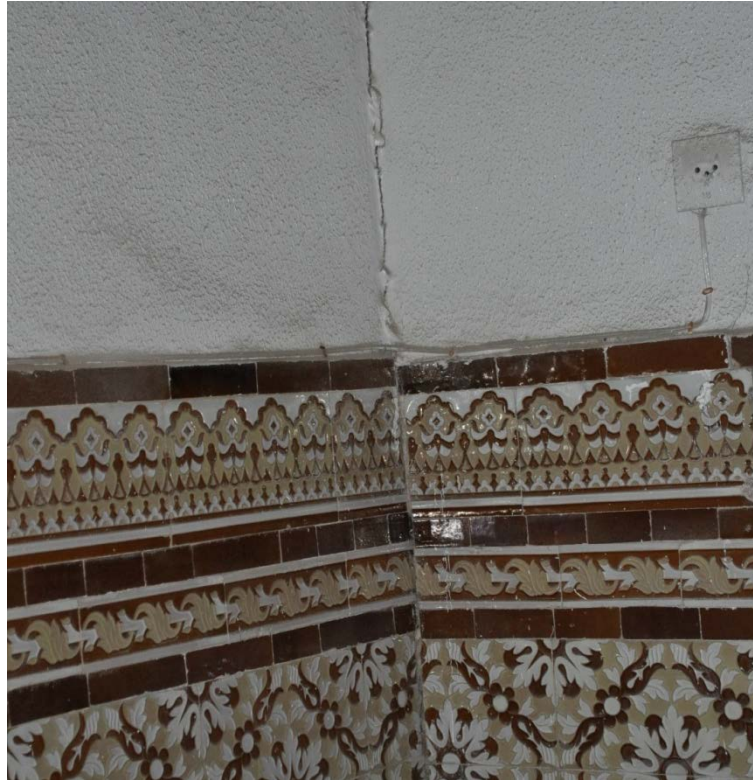
**Figure 4.** *Offset between tiled baseboards and cracks in the ground floor walls.*

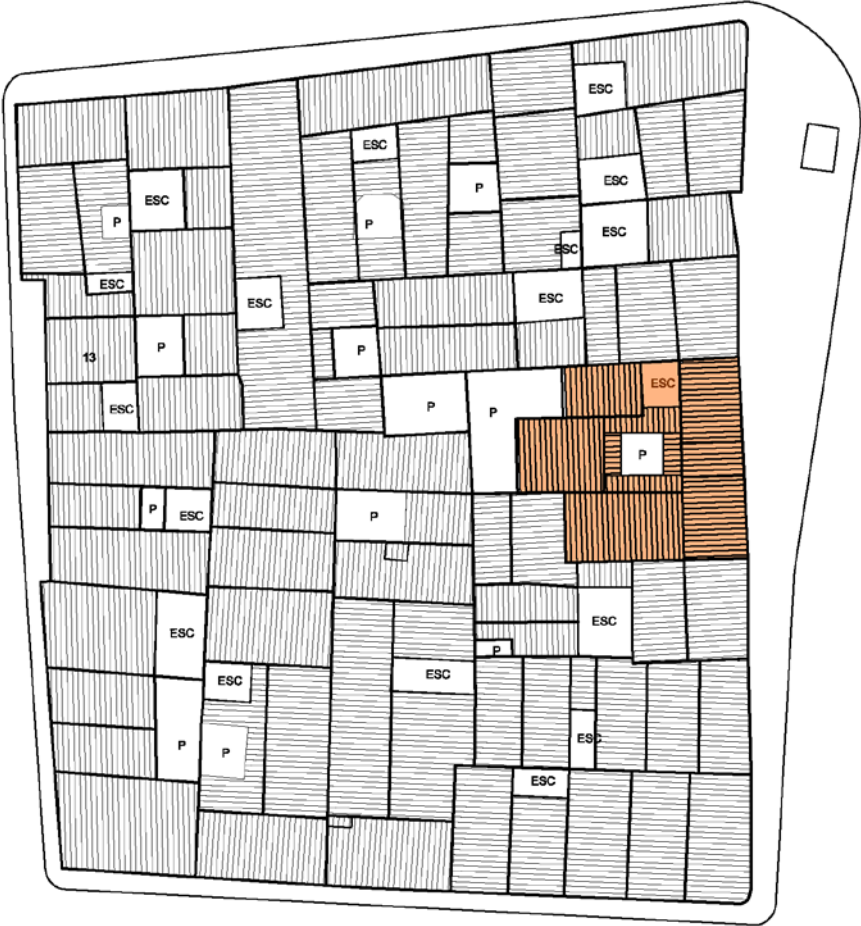
**Figure 5.** Block scheme, indicating the situation of the selected building.

We carried out various dynamic analysis on a FEM model of a building located within a block. To this end, we have chosen a medium type block and we have selected a building located in the middle of one of its edges.

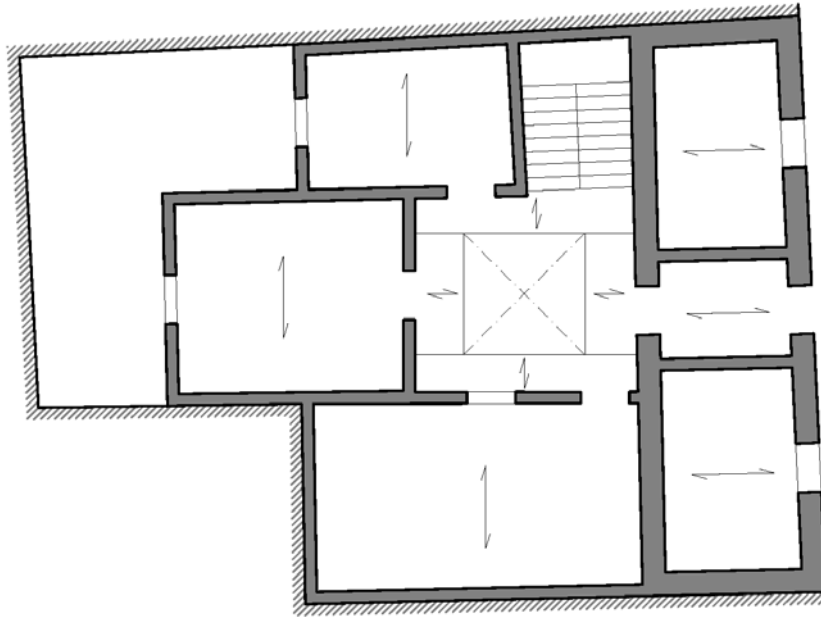
**Figure 6.** Floor scheme of the selected building.

The selected building fits the target of the research project: It is a three-storey building with traditional masonry structure. It has a first span parallel to the facade, a central courtyard with a perimeter gallery, two lateral bays and one end bay perpendicular to the facade.

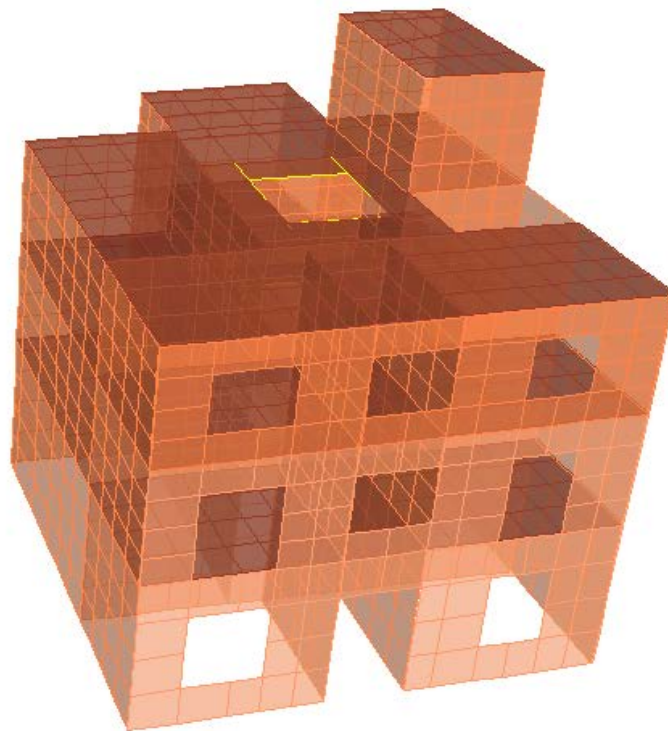
**Figure 7.** 3D presentation of isolated building FEM model.

The dynamic response analysis was carried out by the finite element method (FEM), using the computer program Sap2000. On all calculated models, we have discretized walls and floors with surface elements (*shell*) and beams with linear elements (*frame*). In fig. 7 and 8 there are represented FEM models of the isolated building and the full block.

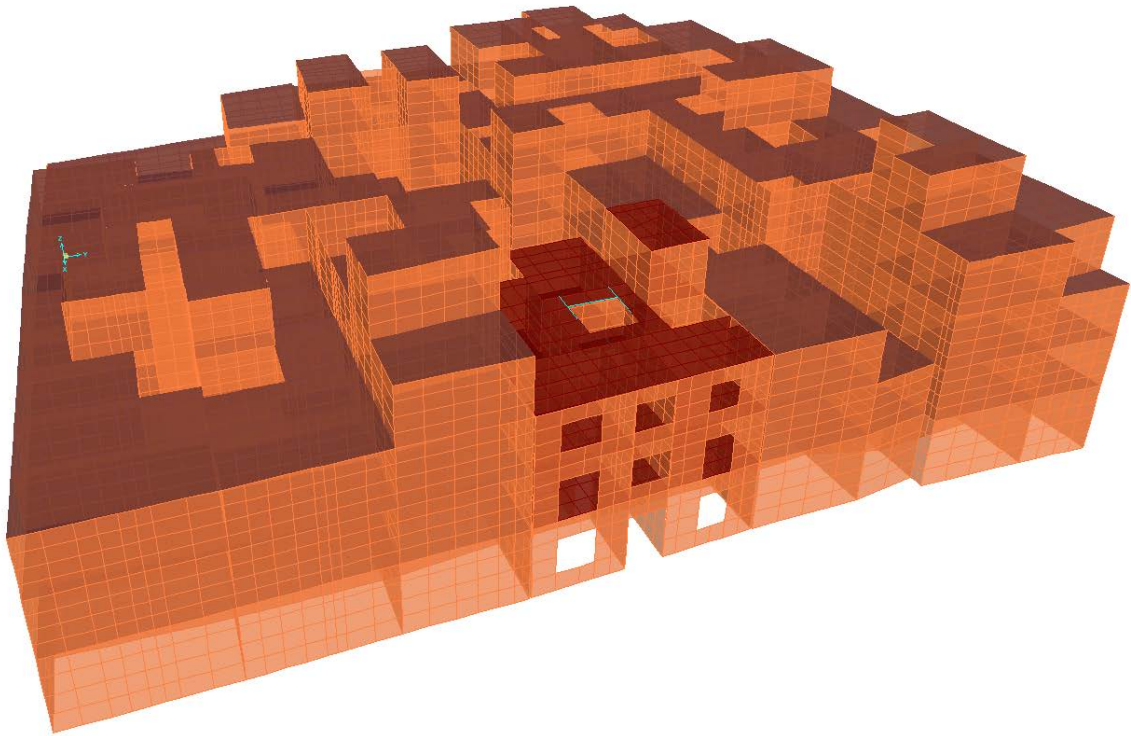
**Figure 8.** 3D presentation of the block FEM model.

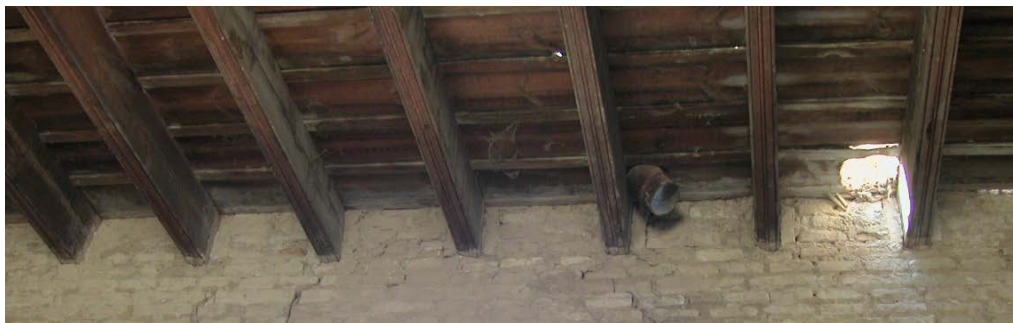
**Figure 9.** Floor constructed with wooden beams and planking.

The floor has been discretized by assimilation to a flat slab. We have used a constant modifier for the longitudinal bending stiffness ( $M_{11}$ ). In the several calculations, we have used modifiers to reduce transverse bending stiffness ( $M_{22}$ ) and the floor stiffness to tangential stresses ( $F_{12}$ ). In this way we can simulate slabs and one way slabs with or without a compression coat (Fig. 9).

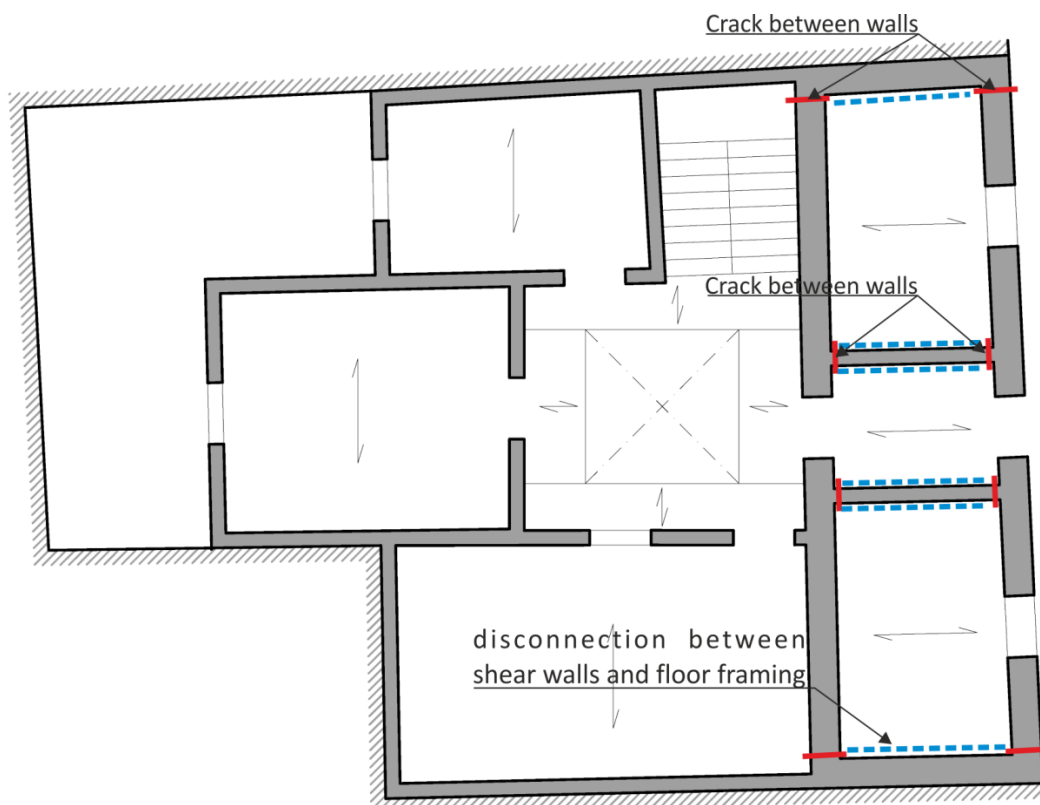
**Figura 10.** Esquema del edificio con indicación de las lesiones que se han introducido.

Of the various damages, we have selected those located on the first bay (Fig. 10). In this position and due to the positioning of the joists perpendicular to the facade, the stiffening effect of the block is obviously lower than the inner region.

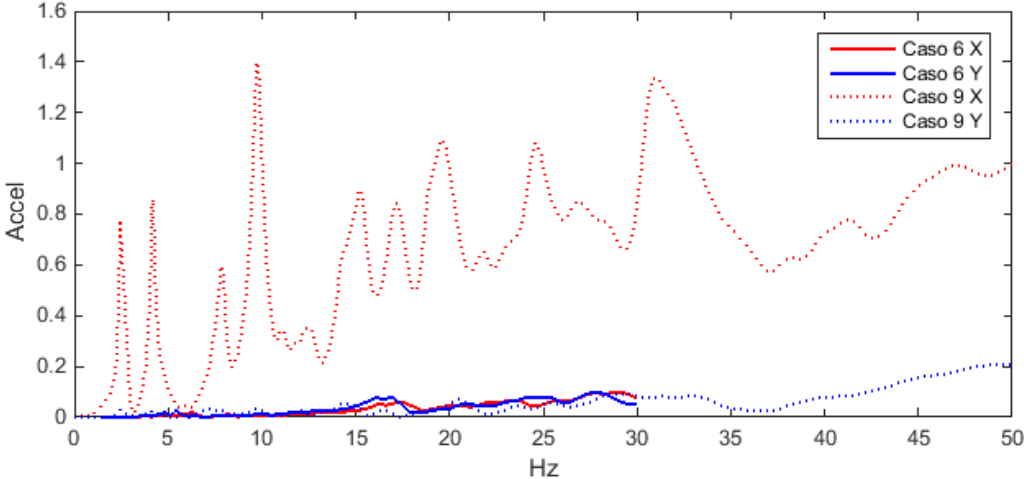
**Figura 11.** Dynamic response graph for the studied point. Case 6 (isolated building with flexible floor and without damages) and case 9 (isolated building with flexible floor disconnected from shear walls and cracks between bearing walls and shear walls).

We found that when the floor only has a wood plank (without diaphragm effect) instead a compression layer, a significant difference in terms of scale appears on the curve corresponding to response in the X direction (perpendicular to facade). In Fig. 11, we can see the difference between case 6 (isolated building with flexible floor and without damages) and case 9 (isolated building with flexible floor disconnected from shear walls and cracks between bearing walls and shear walls).

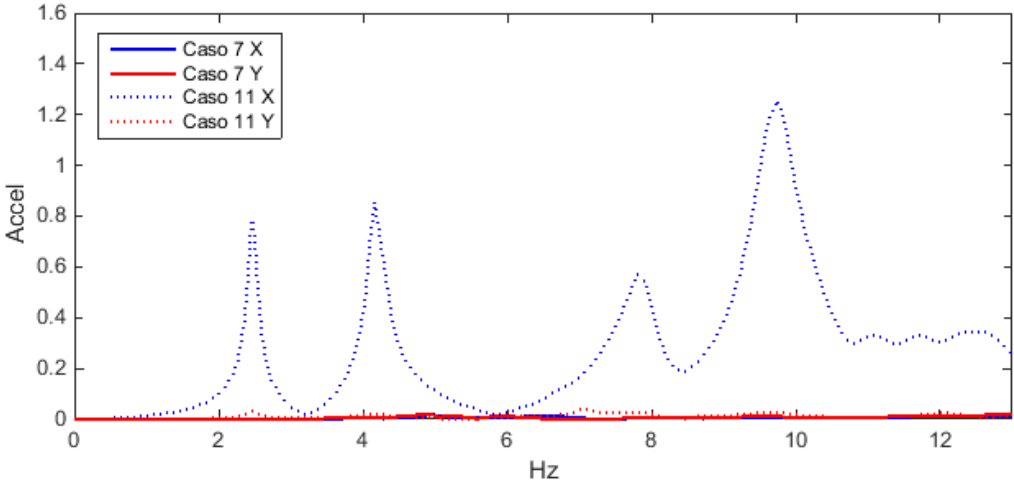
**Figura 12.** Dynamic response graph for the studied point. Case 7 (Clustered building with common party wall, flexible floor and without damages) and case 11 (clustered building with common party wall, flexible floor disconnected from shear walls and cracks between bearing walls and shear walls).

In a similar study (Fig 12) including the block (cases 7 and 11), we can see that a great difference

appears again in X direction (perpendicular to facade).

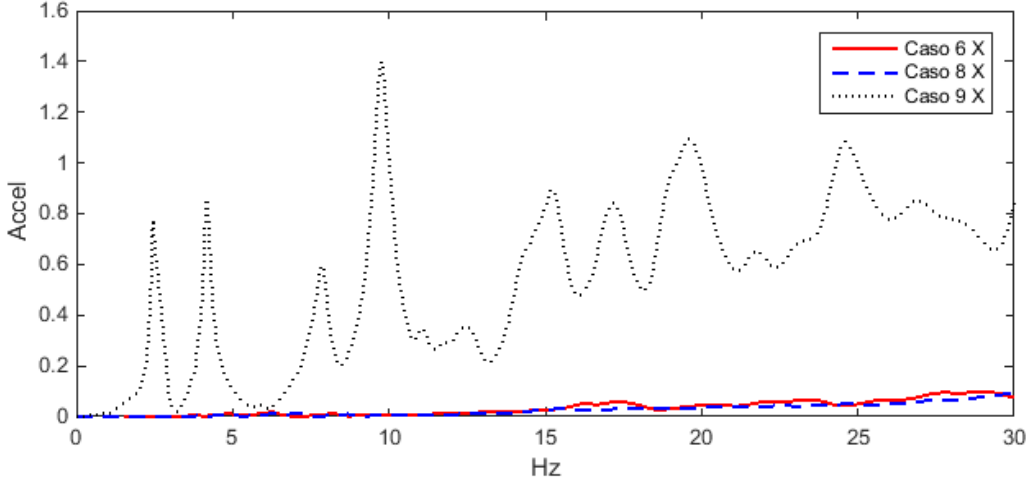
**Figura 13.** Dynamic response graph for the studied point. Case 6 (isolated building with flexible floor and without damages), case 8 (isolated building with flexible floor and crack between bearing walls and shear walls) and case 9 (isolated building with flexible floor disconnected from shear walls and cracks between bearing walls and shear walls).

In figure 13 we have focused on the response in the X direction (perpendicular to facade) and cases 6, 8 and 9 have been overlapped. We can see that the response of Case 8 (isolated building

with flexible floor and cracks between bearing walls and shear walls) is very similar to Case 6 (isolated building with flexible floor and without damages).

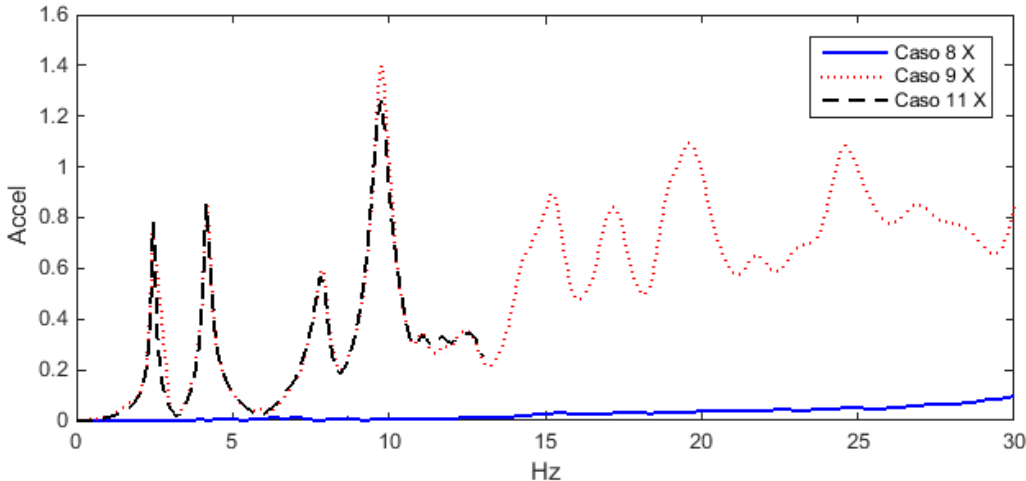
**Figura 14.** Dynamic response graph for the studied point. Case 8 (isolated building with flexible floor and crack between bearing walls and shear walls), 9 (isolated building with flexible floor disconnected from shear walls and cracks between bearing walls and shear walls) and 11 (clustered building with flexible floor disconnected from shear walls and cracks between bearing walls and shear walls).

Moreover, in Fig. 14 we can see how the block (case 11) does not affect the dynamic response of the building. Curves 9 and 11 almost directly coincide.

In the results presented in the previous section, we note that, in the case of buildings with a flexible floor disconnected from shear walls and with cracks between bearing walls and shared walls, the dynamic response perpendicular to the facade rise hugely. For this particular case, the block has little effect on the response in that direction, as shown in Figure 14.

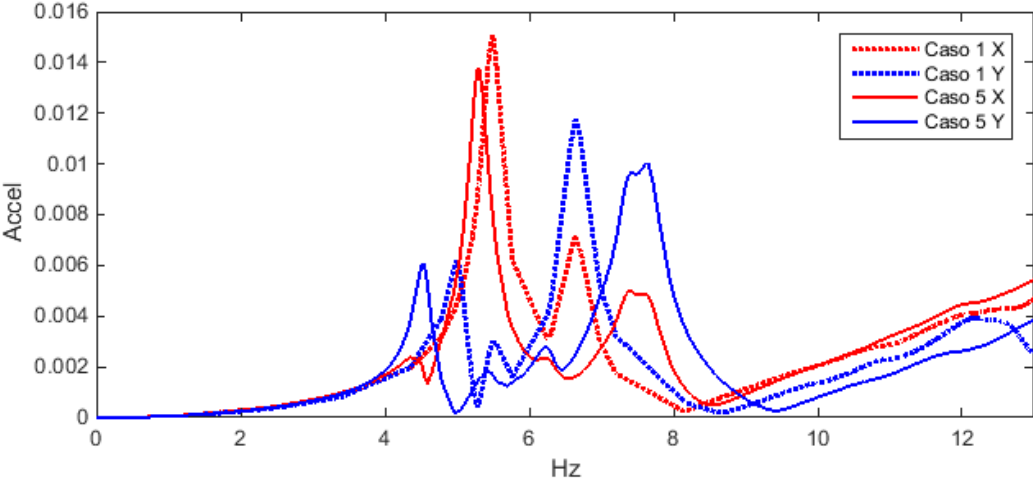
**Figure 15.** Dynamic response graph for the studied point. Case 1 (isolated building with rigid floor and without damages) and case 5 (isolated building with rigid floor disconnected from shear walls and cracks between bearing walls and shear walls).

Fig. 15 corresponds to cases with a rigid floor frame (with diaphragm effect). In it, we find that the difference between Case 1 (isolated building with rigid floor and without damages) and Case 5 (isolated building with rigid floor disconnected from shear walls and cracks between bearing walls and shear walls) are quite subtle. We have changed the vertical scale (accel.) to tell the difference.

However, when the floor is connected with shear walls, or when the floor framing is rigid, the change in the dynamic response is too weak to identify by few simple tests, as we can deduce from the figures 15 and 16. Therefore, in these cases, the block doesn't causes significant effects on the dynamic response of the building.

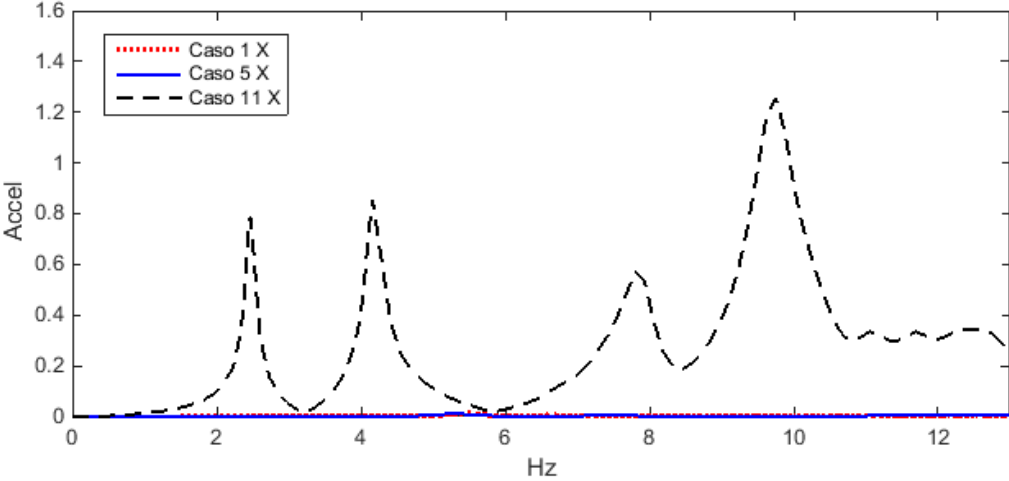
**Figure 16.** . Dynamic response graph for the studied point. Case 1 (isolated building with rigid floor and without damages), case 5 (isolated building with rigid floor disconnected from shear walls and cracks between bearing walls and shear walls) and case 11 (clustered building with flexible floor disconnected from shear walls and cracks between bearing walls and shear walls).

In fig. 16 we have superimposed case 11 on the graph of fig. 15, in order to see the difference between the rigid and flexible floor framing, when the floor is disconnected from shear wall
